PE19-004  
KIA  
6/28/2019  
DEFECT C  
TECHLINES  
FORTE KOUP

PE19-004\_Expanded Scope\_Forte  
Koup\_Alleged Defect C

# Kia Motors America Technical Assistance Center

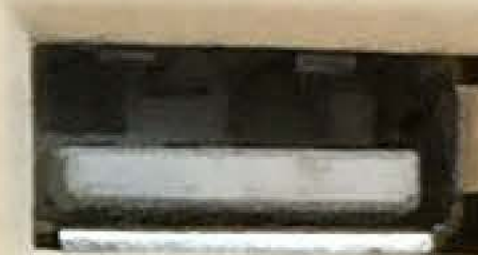
BLACK+DECKER

120W AC120V  
OUTPUT

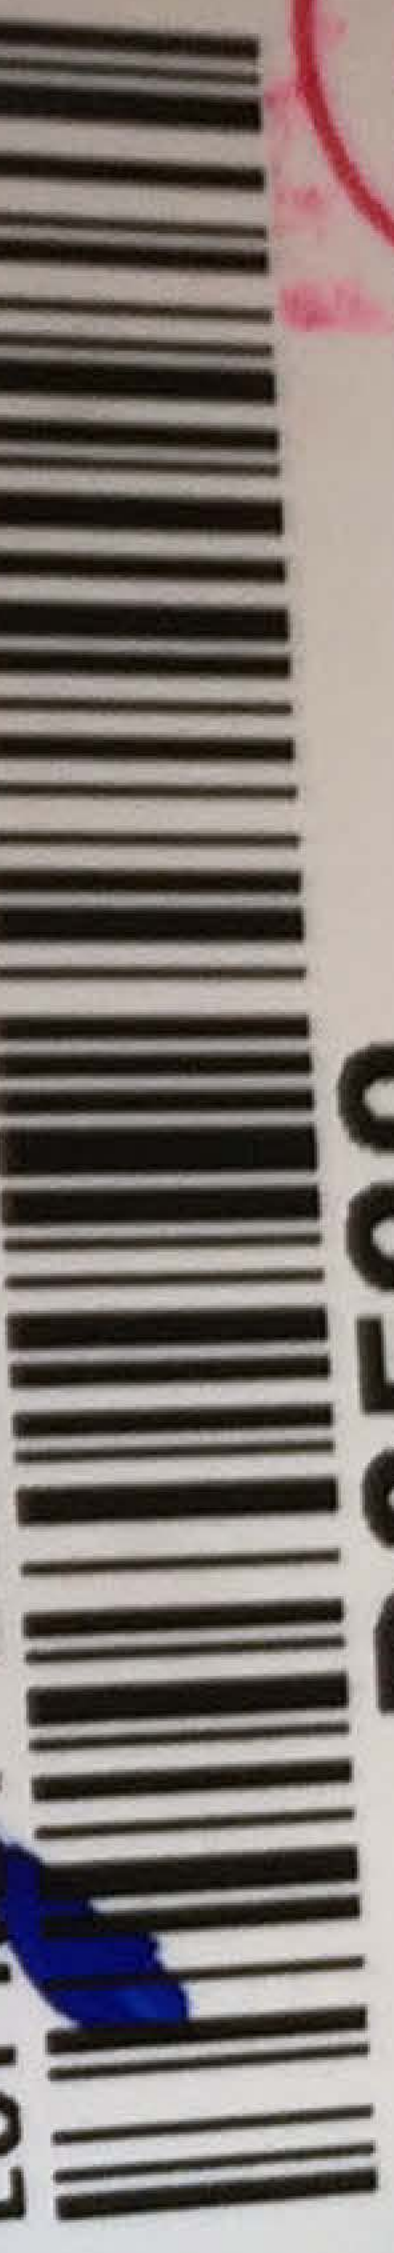
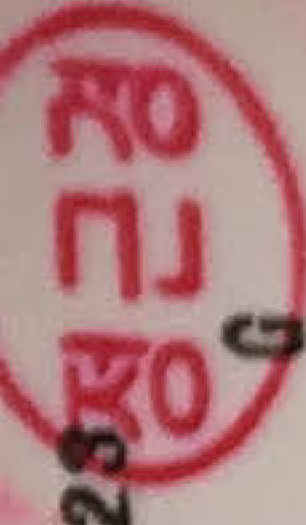
91950 - **D9530**

checked and found control box for trailer harness had melted, checked harness for any damage none found internal short in box.

LOT NO.: D95301605131822 H: 1.01 S: 1.02
