PE19-005

ISUZU

Campaign CB11-J-002 Cruise
Control Will Not Cancel

Campaign CB11-J-002 Cruise Control Will Not Cancel - Safety Recall 11V-415 (Transport Canada # TC)

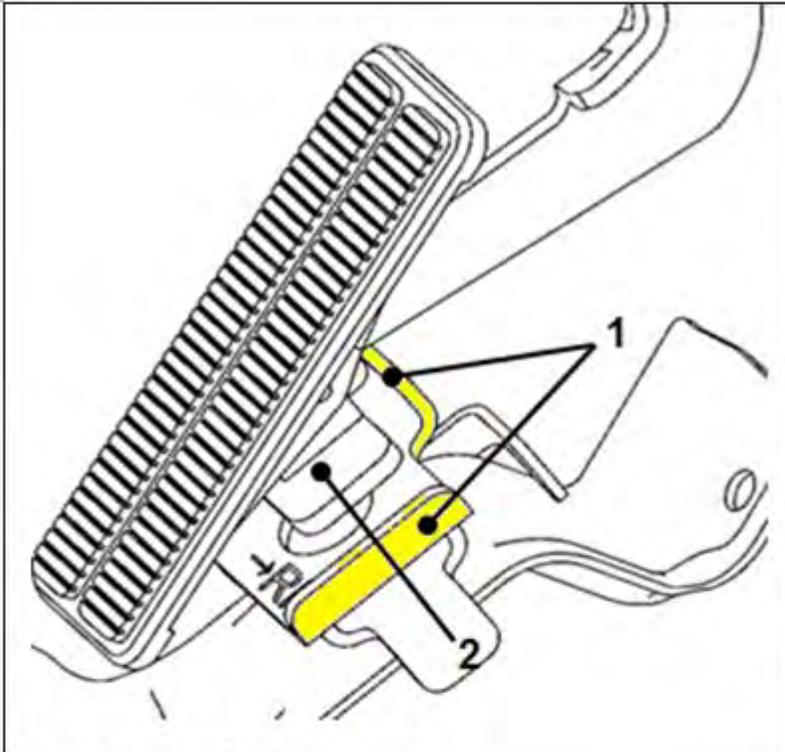
Figure 5 – View From Right Side

5. Depress the accelerator and ensure the stopper plate does not hit the flanged area of the stopper bracket (see Figures 5 and 6).

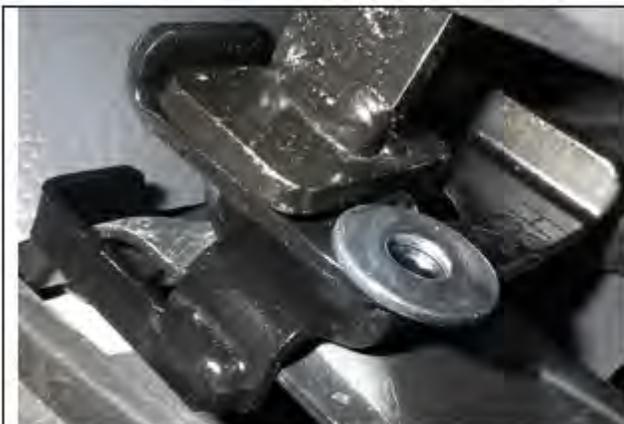
Figure 7 – View From Left Side

b. If the stopper plate does not contact the stopper bracket, check the clearance by depressing the pedal to WOT and attempting to insert one of the washers provided with the stopper bracket between the stopper plate and the stopper bracket (see Figure 7).

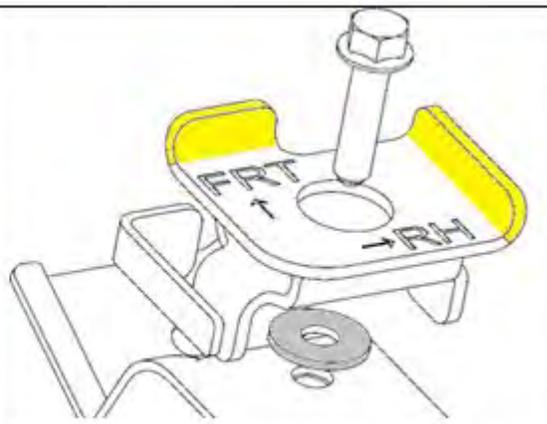
Figure 8 – View From Left Side. Yellow indicates stopper bracket flange.

ii. If the washer does fit between these two parts, remove the stopper bracket and add the washer between the stopper bracket and the floor (see Figure 8), and reinstall. This will adjust the clearance. Check the clearance again by repeating Step 6 with the second washer and follow the results.

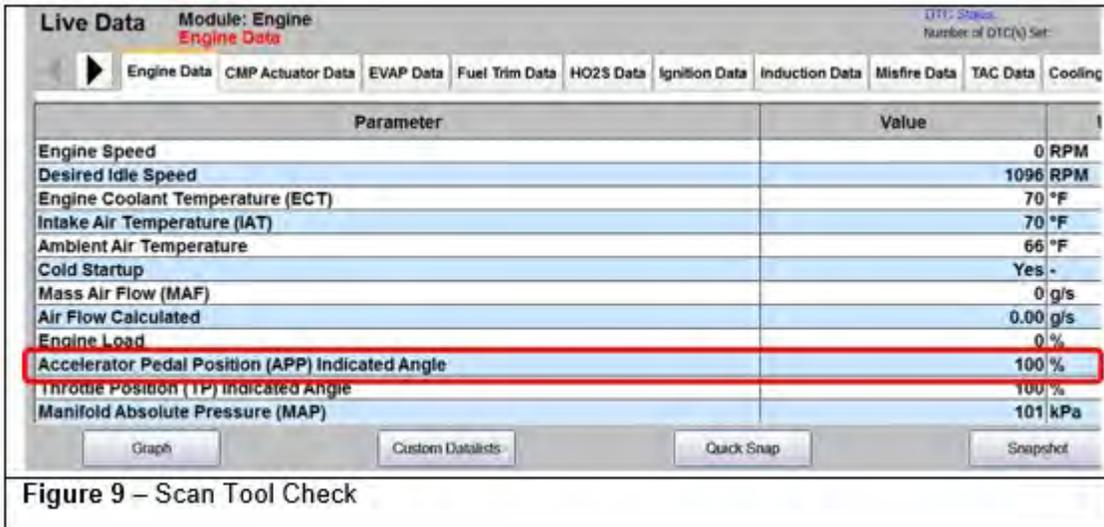
7. Connect IDSS, turn the key ON/engine OFF, and navigate to the engine control module data list to confirm “Accelerator Pedal Position (APP) Indicated Angle” parameter is at 100% during WOT (see Figure 9).

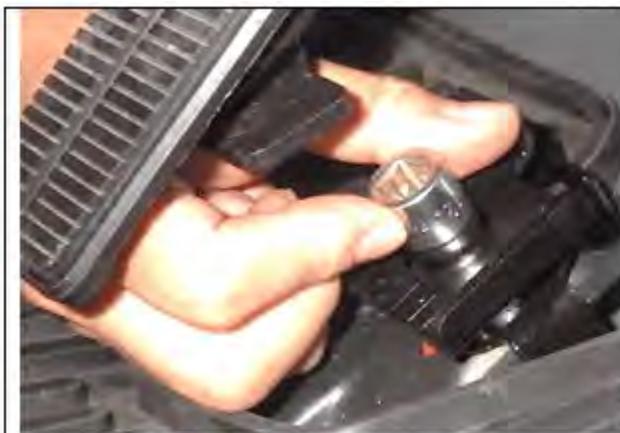
Figure 3 – Temporary Bracket Installation

4. Temporarily install and hand tighten the new stopper bracket using the new bolt provided (see Figure 3). When tightened (even by hand), the head of the new mounting bolt should be below the flat surface of the new stopper bracket. Be sure the stopper bracket is aligned properly (see Figure 4).

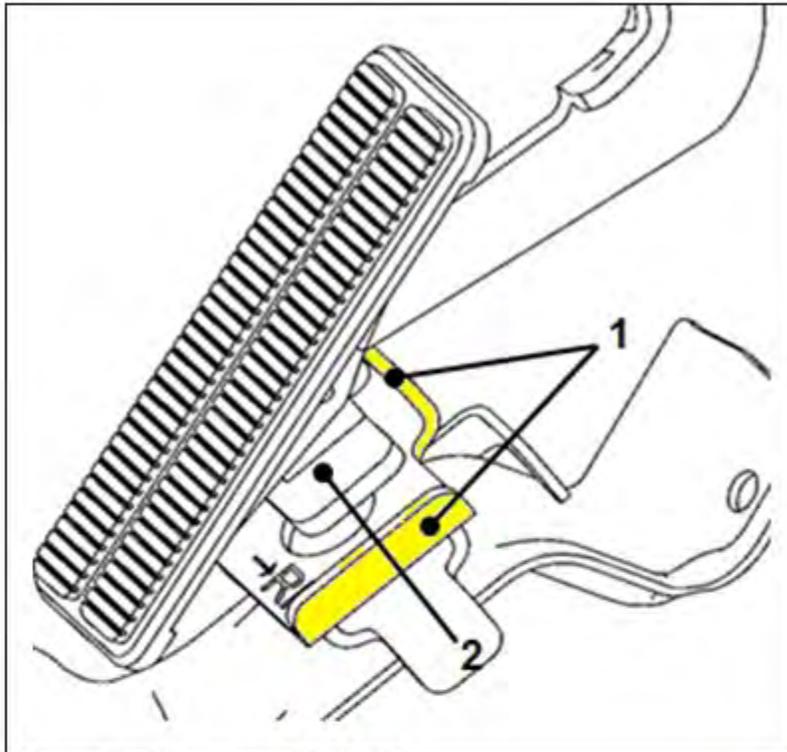
Figure 5 – View From Right Side

5. Depress the accelerator and ensure the stopper plate does not hit the flanged area of the stopper bracket (see Figures 5 and 6).

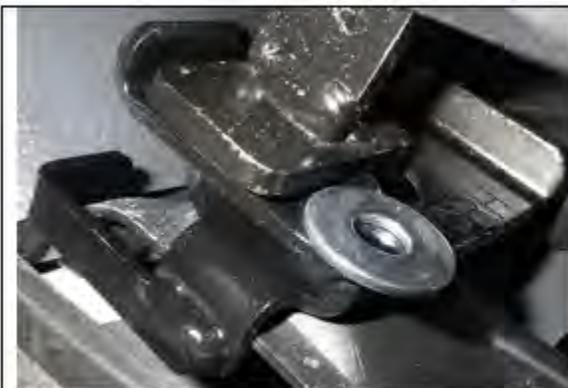
Figure 7 – View From Left Side

b. If the stopper plate does not contact the stopper bracket, check the clearance by depressing the pedal to WOT and attempting to insert one of the washers provided with the stopper bracket between the stopper plate and the stopper bracket (see Figure 7).

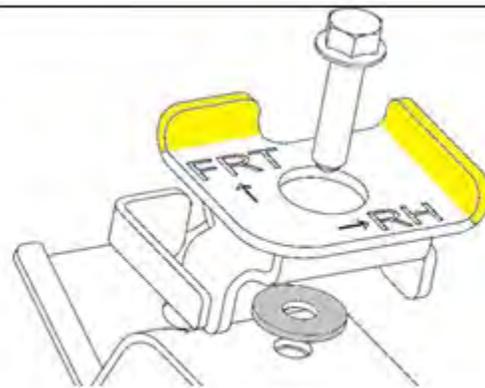
Figure 8 – View From Left Side. Yellow indicates stopper bracket flange.

ii. If the washer does fit between these two parts, remove the stopper bracket and add the washer between the stopper bracket and the floor (see Figure 8), and reinstall. This will adjust the clearance. Check the clearance again by repeating Step 6 with the second washer and follow the results.

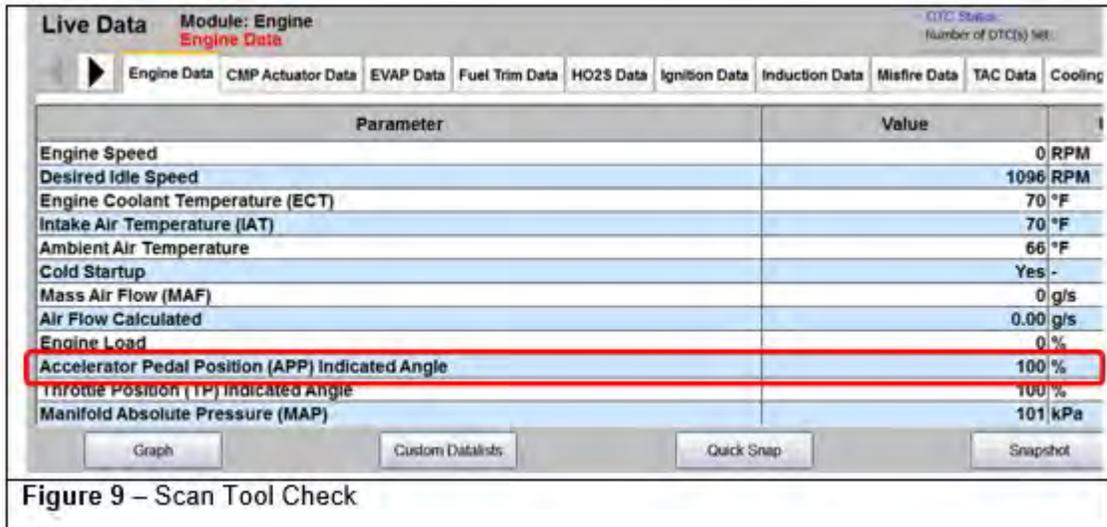
7. Connect IDSS, turn the key ON/engine OFF, and navigate to the engine control module data list to confirm “Accelerator Pedal Position (APP) Indicated Angle” parameter is at 100% during WOT (see Figure 9).

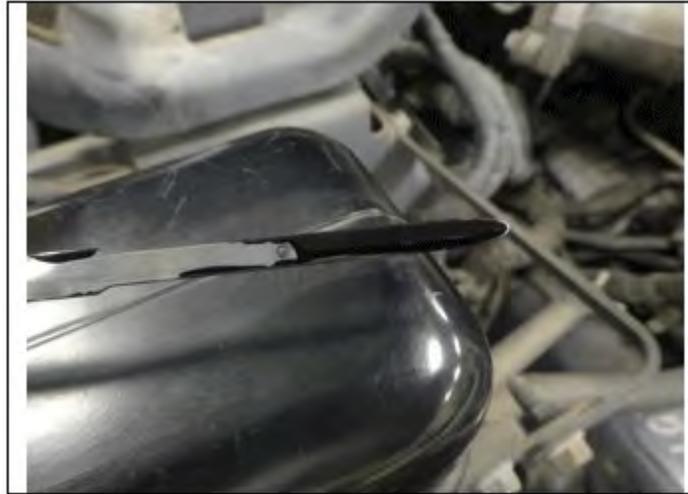
Figure 1.

1. Engine oil is overfilled during maintenance.

Refer to figure 1 for correct oil level on a dipstick.

When refilling the engine oil, refer to the Workshop Manual (WSM) for the oil capacity of the engine you are servicing. Fill the engine with about 80% of the oil capacity. Start the engine to allow the oil filter to fill. Turn the engine off and allow the oil to drain down for several minutes, then check the dipstick. Continue to add oil as necessary to bring the level up to the full mark on the dipstick.
