# 2016 Forester B1650/B1760 QRA

# Customer states Air Bag Indicator on.

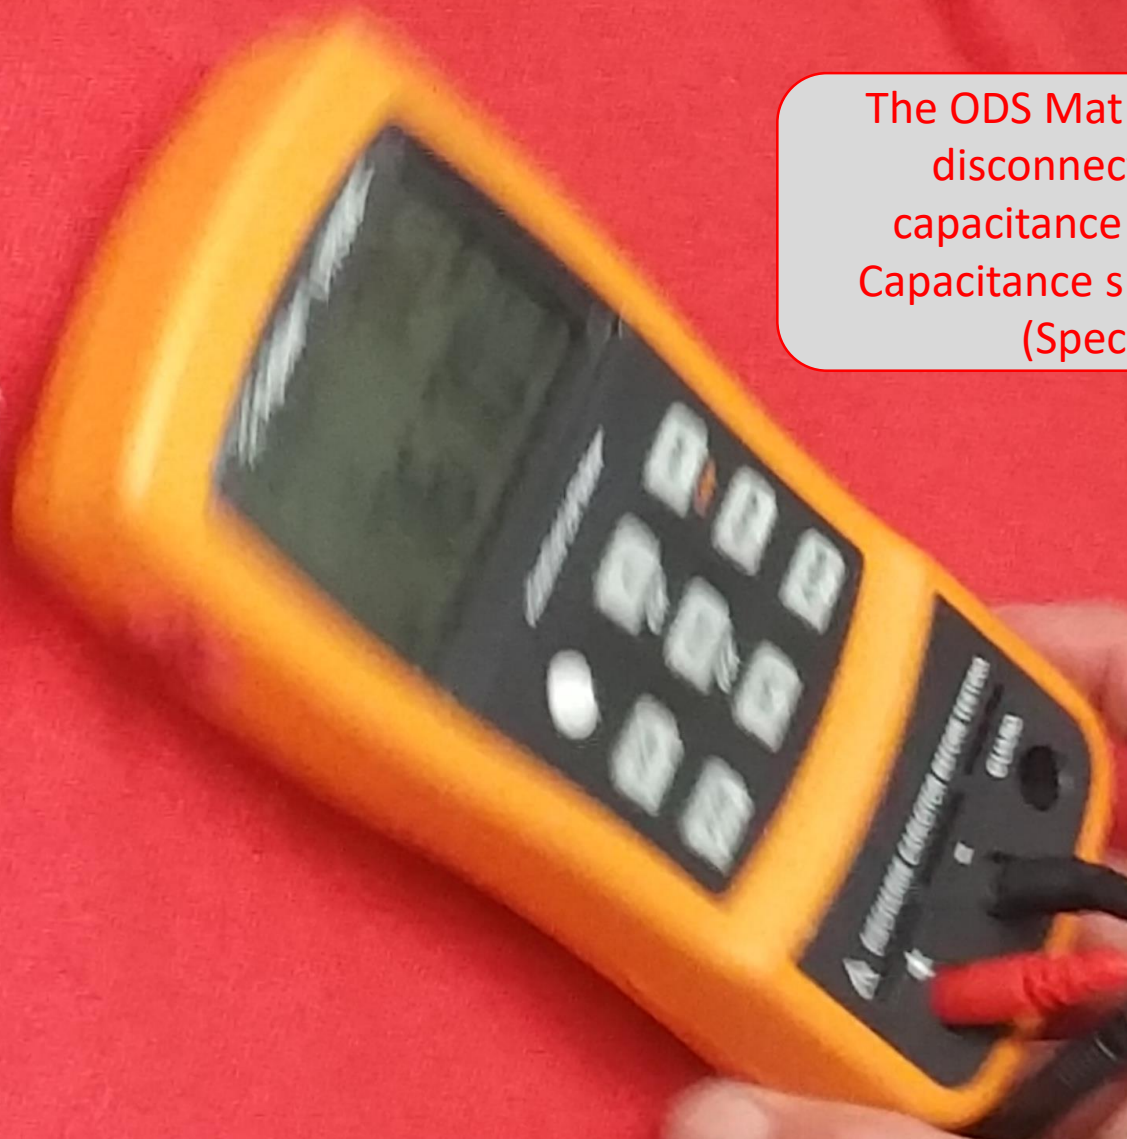
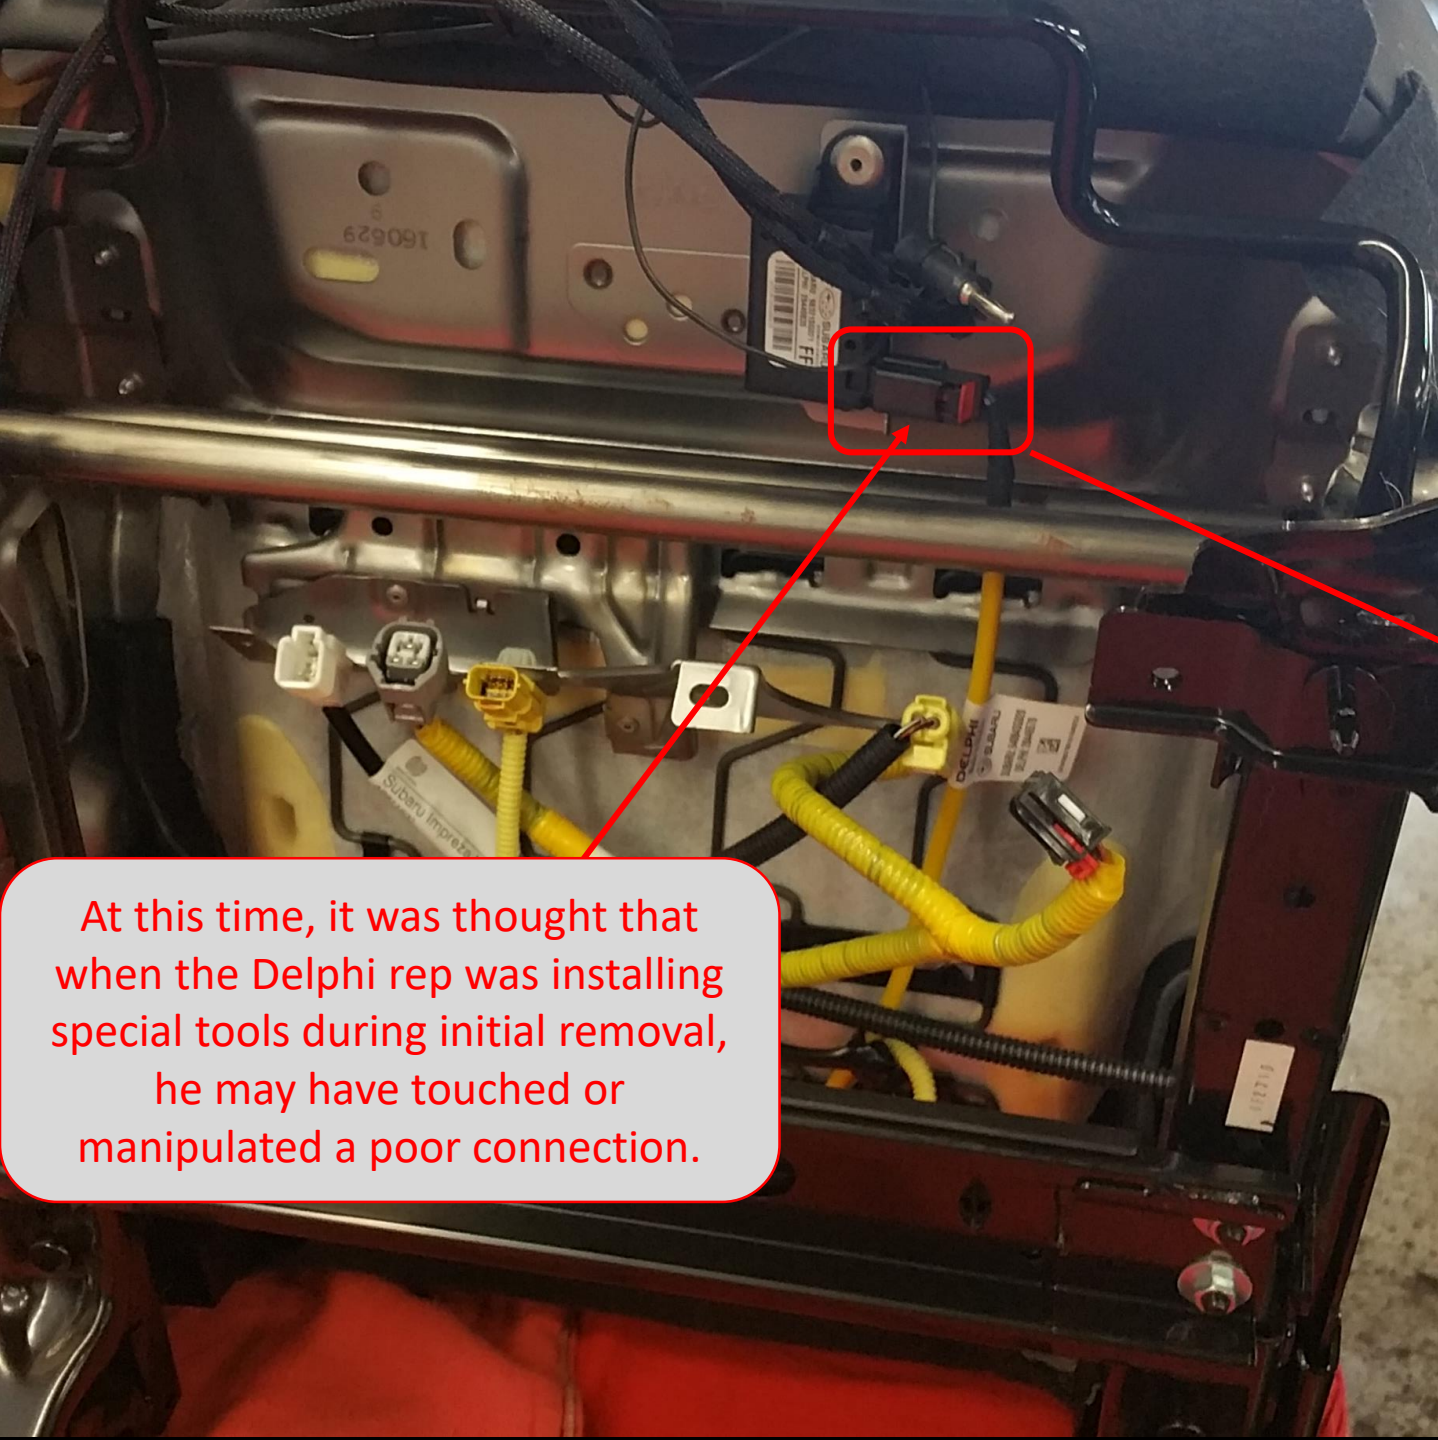
The ODS Mat connector was disconnected and the capacitance was checked. Capacitance showed at 7.6nF (Spec 7-8nF)

At this time, it was thought that when the Delphi rep was installing special tools during initial removal, he may have touched or manipulated a poor connection.
