STAR CENTER NEWS

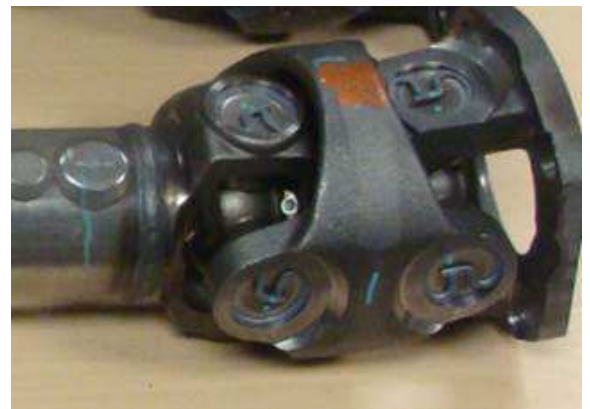
Double Cardan Joint Maintenance

Since 2005 model year, 2500/3500 Ram 4X4 trucks have been using a double cardan universal joint on the front propeller driveshaft (pictured below).

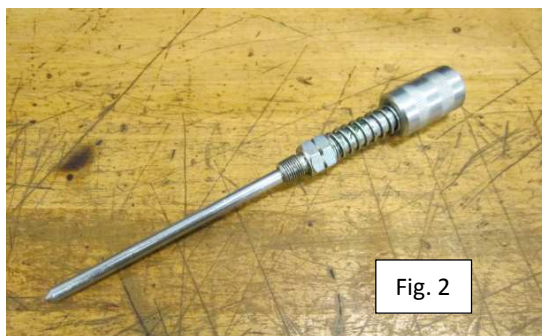
The fitting is actually a conical depression in the joint that has a small steel check ball at the bottom.

The design and location of the fitting requires a special grease nozzle (Fig. 2) to access the lubrication point.

The Maintenance schedule in TechCONNECT and the Vehicle Owner’s Manual indicates lubrication at every oil change.

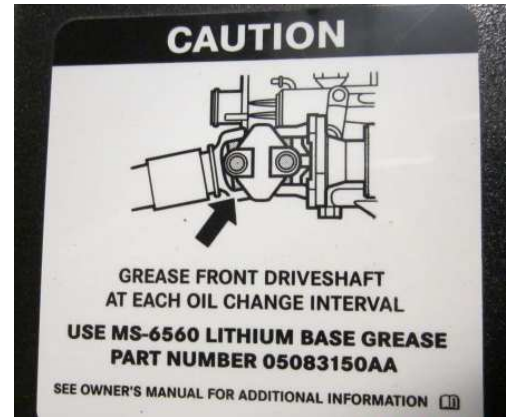
There is also a Caution Label on the left front fender that reminds of the required maintenance and the type of grease that should be used (see below).
