This attachment contains FCA US’ response to the IR issued in Investigation PE19-017, as clarified via email with Ryan Rahimpour of the National Highway Traffic Safety Administration’s (“NHTSA”) Office of Defects Investigation (“ODI”) on January 6, 2020, January 24, 2020 and January 28, 2020.

Mr. Bruce York
Reference: NEF-106 RR; PE19-017
February 28, 2020

ATTACHMENT

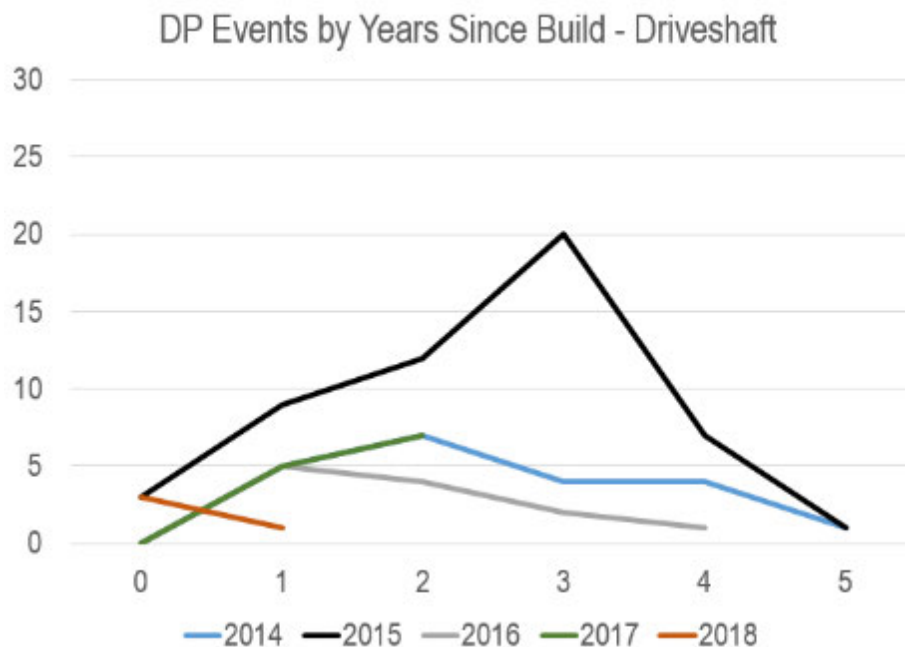
Third, FCA US' records reflect failures only for 2014-2018MY Subject Vehicles. Data of unique driveshaft events stratified by years since build reflects a predominance of driveshaft issues related to 2015MY Subject Vehicles, increasing to a peak at three years, but reducing to low levels consistent with the remaining Subject Vehicle population by the fifth year in service.
