Thomas McCarthy
Head, Vehicle Safety Compliance and
Product Analysis

Reference: NEF-106rr; PE19-017

This attachment contains FCA US’ response to the IR issued in Investigation PE19-017, as clarified via email with Ryan Rahimpour of the National Highway Traffic Safety Administration’s (“NHTSA”) Office of Defects Investigation (“ODI”) on January 6, 2020, January 24, 2020 and January 28, 2020.

ATTACHMENT

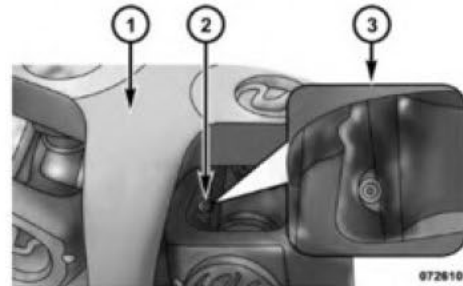
0726101541NA

The grease fitting is located at the rear of the front driveshaft, near the centering mechanism of double cardan joint. Refer to the "Maintenance Schedule" for the proper maintenance intervals. Use Mopar Type MS-6560 (lithium-based grease), or equivalent.

Double Cardan Joint

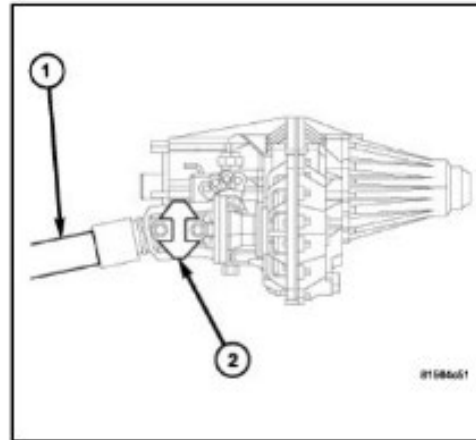
Vehicles with double cardan universal joint front driveshafts (1) are equipped with a grease fitting (2).
