DP20-001

Petitioner email attachment 6-22-2020 - Fifth Addendum to Motor Vehicle Defect Petition

**Fifth Addendum to Motor Vehicle Defect Petition:
Petition to Recall Tesla Vehicles Due To SUA**

June 22, 2020

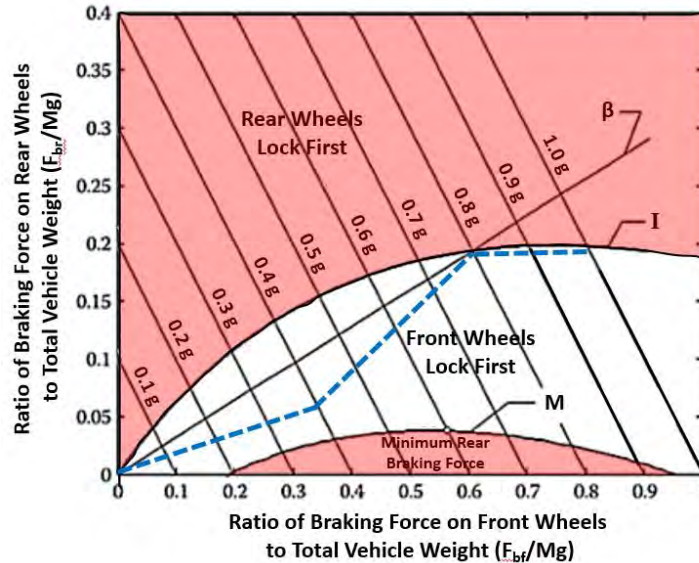
Figure 27. Brake distribution function for the total brake force (friction plus regen).²³
 The dashed blue line shows an arbitrary distribution function possible using the iBooster.

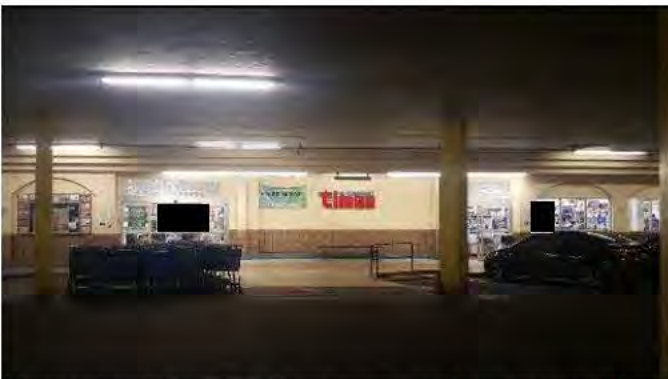
Figure 33. Store entrance near parking space. The parking space with the BMW i3 is to the left.

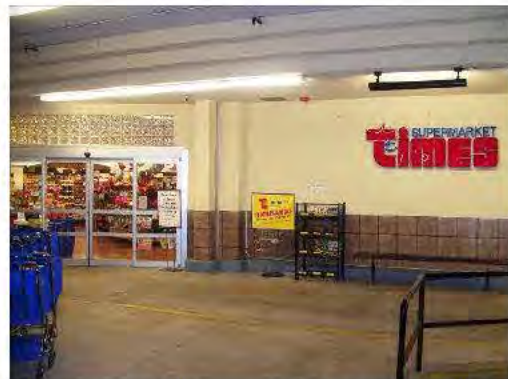
Figure 34. Close-up of store entrance showing the name of the supermarket.

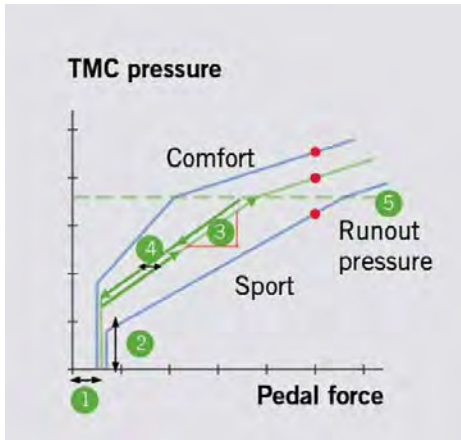
Figure 35 shows three **different transfer functions; a) a gradual one labeled “Sport”, b) a rapid one labeled “Comfort”, and c) an in-between one having no label**. The in-between one is shown with a hysteresis that gives it a slightly different transfer function during brake engagement than during release. The other two transfer functions have a similar hysteresis behavior. The three transfer curves are distinguished by having different values of the same adjustable parameters labeled by the circled numbers in Figures 33 and 34. These parameters will now be discussed.

Figure 35. iBooster TMC pressure versus pedal force showing three possible transfer curves.⁵²
