Recall Bulletin

PRODUCT SAFETY RECALL

SUBJECT: Safety Belt Lap Anchor Tensioner Cable

MODELS: 2011-2012 Chevrolet Malibu

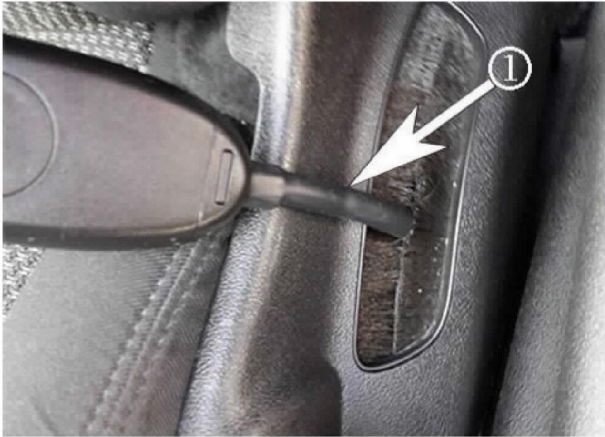
4286619

2. Inspect the safety belt shrink sleeve for any cuts or cracks. Bend the seat belt cable toward the inside (1) and outside (2) of the vehicle and carefully inspect for any cuts or cracks in the shrink sleeve.

3. If a sleeve is cut or cracked on the cable (1) or where the cable meets the buckle (2), replace the front seat belt anchor plate tensioner in step #10.
4. Remove the front seat belt anchor plate tensioner. Refer to *Front Seat Belt Anchor Plate Tensioner Replacement* in SI. If the shrink sleeve does not show any damage, it is not necessary to disconnect the anchor plate from the belt.
