# Bulletin Summary - N192219480 Driver's Front Seat Belt Lap Pretensioner (Special Coverage)

# Special Coverage Adjustment

## N192289390 Seat Belt Anchor Pretensioner Cable

# Product Safety Recall

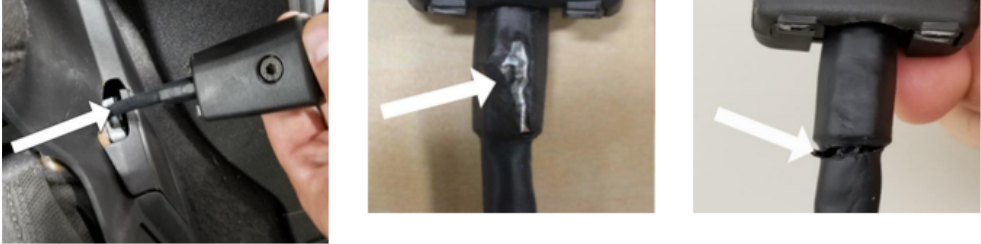
Bulletin Summary: N192219480 Driver's Front Seat Belt Lap Pretensioner (Special Coverage)																
<p><b>Brief</b></p>	<p>If the driver repeatedly sits on the driver's front seat belt pretensioner cable cover when entering the vehicle, the seat belt's pretensioner cable can become damaged. Before any damage will occur to the pretensioner cable itself, signs of wear will be visible on the pretensioner cable cover where it has been repeatedly bent over the seat side shield. Customers are to check the condition of their driver's front seat belt pretensioner cable cover using the pictures and instructions which were mailed to them with the Customer Letter. If they're uncomfortable doing the check themselves, a &lt;Brand&gt; Dealer will do it for them at no cost.</p> <p style="text-align: center;"><b>Owners are to check the driver's seatbelt pretensioner cable cover for signs of damage.</b></p>
