Special Coverage Adjustment

N192268380 Driver Seat Belt Anchor Pretensioner Cable

Release Date: August 2020

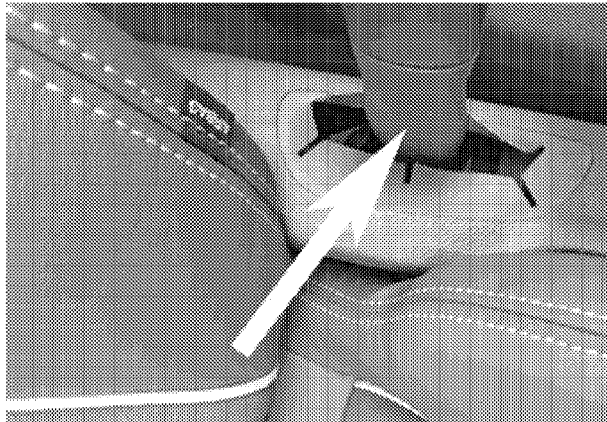
1. Move the driver seat to the full forward and full down position.
2. Inspect the seat belt pretensioner cable cover for damage. Inspect the complete cable cover from the base of the cable to the latch. Damage includes any splits, holes or cracks.

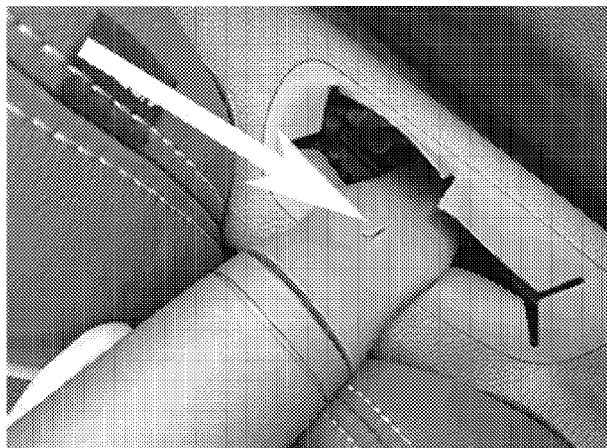
3. Flex the seat belt in an outboard direction and look on inboard side of driver seat seatbelt anchor cover for damage.

4. Flex the seat belt to the inboard side and look on outboard side of driver seat seatbelt anchor cover for damage.
 - If any damage is found, it will be necessary to take the car to your dealer for repairs.
 - If no damage is found, monitor the condition at regular 7,500 mile (12,000 km) intervals as described in the owner manual.

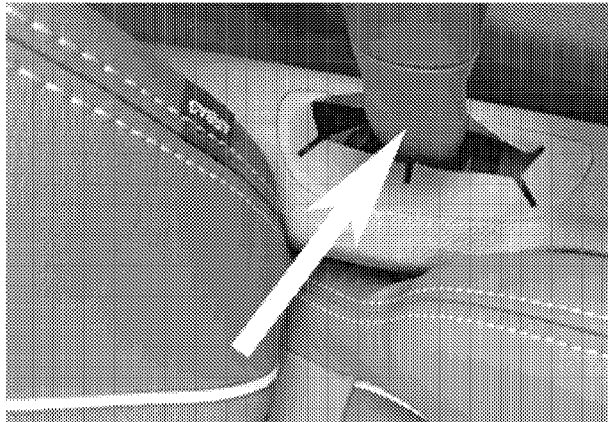
1. Move the driver seat to the full forward and full down position.
2. Inspect the seat belt pretensioner cable cover for damage. Inspect the complete cable cover from the base of the cable to the latch. Damage includes any splits, holes or cracks.

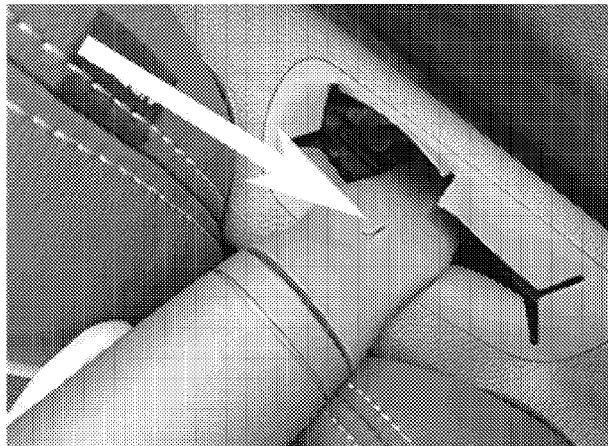
3. Flex the seat belt in an outboard direction and look on inboard side of driver seat seatbelt anchor cover for damage.

4. Flex the seat belt to the inboard side and look on outboard side of driver seat seatbelt anchor cover for damage.
 - If any damage is found, it will be necessary to take the car to your dealer for repairs.
 - If no damage is found, monitor the condition at regular 7,500 mile (12,000 km) intervals as described in the owner manual.

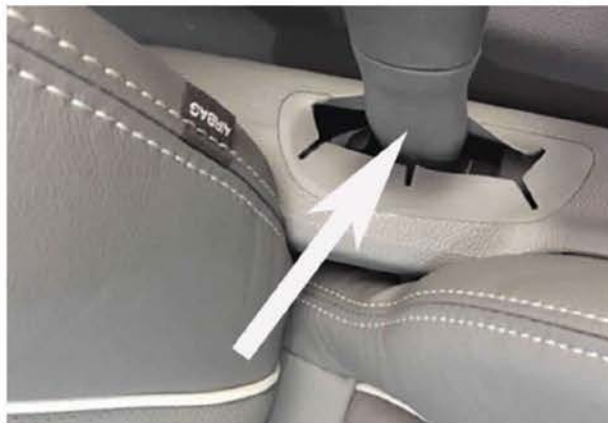
1. Move the driver seat to the full forward and full down position.
2. Inspect the seat belt pretensioner cable cover for damage. Inspect the complete cable cover from the base of the cable to the latch. Damage includes any splits, holes or cracks.

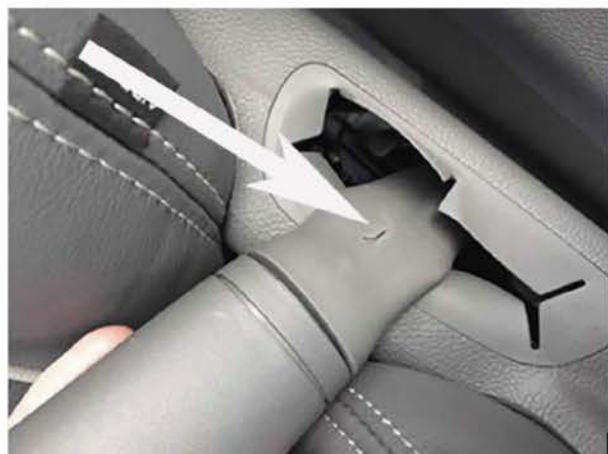
3. Flex the seat belt in an outboard direction and look on inboard side of driver seat seatbelt anchor cover for damage.

4. Flex the seat belt to the inboard side and look on outboard side of driver seat seatbelt anchor cover for damage.

- If any damage is found, replace the driver side front seat belt anchor plate pretensioner and the front seat cushion outer finish cover, refer to step #5.
- If no damage is found, no further action is required. Inform the customer that the special coverage condition is not present on their vehicle at this time and to keep monitoring as described in the customer letter.

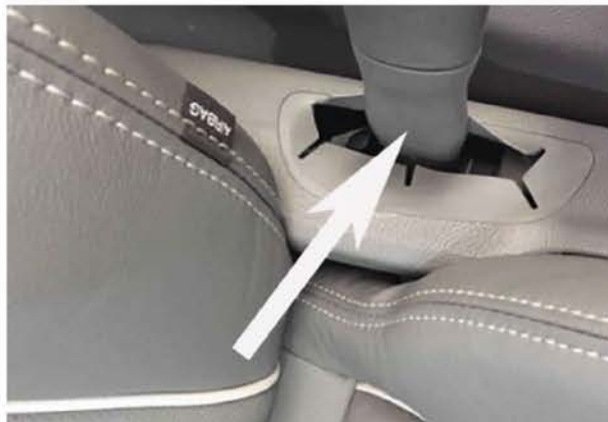
1. Move the driver seat to the full forward and full down position.
2. Inspect the seat belt pretensioner cable cover for damage. Inspect the complete cable cover from the base of the cable to the latch. Damage includes any splits, holes or cracks.

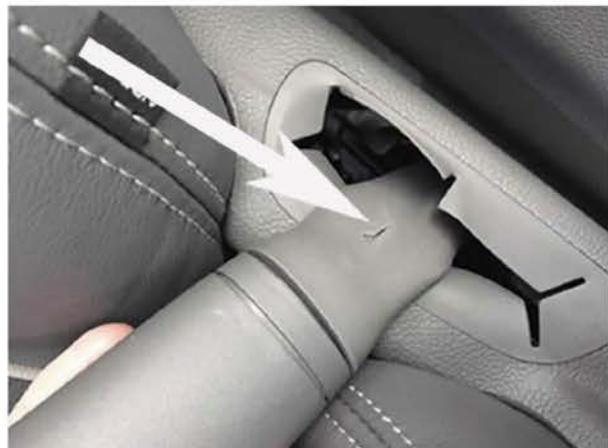
3. Flex the seat belt in an outboard direction and look on inboard side of driver seat seatbelt anchor cover for damage.

4. Flex the seat belt to the inboard side and look on outboard side of driver seat seatbelt anchor cover for damage.
 - If any damage is found, it will be necessary to take the car to your dealer for repairs.
 - If no damage is found, monitor the condition at regular 7,500 mile (12,000 km) intervals as described in the owner manual.

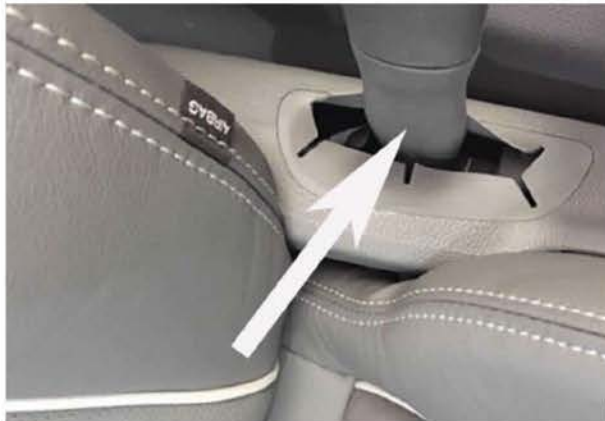
1. Move the driver seat to the full forward and full down position.
2. Inspect the seat belt pretensioner cable cover for damage. Inspect the complete cable cover from the base of the cable to the latch. Damage includes any splits, holes or cracks.

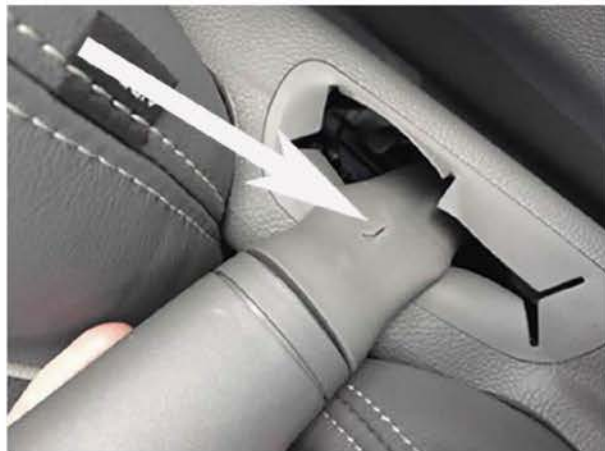
3. Flex the seat belt in an outboard direction and look on inboard side of driver seat seatbelt anchor cover for damage.

4. Flex the seat belt to the inboard side and look on outboard side of driver seat seatbelt anchor cover for damage.

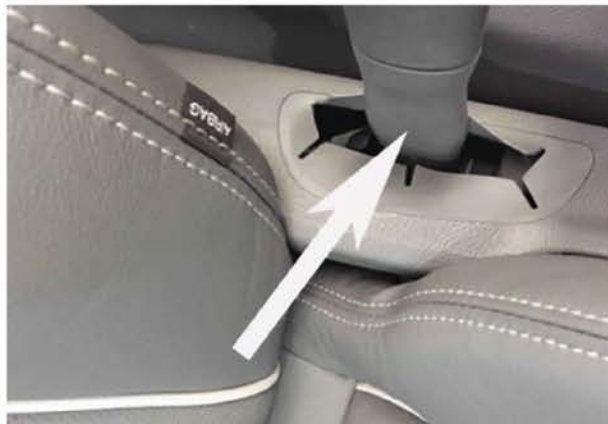
1. Move the driver seat to the full forward and full down position.
2. Inspect the seat belt pretensioner cable cover for damage. Inspect the complete cable cover from the base of the cable to the latch. Damage includes any splits, holes or cracks.

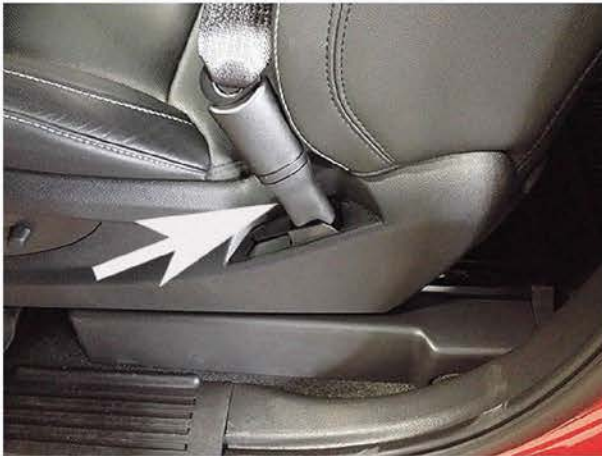
2. Inspect the seat belt tensioner cable cover for damage. Inspect the complete cable cover from the base of the cable to the buckle.

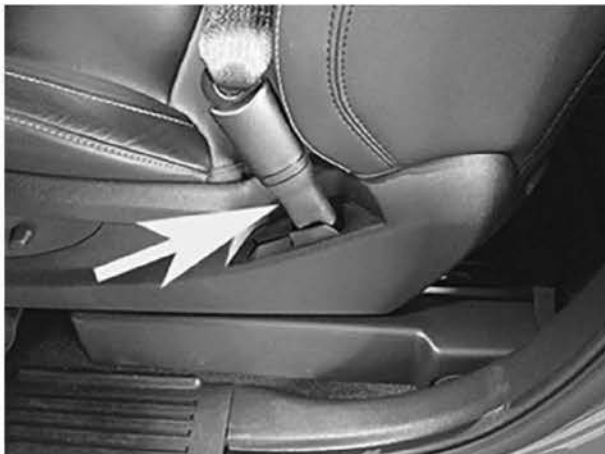
2. Inspect the seat belt tensioner cable cover for damage. Inspect the complete cable cover from the base of the cable to the buckle.

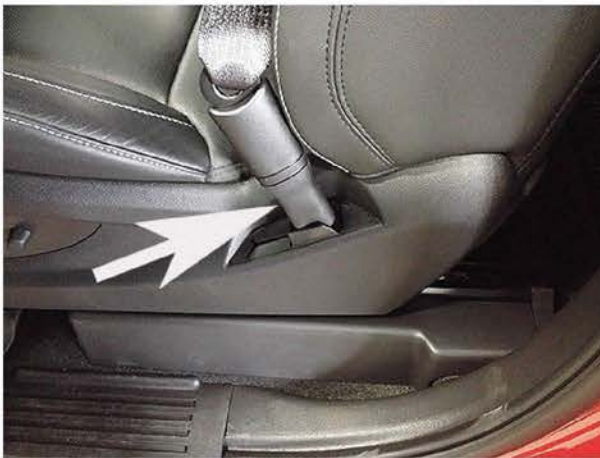
2. Inspect the seat belt tensioner cable cover for damage. Inspect the complete cable cover from the base of the cable to the buckle.

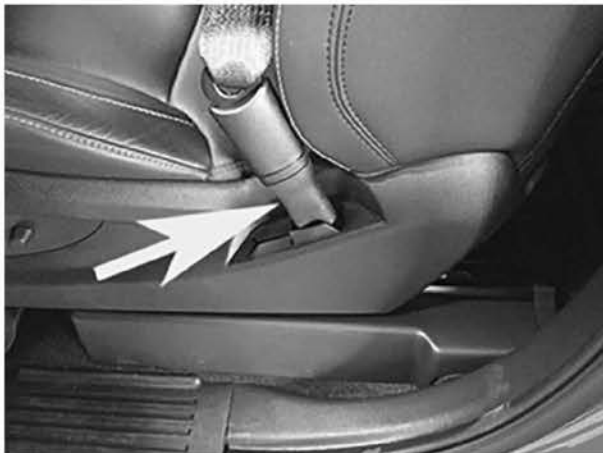
2. Inspect the seat belt tensioner cable cover for damage. Inspect the complete cable cover from the base of the cable to the buckle.
