Special Coverage Adjustment

N192289390 Seat Belt Anchor Pretensioner Cable

Release Date: June 2020

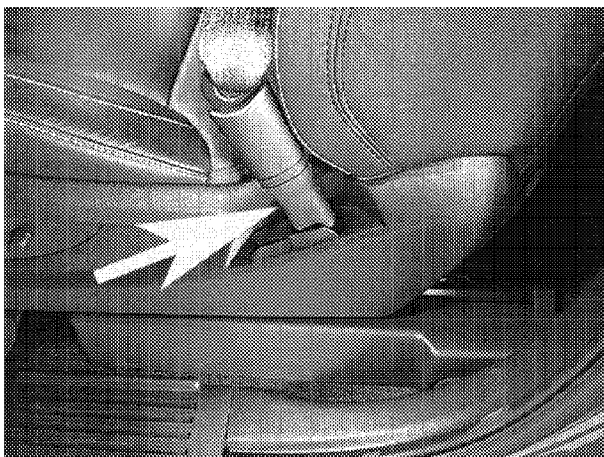
4522278

2. Inspect the seat belt tensioner cable cover for damage. Inspect the complete cable cover from the base of the cable to the buckle.

This damage will be in the form of holes (1) or splitting (2).

- If **any damage** is found, replace the driver side front seat belt anchor plate tensioner and the front seat cushion outer finish cover.
- If no damage is found, inform the customer that the special coverage condition is not present on their vehicle at this time.

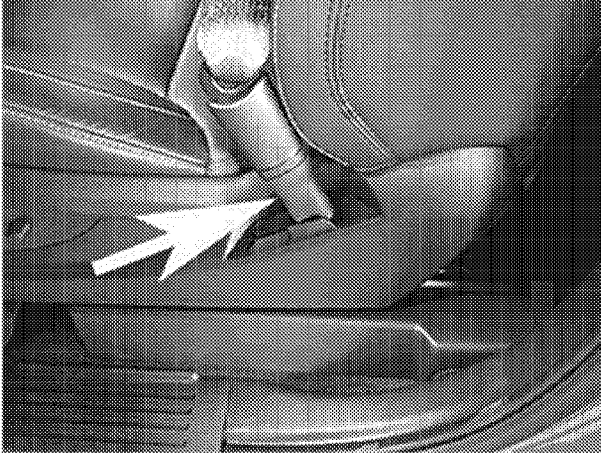
2. Inspect the seat belt tensioner cable cover for damage. Inspect the complete cable cover from the base of the cable to the buckle.

This damage will be in the form of holes (1) or splitting (2).

- If **any damage** is found, take the vehicle to the dealer for service.
- If no damage is found, the special coverage condition is not present on the vehicle at this time.

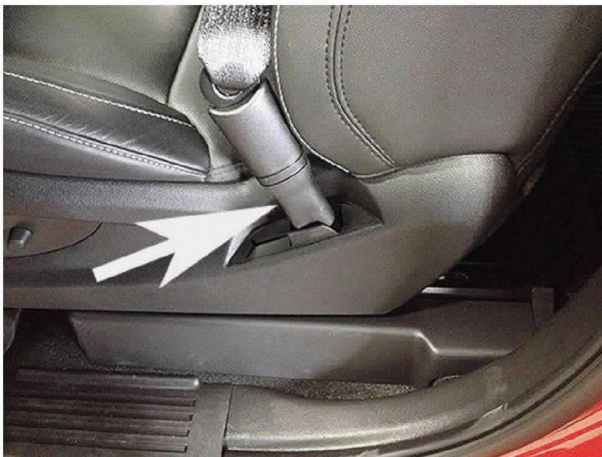
4522278

2. Inspect the seat belt tensioner cable cover for damage. Inspect the complete cable cover from the base of the cable to the buckle.

This damage will be in the form of holes (1) or splitting (2).

- If **any damage** is found, replace the driver side front seat belt anchor plate tensioner and the front seat cushion outer finish cover.
- If no damage is found, inform the customer that the special coverage condition is not present on their vehicle at this time.

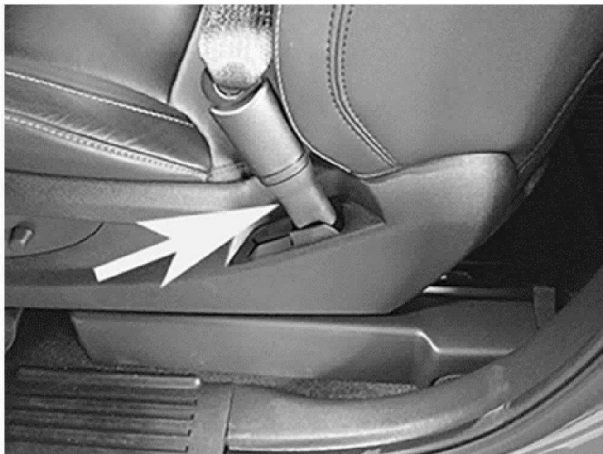
2. Inspect the seat belt tensioner cable cover for damage. Inspect the complete cable cover from the base of the cable to the buckle.

This damage will be in the form of holes (1) or splitting (2).

- If **any damage** is found, take the vehicle to the dealer for service.
- If no damage is found, the special coverage condition is not present on the vehicle at this time.
