## Product Safety Recall

### N202312100 Seat Belt Cable Separation – US Only

<b>Condition</b>	General Motors has decided that a defect which relates to motor vehicle safety exists in certain 2014-2016 model year Chevrolet Caprice Police Pursuit Vehicles (PPVs) and Chevrolet SS vehicles that were subject to NHTSA Recall No. 16V518 and may not have received a complete repair under the recall. The flexible steel cable that connects the safety belt to the vehicle at the outside of the front driver seat can fatigue and separate over time if the driver's movement into the seat repeatedly bends the steel seat belt cable down against the seat edge. The covering on the cable may show visible signs, including tears, holes, or wear marks. In a crash, a fatigued cable could break, reducing the effectiveness of the vehicle's safety belts and increasing the risk of injury to the occupant. <b>As part of the remedy under NHTSA Recall No. 16V518 (bulletin 31340), dealers were instructed to install a new seat trim piece with a redesigned opening for improved cable routing. In some of the vehicles repaired under that recall, dealers did not replace the seat trim as specified.</b>

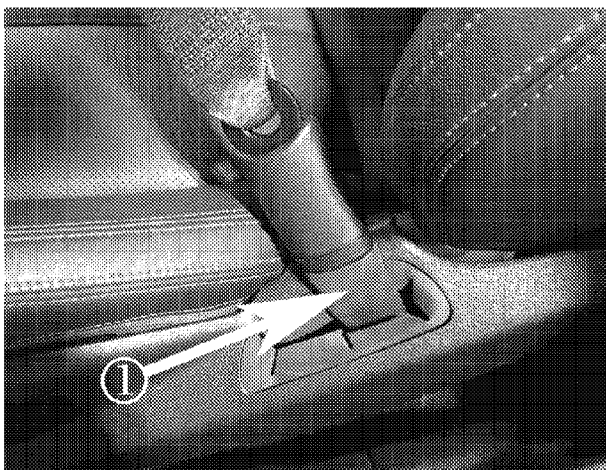
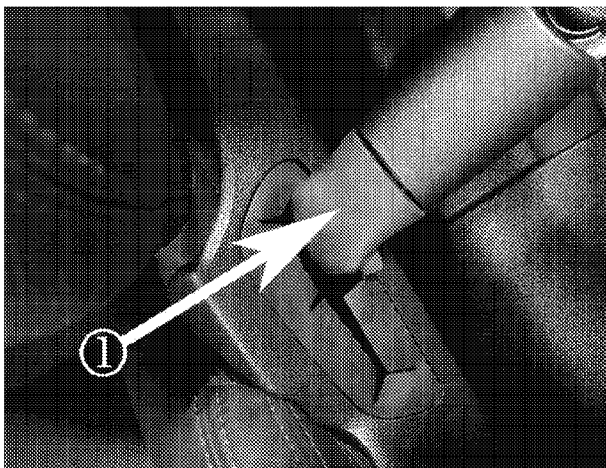
1. Using the seat adjustment switch, move the driver seat as far rearward and downward as possible. The front safety belt cable sleeve (hereinafter, "sleeve") covers the flexible steel cable that connects the safety belt to the vehicle at the front outside seating position. The sleeve is covered by the seat trim and comes out of the slot on the side of the front seat.

2. Inspect the sleeve for any cuts or cracks. Bend the cable toward the inside and outside of the vehicle and inspect the area near arrows (1) above.

- If **any damage** is found, replace the tensioner and revised seat trim listed above. Refer to *Front Seat Belt Anchor Plate Tensioner Replacement* in SI.
- If no damage is found, only install the revised seat cushion outer finish cover.

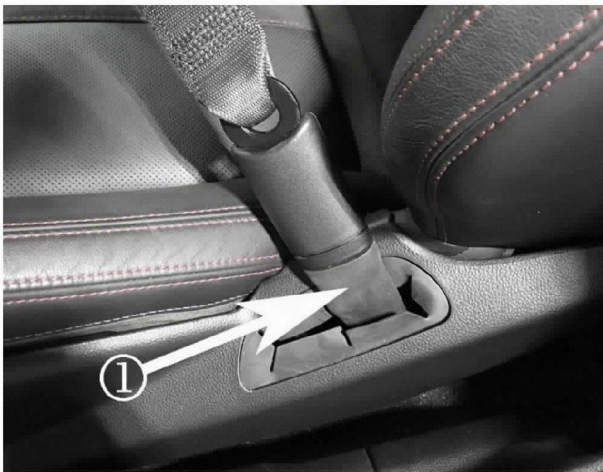
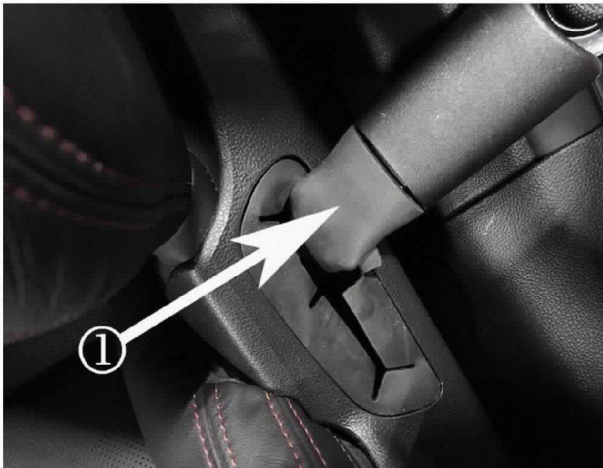
1. Using the seat adjustment switch, move the driver seat as far rearward and downward as possible. The front safety belt cable sleeve (hereinafter, “sleeve”) covers the flexible steel cable that connects the safety belt to the vehicle at the front outside seating position. The sleeve is covered by the seat trim and comes out of the slot on the side of the front seat.

2. Inspect the sleeve for any cuts or cracks. Bend the cable toward the inside and outside of the vehicle and inspect the area near arrows (1) above.

- If **any damage** is found, replace the tensioner and revised seat trim listed above. Refer to *Front Seat Belt Anchor Plate Tensioner Replacement* in SI.
- If no damage is found, only install the revised seat cushion outer finish cover.

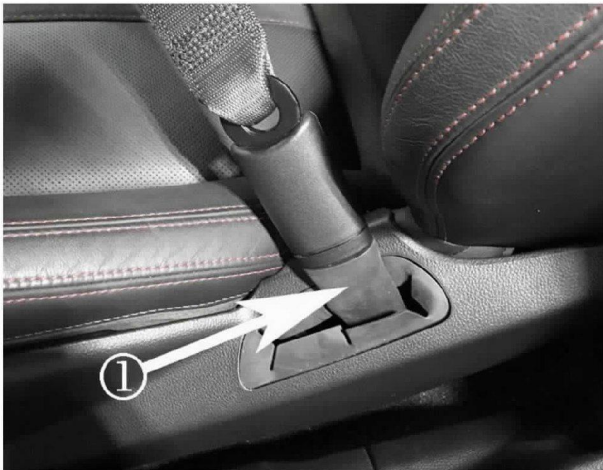
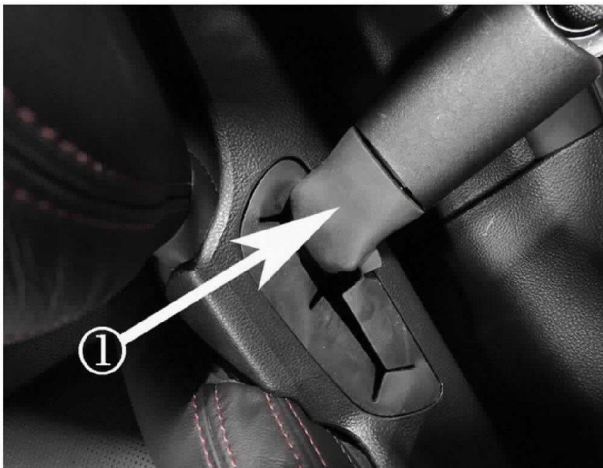
1. Using the seat adjustment switch, move the driver seat as far rearward and downward as possible. The front safety belt cable sleeve (hereinafter, “sleeve”) covers the flexible steel cable that connects the safety belt to the vehicle at the front outside seating position. The sleeve is covered by the seat trim and comes out of the slot on the side of the front seat.

2. Inspect the sleeve for any cuts or cracks. Bend the cable toward the inside and outside of the vehicle and inspect the area near arrows (1) above.

- If **any damage** is found, replace the tensioner and revised seat trim listed above. Refer to *Front Seat Belt Anchor Plate Tensioner Replacement* in SI.
- If no damage is found, only install the revised seat cushion outer finish cover.

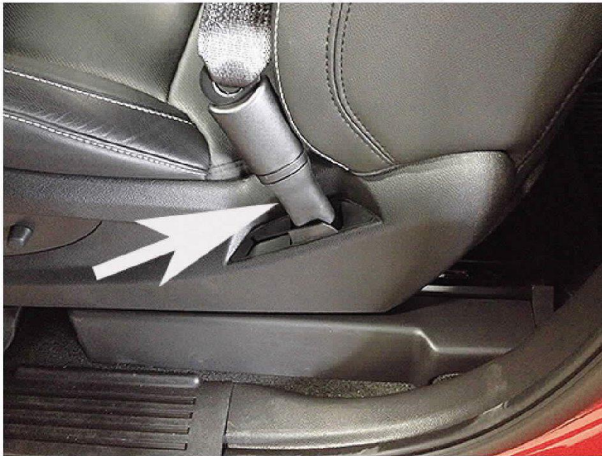
4522278

2. Inspect the seat belt tensioner cable cover for damage. Inspect the complete cable cover from the base of the cable to the buckle.

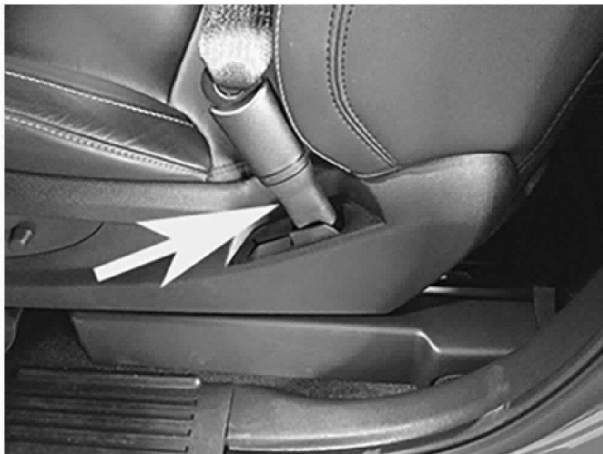
2. Inspect the seat belt tensioner cable cover for damage. Inspect the complete cable cover from the base of the cable to the buckle.

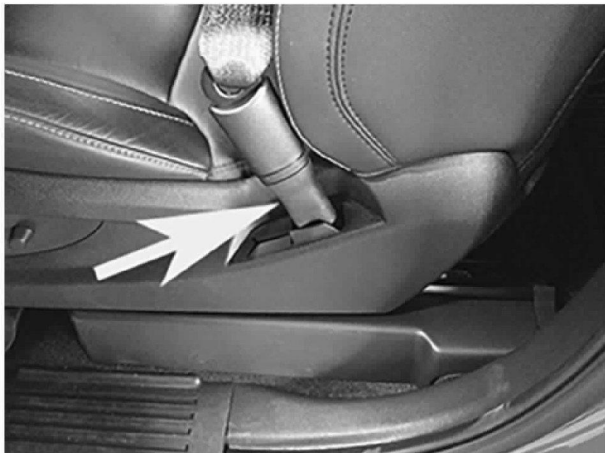
2. Inspect the seat belt tensioner cable cover for damage. Inspect the complete cable cover from the base of the cable to the buckle.

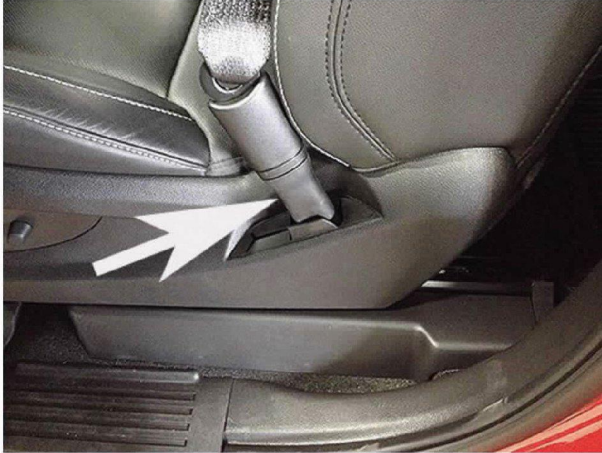
4522278

2. Inspect the tensioner cable cover for damage. Inspect the complete cable from the base of the cable to the buckle.
