IMPORTANT SAFETY RECALL

General Motors has decided that a defect, which relates to motor vehicle safety, exists in certain 2014-2015 model year Chevrolet Silverado Series 1500 and GMC Sierra Series 1500 vehicles. As a result, GM is conducting a safety recall. We apologize for this inconvenience. However, we are concerned about your safety and continued satisfaction with our products.

General Motors has decided that a defect which relates to motor vehicle safety exists in **certain** 2014-2015 model year Chevrolet Silverado 1500 Series and GMC Sierra 1500 Series vehicles. Some of these vehicles have a condition in which the flexible steel cable that connects the driver’s seat belt to the outboard side of the seat (the “tensioner cable”) can fatigue and separate over time as a result of occupant movement into the driver’s seat. In a crash, a fatigued tensioner

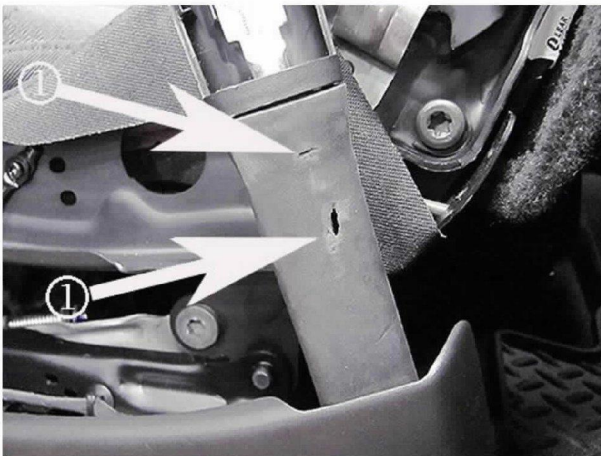
4522272

2. Inspect the tensioner cable cover for damage over its entire length.

Note: The following photos were taken with the seat trim removed to better show the condition. It is not necessary to remove the seat trim for the inspection.

Use the following steps to inspect the flexible steel cable cover that connects the driver's seat belt to the outboard side of the seat and confirm that there is no evidence of fatigue, fraying, separation or any other problem. If a problem is found, replace the driver seat tensioner.

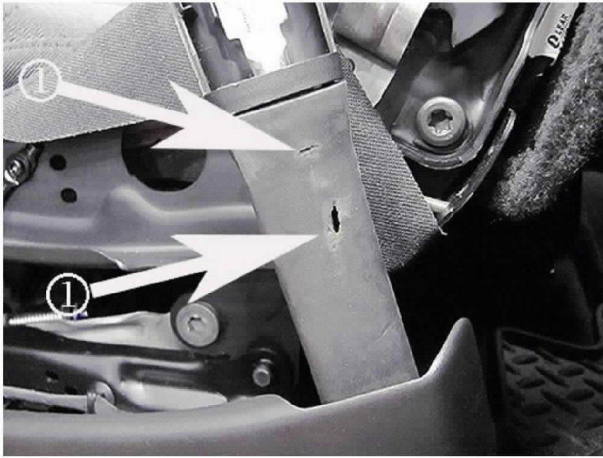
4522272

2. Inspect the tensioner cable cover for damage. Inspect the complete cable from the base of the cable to the buckle.

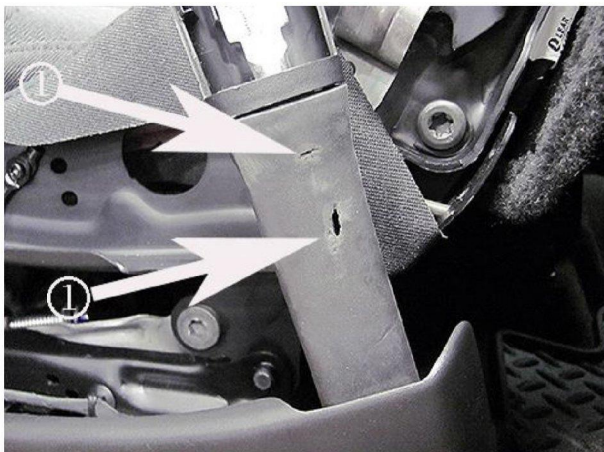
4522272

2. Inspect the seat belt tensioner cable cover for damage. Inspect the complete cable cover from the base of the cable to the buckle.

- If **any damage** is found, replace the driver side front seat belt anchor plate tensioner and the front seat cushion outer finish cover.
- If no damage is found, inform the customer that the special coverage condition is not present on their vehicle at this time.

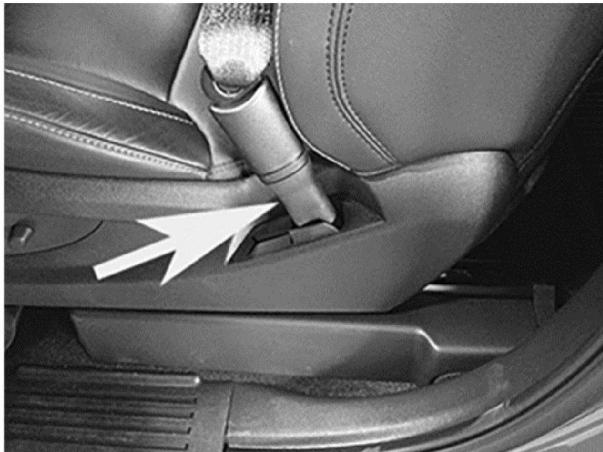
2. Inspect the seat belt tensioner cable cover for damage. Inspect the complete cable cover from the base of the cable to the buckle.
