This file represents a consolidation of multiple files sent by the manufacturer. Please use the bookmarks to navigate to each file. (Each bookmark label is the name of the original file.)

### CONDITION

General Motors has decided that a defect which relates to motor vehicle safety exists in certain 2010-2015 model year Cadillac SRX vehicles and 2011-2012 Saab 9-4X vehicles. On some of these vehicles, the jam nut in the rear suspension toe adjuster link may not be torqued to the proper specification. A loose toe adjuster link can cause the vehicle to sway or wander at highway speed, activate the vehicle's electronic stability control system, and cause excessive wear to the threads in the link. Additionally, the rear suspension may make loud metallic noises, particularly when the vehicle is travelling over bumps or potholes. If the threads in the link become worn, the link may separate. If separation occurs while the vehicle is being driven, it would create sudden vehicle instability, increasing the risk of a crash.

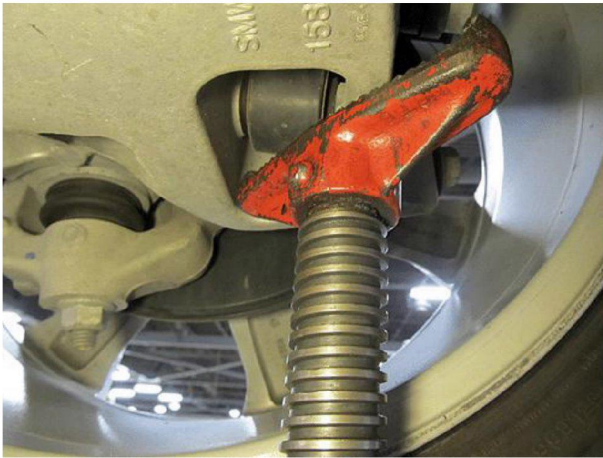
3980940

- Inspect the toe link assembly for loosened jam nuts. Use a piece of paper to determine if there is a gap between the jam nut and the adjustment collar.
5. If the adjustment link fails any of the above tests, replace the adjustment link assembly. Refer to *Adjust Link Replacement* in SI.

**Note:** Load the suspension so the wheels are in the same position they would be if the vehicle was on the ground.
