Field Product Quality Report

Distributor	KUS	Report #	[REDACTED]
Region	CE12	Report Create	08/11/2019
Dealer*	[OH072] BEAVERCREEK MOTORS, INC.	Dealer City, State	BEAVERCREEK, OH
Name	Hanagan, Jack - FTS	Attached	
Model Number	J4232	Model	Telluride 2020 - 2thx MY
VIN*	5XYP64H0GLC [REDACTED]	Production Date	04/14/2019
Engine No	G6DNKS874130	Delivery Date	04/26/2019
Trans No	LB8UCA994293	FTS Visit Date	08/01/2019
Trans Type	Auto	RO Open Date	07/10/2019
Mileage In	2554	Mileage Out	2554
Part No	99211 S9100	Part Desc	UNIT ASSY-FR VIEW CA
Other Part #1	-	Other Part #2	-
Condition/Nature	DA - Operation > Warning light on > Lamp on	Cause	ZZ3 - Part function/operation
Subject*	[REDACTED]

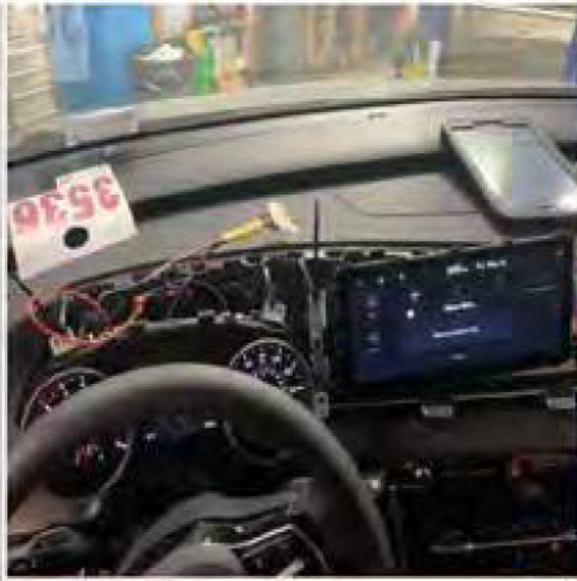
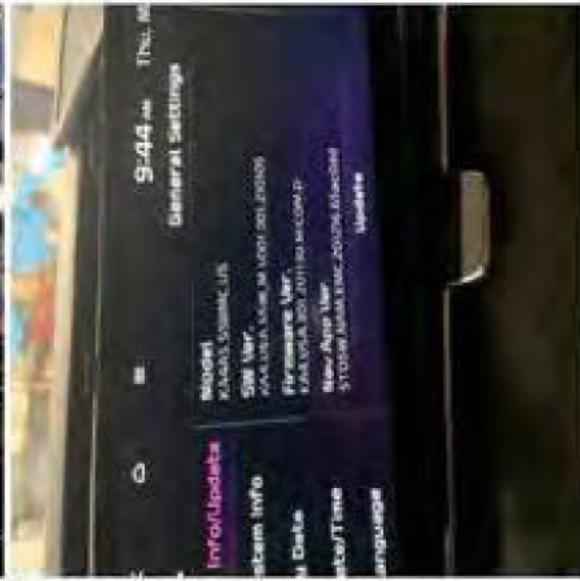
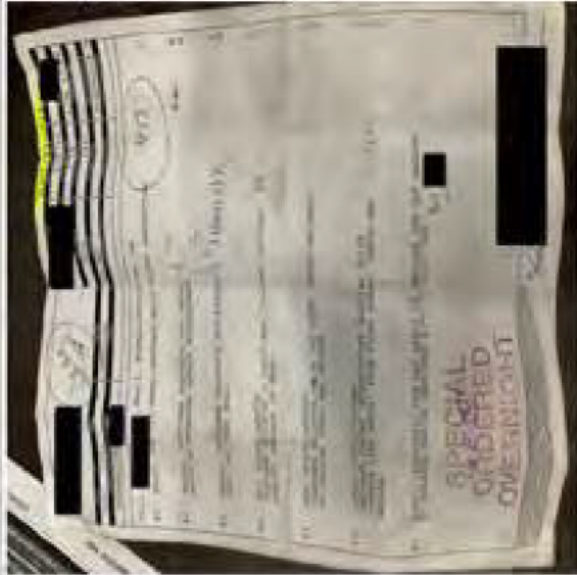
Condition	
Customer Complaint	Customer receives a check HAD (Highway driving assist) message in dash.
Actual Condition	The vehicle was started, and no MIL or warning messages were seen.
Analysis	
Investigation Results	I drove the vehicle with the MOBIS FSE. He collected CAN logs and head unit logs during the road test. The road test included city driving with several turns 25-35 MPH. The system was checked with the KDS and the code was reset several times during the test drive.
Possible Cause	The root cause was not identified during the inspection.
Corrective Action	Information was passed on to NAGC. More data was requested. I had them order a Head unit but hold off on the replacement.

Open	File Name	Comments
Open	IMG_3716.JPG	
Open	IMG_3717.JPG	
Open	IMG_3718.JPG

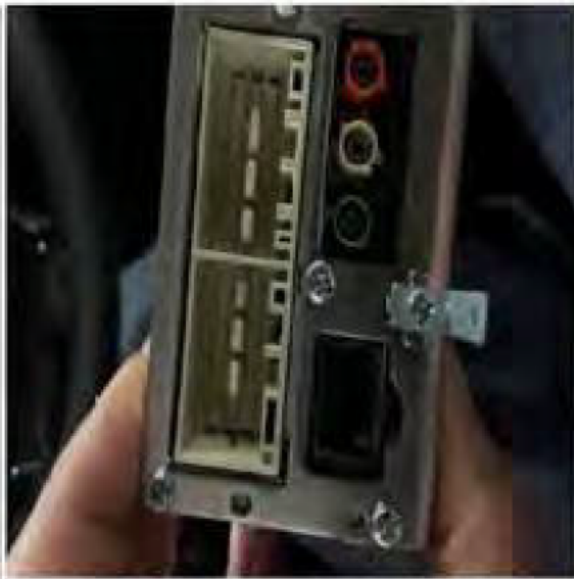
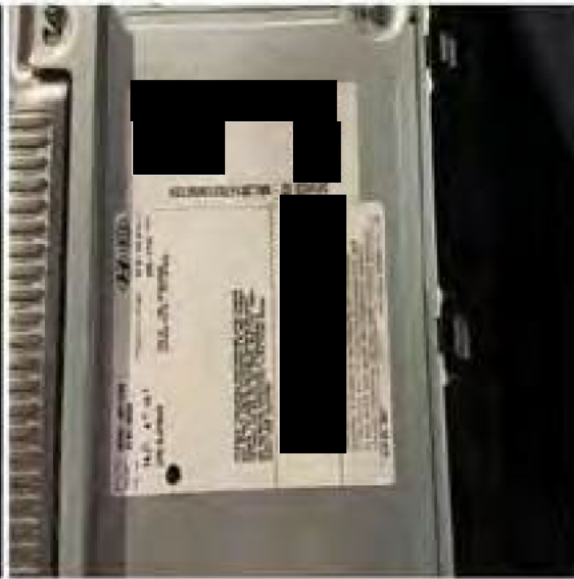
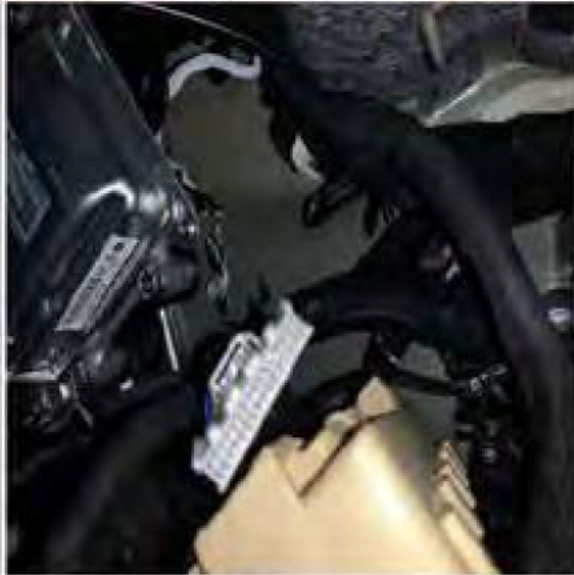
Condition	
Customer Complaint	Customer receives a check HAD (highway driving assist) message in dash. Second visit to vehicle.
Actual Condition	The vehicle was started, and no MIL or warning messages were seen.
Analysis	
Investigation Results	<p>I supported MOBIS data collection. The vehicle was scanned and some DTCs were found. Some codes were related to the components being unplug to set up the data collection. The codes were cleared. I drove the vehicle with the MOBIS FSE. He collected CAN logs and head unit logs during the road test. The road test included city driving with several turns 25-35 MPH. The system was checked with the KDS and the code was read several times during the test drive. The cluster warning message that was reported by the customer on the RO was not experienced during the inspection. The DTC would set in the Multi function camera module (C183186) The code would be cleared and then would reset during the driving.</p> <p>The vehicle was fueled and the test drive was continued. We attempted to identify to locate areas, signage or driving styles that would set the DTC.</p> <p>After the data was collected I check circuit connections and found no concerns. I compared module variant coding to a like vehicle that had not set the DTC during a test drive. No coding issues were identified.</p> <p>I look call from NAOC and collect information to help with the investigation.</p>

Possible Cause	The root cause was not identified during the inspection.
Corrective Action	Information was passed on to NAOC.

Open	File Name	Comments
Open	IMG_3752 1st scan.JPG	
Open	IMG_3761 VC.JPG	
Open	IMG_3762 VC.JPG	
Open	IMG_3766 conn.JPG	
Open	IMG_3771 conn.JPG	
Open	IMG_3772 HU.JPG	
Open	IMG_3774 conn.JPG

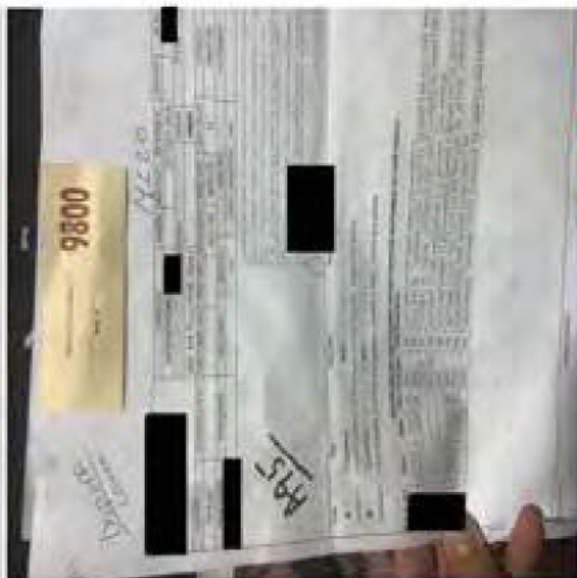
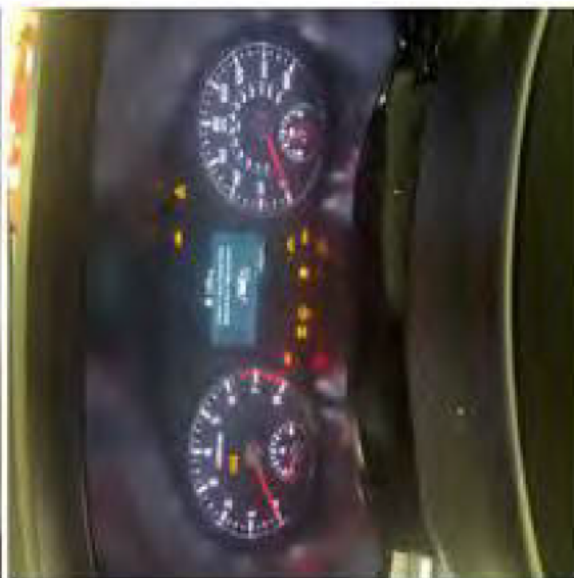
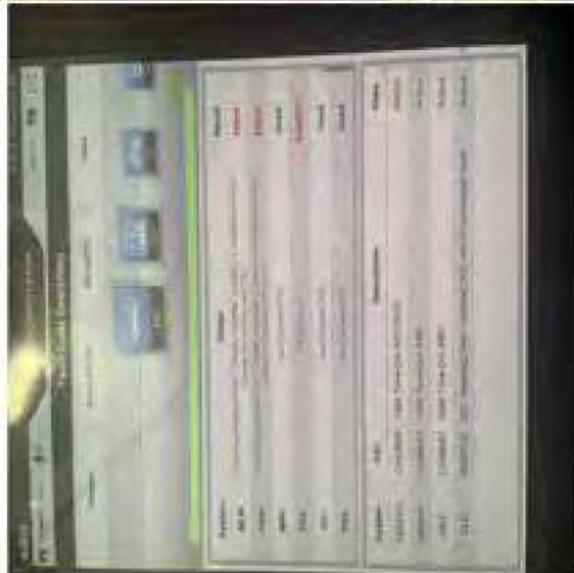
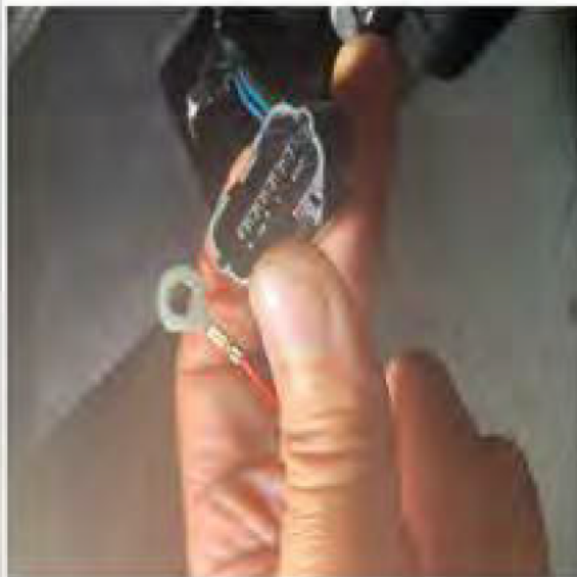
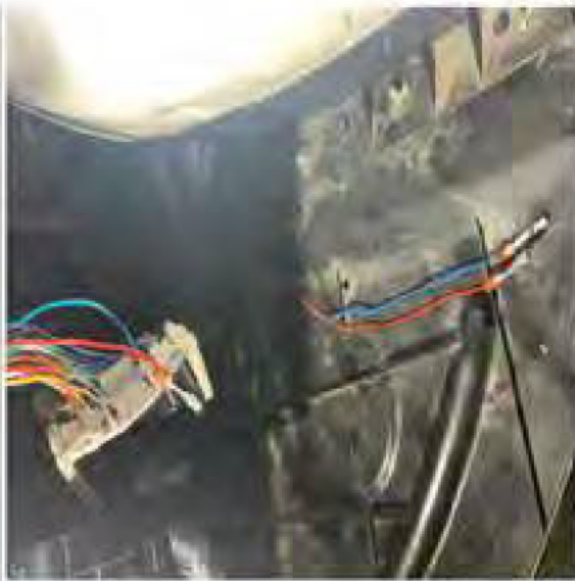
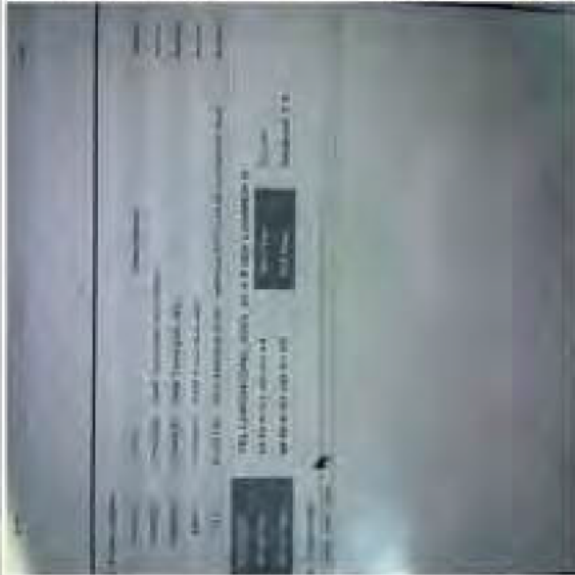
Condition	
Customer Complaint	Customer states cruise control is inop. Check and advise. Pre collision system is inop check and advise.
Actual Condition	The vehicle came in for front radar unit DTCs. (see attached) I turned on the vehicle KOEO and the cluster had a number of MIL come on (see photo). When I attempted to use the KDS to scan for DTCs the tool could not auto VIN. The vehicle was selected, and the vehicle scanned and a number of DTCs were set and a number of modules did not communicate that should (see eReports and attached)
Analysis	
Investigation Results	A checked for resistance across the C-CAN lines from the E51, which showed an open on the circuit. It was found that the JE02 had a soft set connection. Auto VIN with the KDS was reestablished and the codes that the vehicle came in with were found (see attached KDS screen shot). Could not communicate with the front radar unit when using the KDS. Pin tension at E51 (4 pins) and EE11 was found to be loose (see video and photos). For testing purposes the E51 connector and pins at the EE11 were replaced. The vehicle was scanned and no DTCs were found. During checks it was found the codes returned. A number of modules were not communicating including the front radar. Pin tension at the JE02 was loose. Further checks showed a C-CAN issue at EM21 (see photos and video). The connections were repaired and all modules communicated. During wiggle testing the front radar issue returned. The issue was at the EE11 harness.

Possible Cause	Multiple connection issues on the C-CAN
Corrective Action	It was recommended the engine and the bumper harness be exchanged and the vehicle test driven. Report the finding to the FTS.

Open	File Name	Comments
Open	IMG_4056 RO.JPG	
Open	IMG_4057 dash KOEO.JPG	
Open	IMG_4058 soft set joint connector cover.JPG	
Open	IMG_4061 original issue.JPG	
Open	IMG_4062 loose pins at E51.JPG	
Open	IMG_4063 e51 pin tension.MOV	
Open	IMG_4067 pins at EE11.JPG	
Open	IMG_4073 replaced pins EE11.JPG	
Open	IMG_4109 Loose pins at EM21.MOV	
Open	IMG_4112 grease EM21.JPG	
Open	IMG_4115 connection issue EE11.MOV	
Open	IMG_4118 codes after joint connection fix.JPG	
Open	IMG_4119 codes 1st scan.JPG
