# Customer Satisfaction Program

## N202310850 Airbag Indicator Light Intermittent

**Release Date:** December 2020

| <b>Condition</b> | In certain 2021 model year Cadillac Escalade, Escalade ESV, Chevrolet Suburban, Tahoe, GMC Yukon and Yukon XL vehicles, driver movement can disrupt the electrical connection to the seat-mounted inboard airbag system. This airbag system is supplemental and not required equipment under applicable Federal Motor Vehicle Safety Standards. If this occurs, the vehicle's driver information center will display a “Service Restraints System” message to the driver before resistance at the connection will prevent the deployment of the airbag. |

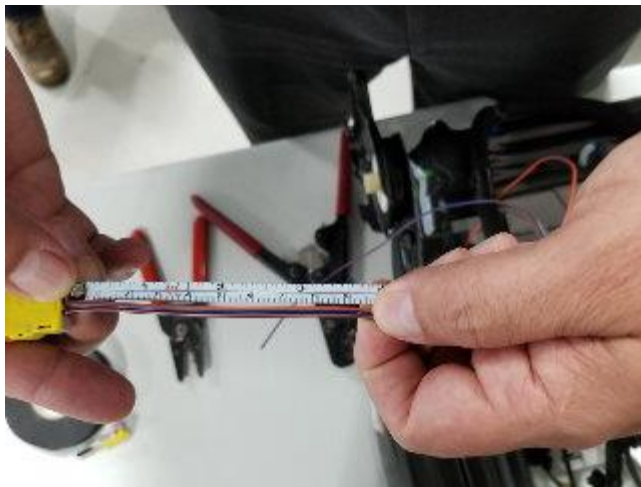
5672148

**Note:** The service connector has exceptionally long leads, discard any unused wire material.

8. Unwrap the electrical tape to the first attachment location.
