**NUMBER:** 18-054-21 REV. A

**SUBJECT:**

Diesel Fuel Pump Failure and System Contamination

This bulletin involves inspecting for fuel pump failure and fuel system contamination. Also fuel system cleaning and fuel system kit replacement.

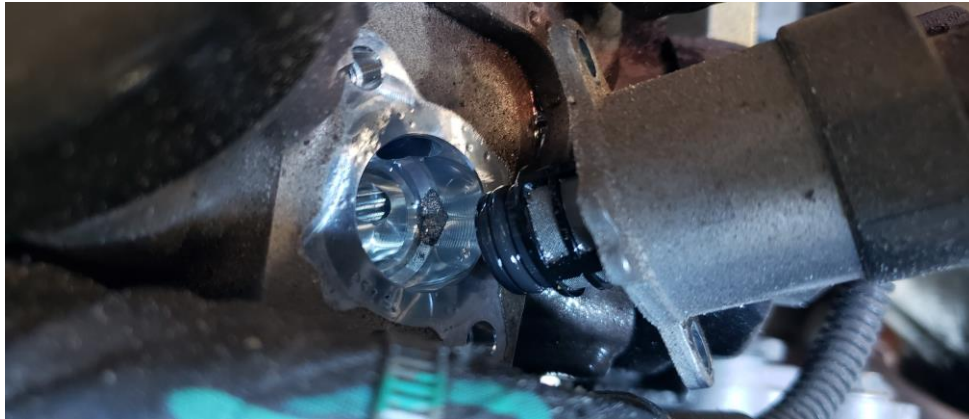
**Figure 2.**

- e. You will then be prompted to input an email address. Input FCA\_DC@cummins.com as the email address and be sure to click "Add" after doing so otherwise the email will not be sent. After selecting add click continue.
3. Inspect the fuel system for external contamination and describe if any found in the STAR Case narrative.
4. Collect a fuel sample in a clean container, and take a clear picture of it. Attach the picture to the Star case.
5. Take a clear photo of the FQS and FQS Bore of the pump to confirm the failure, and attach it to the case. See (Figure 2.) for a good example
