Service Bulletin

Bulletin No.: 21-NA-048

Subject: Black Screen in Reverse with Red Triangle and Red Camera with A Circle and Slash Through It

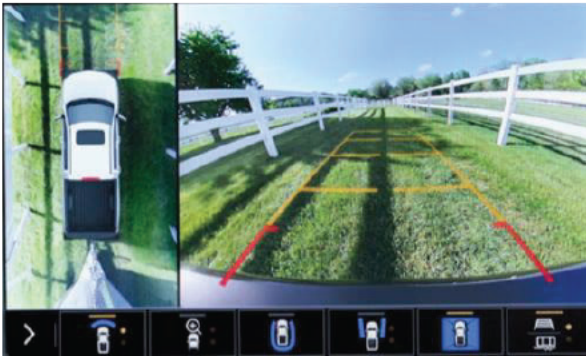
- If the "Cameras" icon is greyed out and not working. The connection issue may be between the VPM and Radio.
- If the touch buttons are working properly, it could be an issue with the coax cable connection from the VPM to the Rear Vision Camera.

Note: Before testing the coax cable, check the cable's exterior for being pinched, cut, damaged, or having loose connections at the components, all of which can cause reception issues.

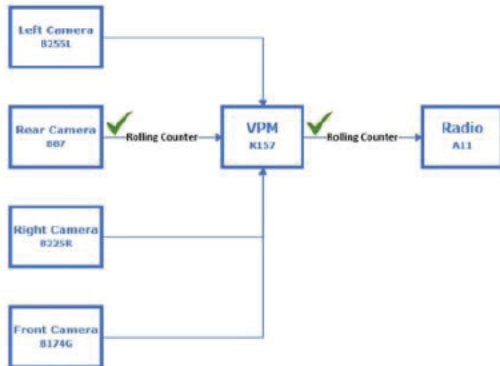
The Radio requires a rolling counter to ensure a video output on the radio screen. This counter prevents a frozen image to be displayed to the vehicle owner when shifting into reverse.

This rolling counter is monitored continuously to ensure we have video signal from the rear camera. It goes from the rear camera to the VPM and from the VPM to the Radio.

If the rear camera or the VPM do not provide the rolling counter, you will see the following black screen with an icon:
