# CONNECTION NEEDED ON NEW CABLE

X903 -- LEFT D-PILLAR  
NOT COMPATIBLE WITH  
UPDATED CABLE FROM  
WPC

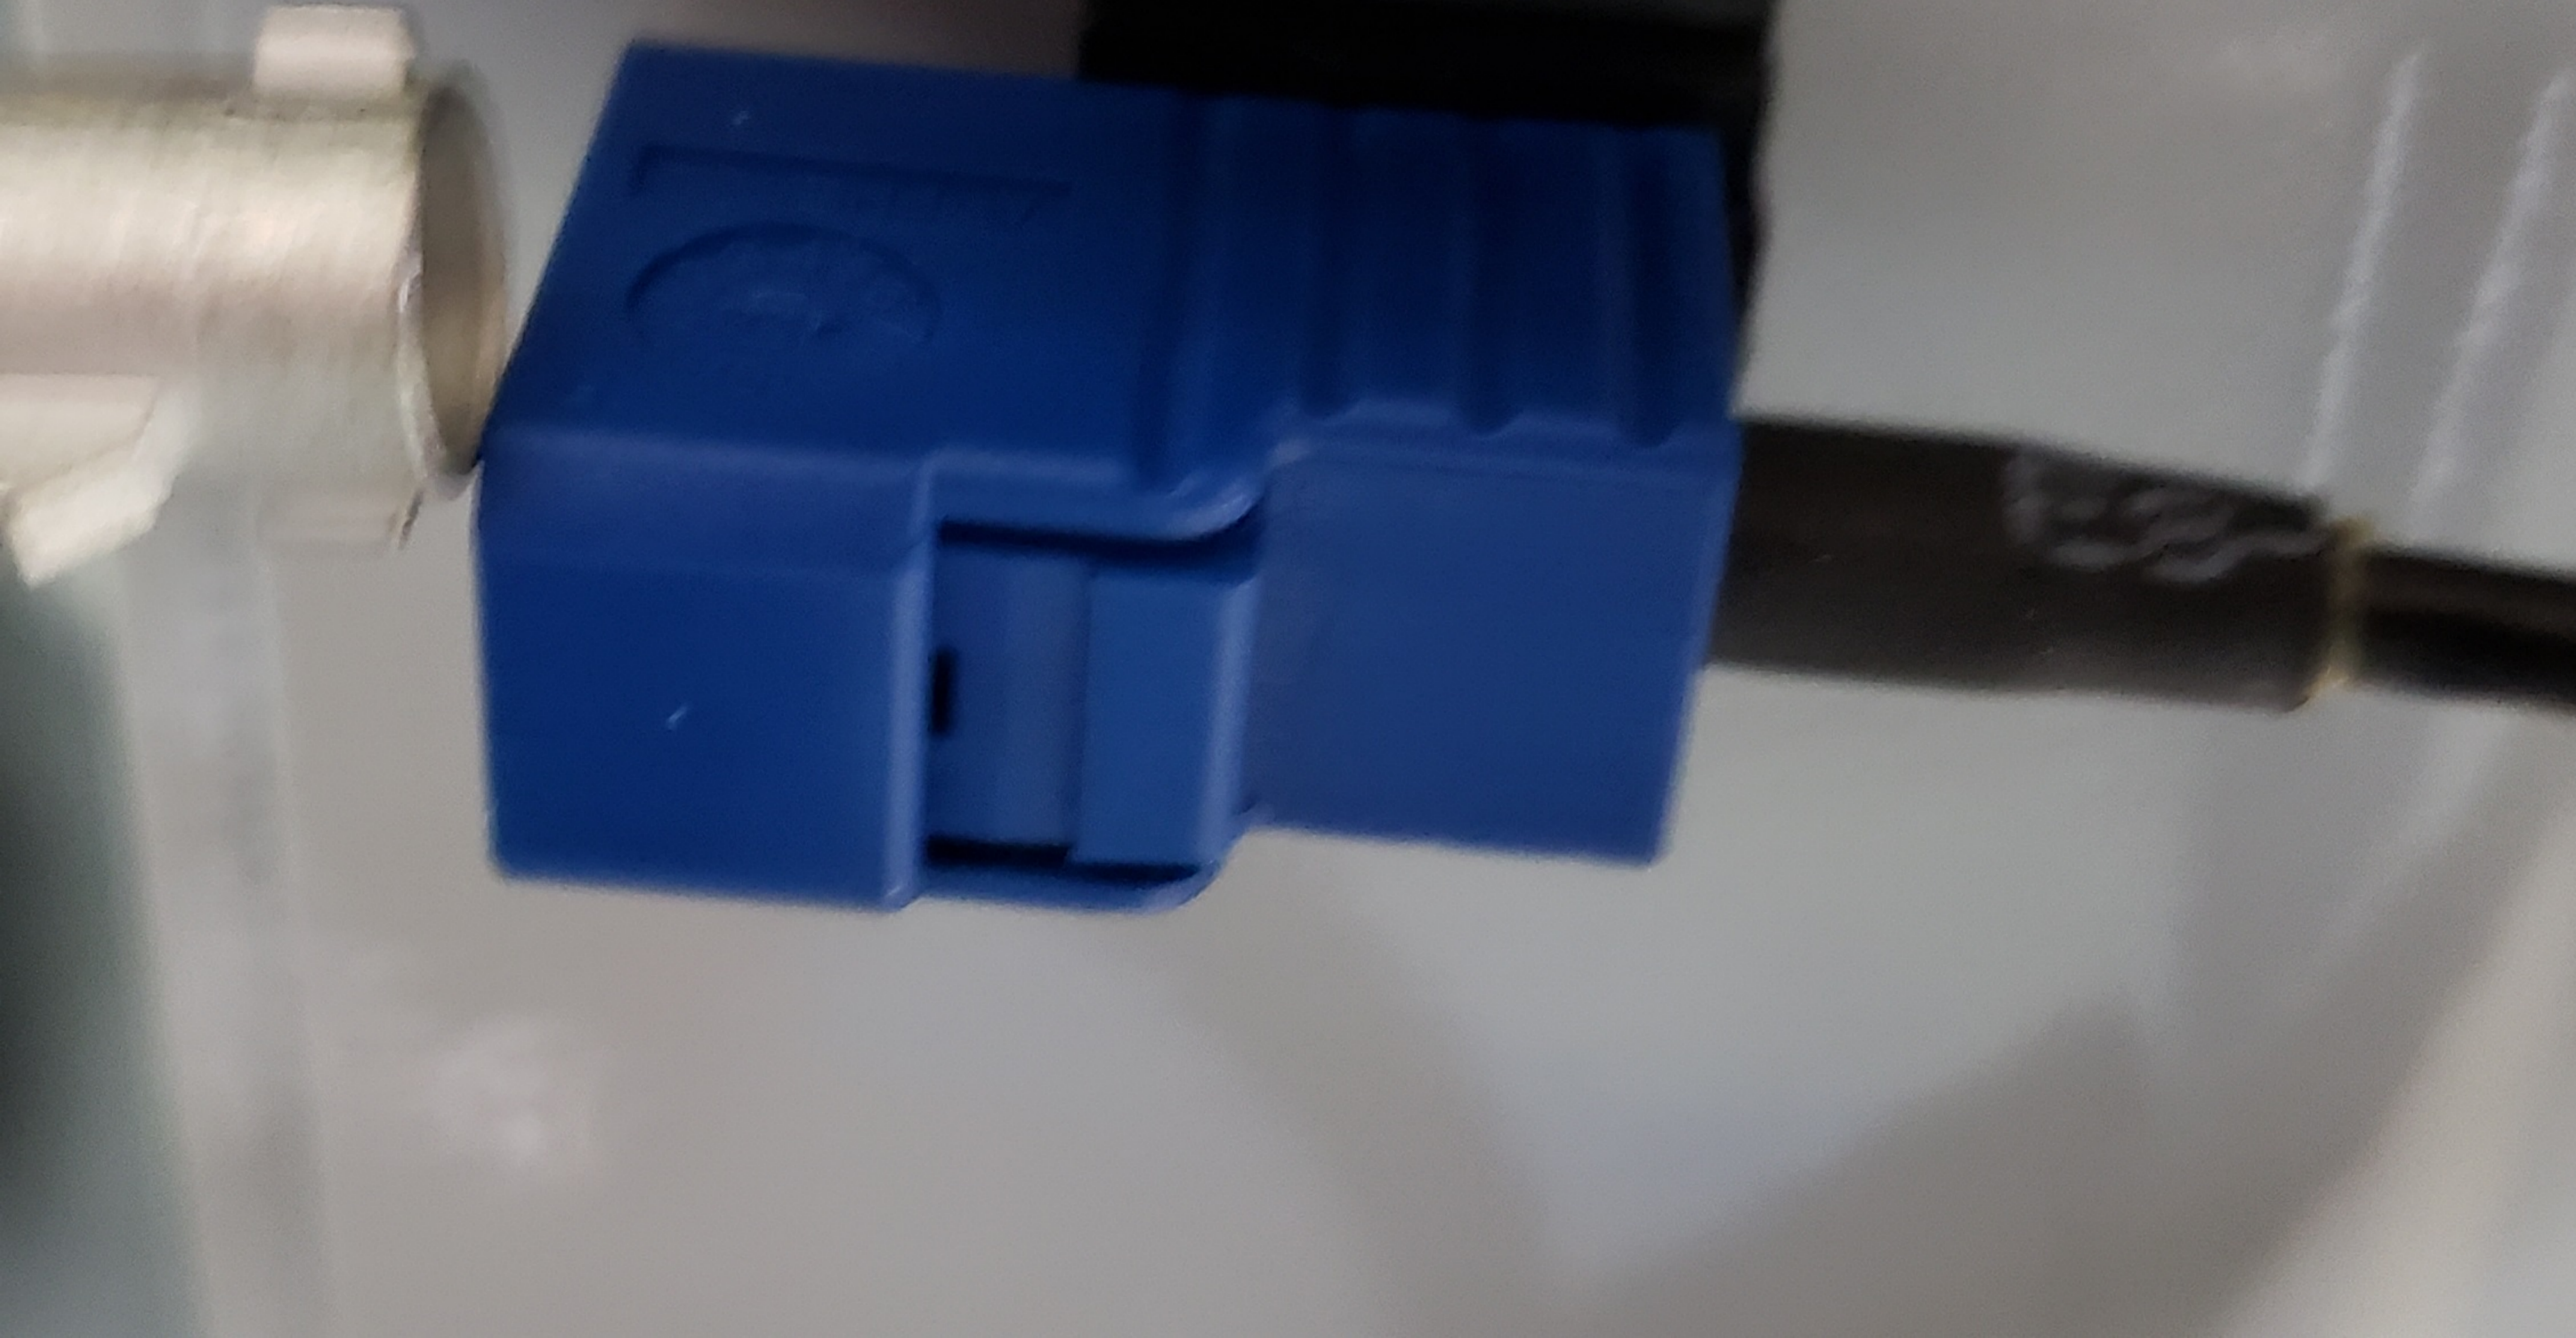
CONNECTION TO  
CAMERA

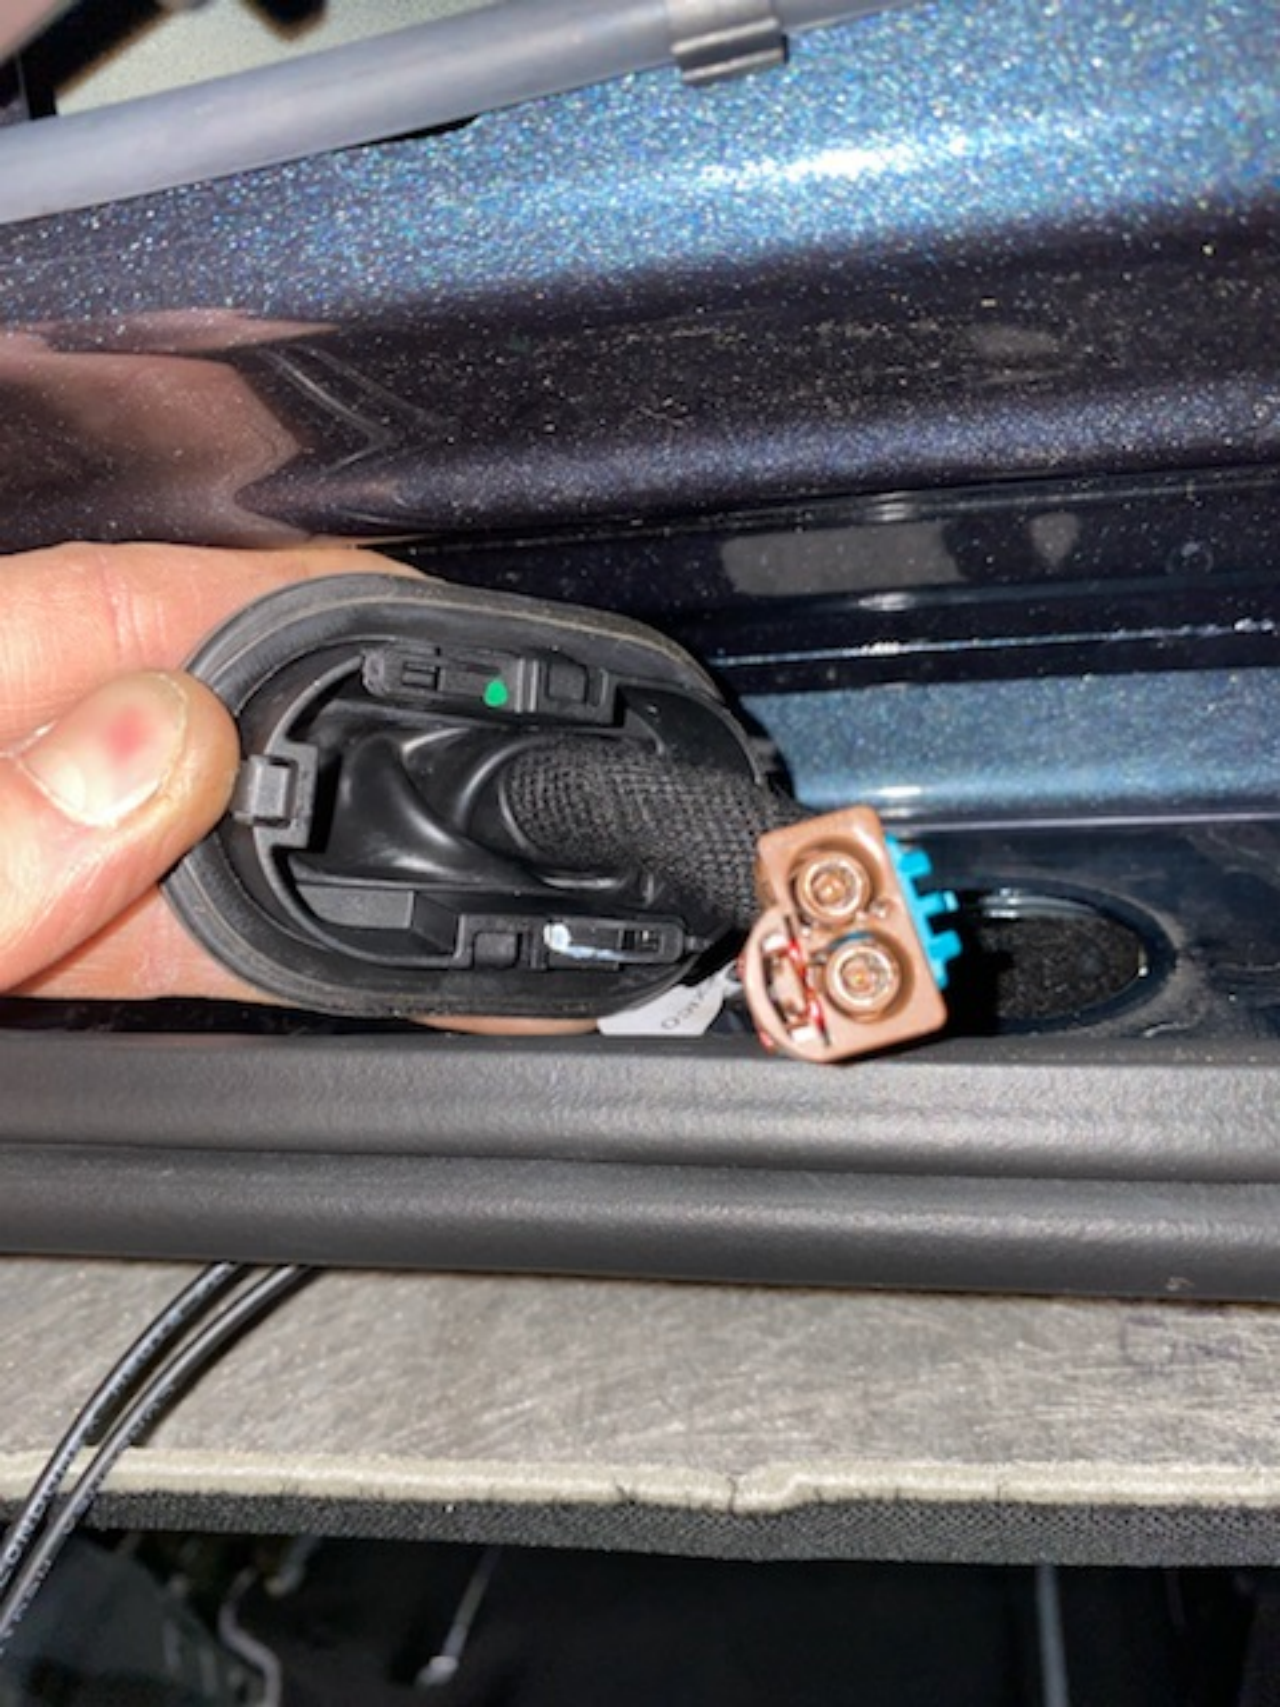
← This brown connector does not fit in this pass-thru.

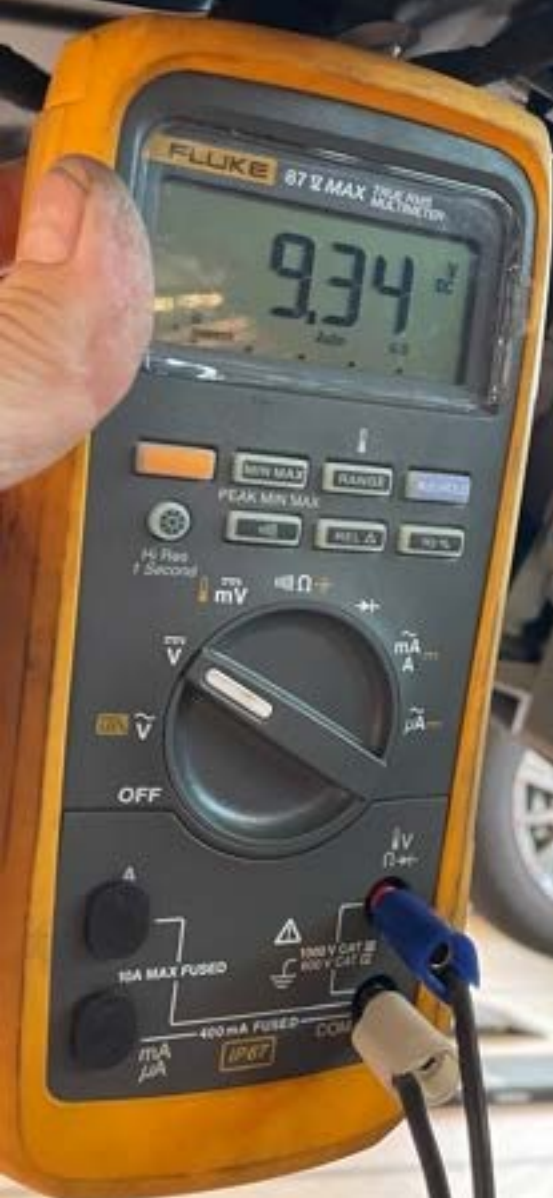
E4491: Reprogramming Error! Check all connections and reset Programming Interface!

E4423: Unknown reprogramming error 5 at step 0
