#21-NA-048: Black Screen in Reverse with Red Triangle and Red Camera with A Circle and Slash Through It - (May 19, 2021)

Subject: Black Screen in Reverse with Red Triangle and Red Camera with A Circle and Slash Through It

2020 Cadillac XT6 - [REDACTED]

2020 XT6 No 360 Camera Image When Put Into Reverse

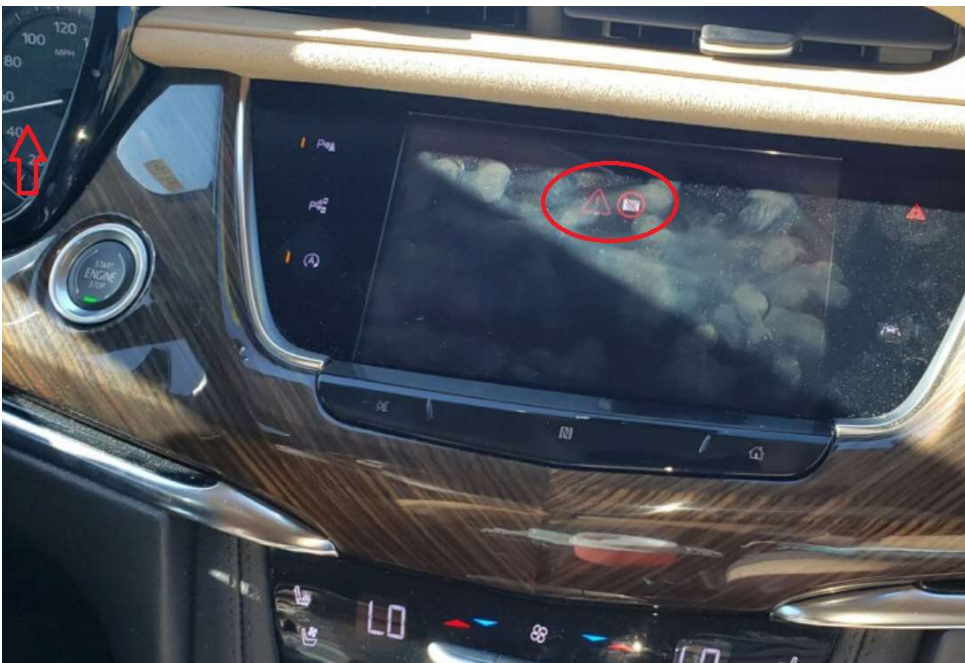
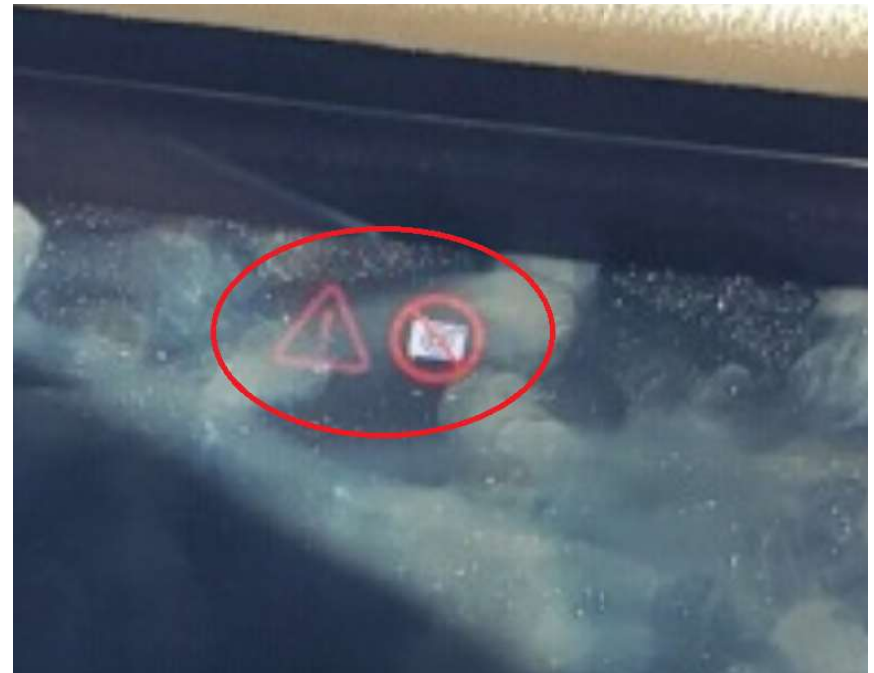
I cannot find any info regarding these symbols in SI, or in the Owner's Manual, I assume they mean camera is unavailable?

(Customer's pic of screen during concern, was in 360 vision mode, traveling @ 50mph.)

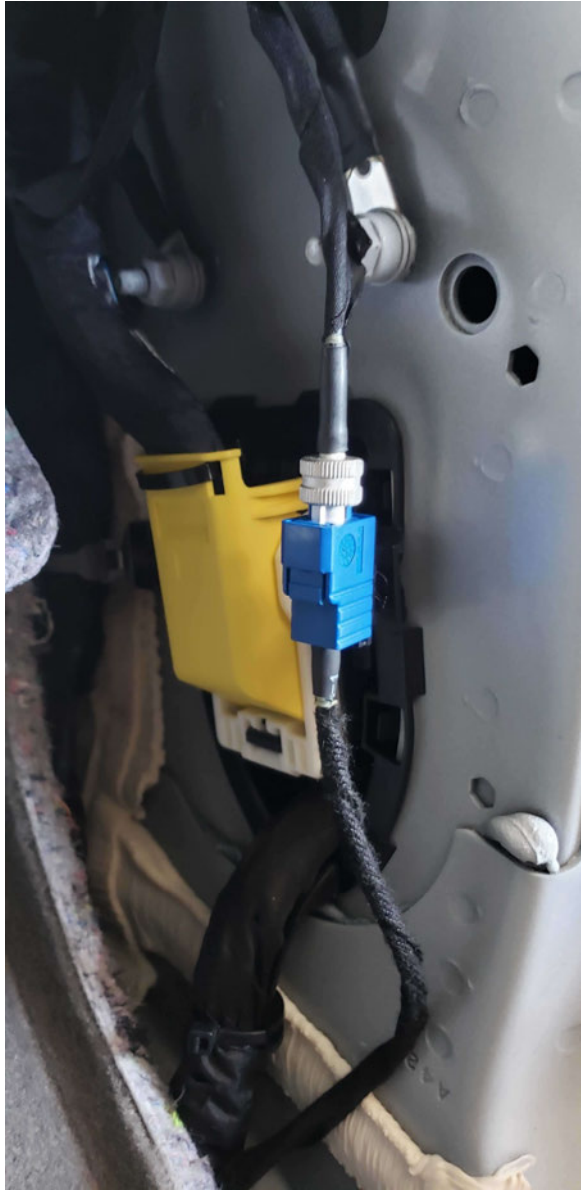
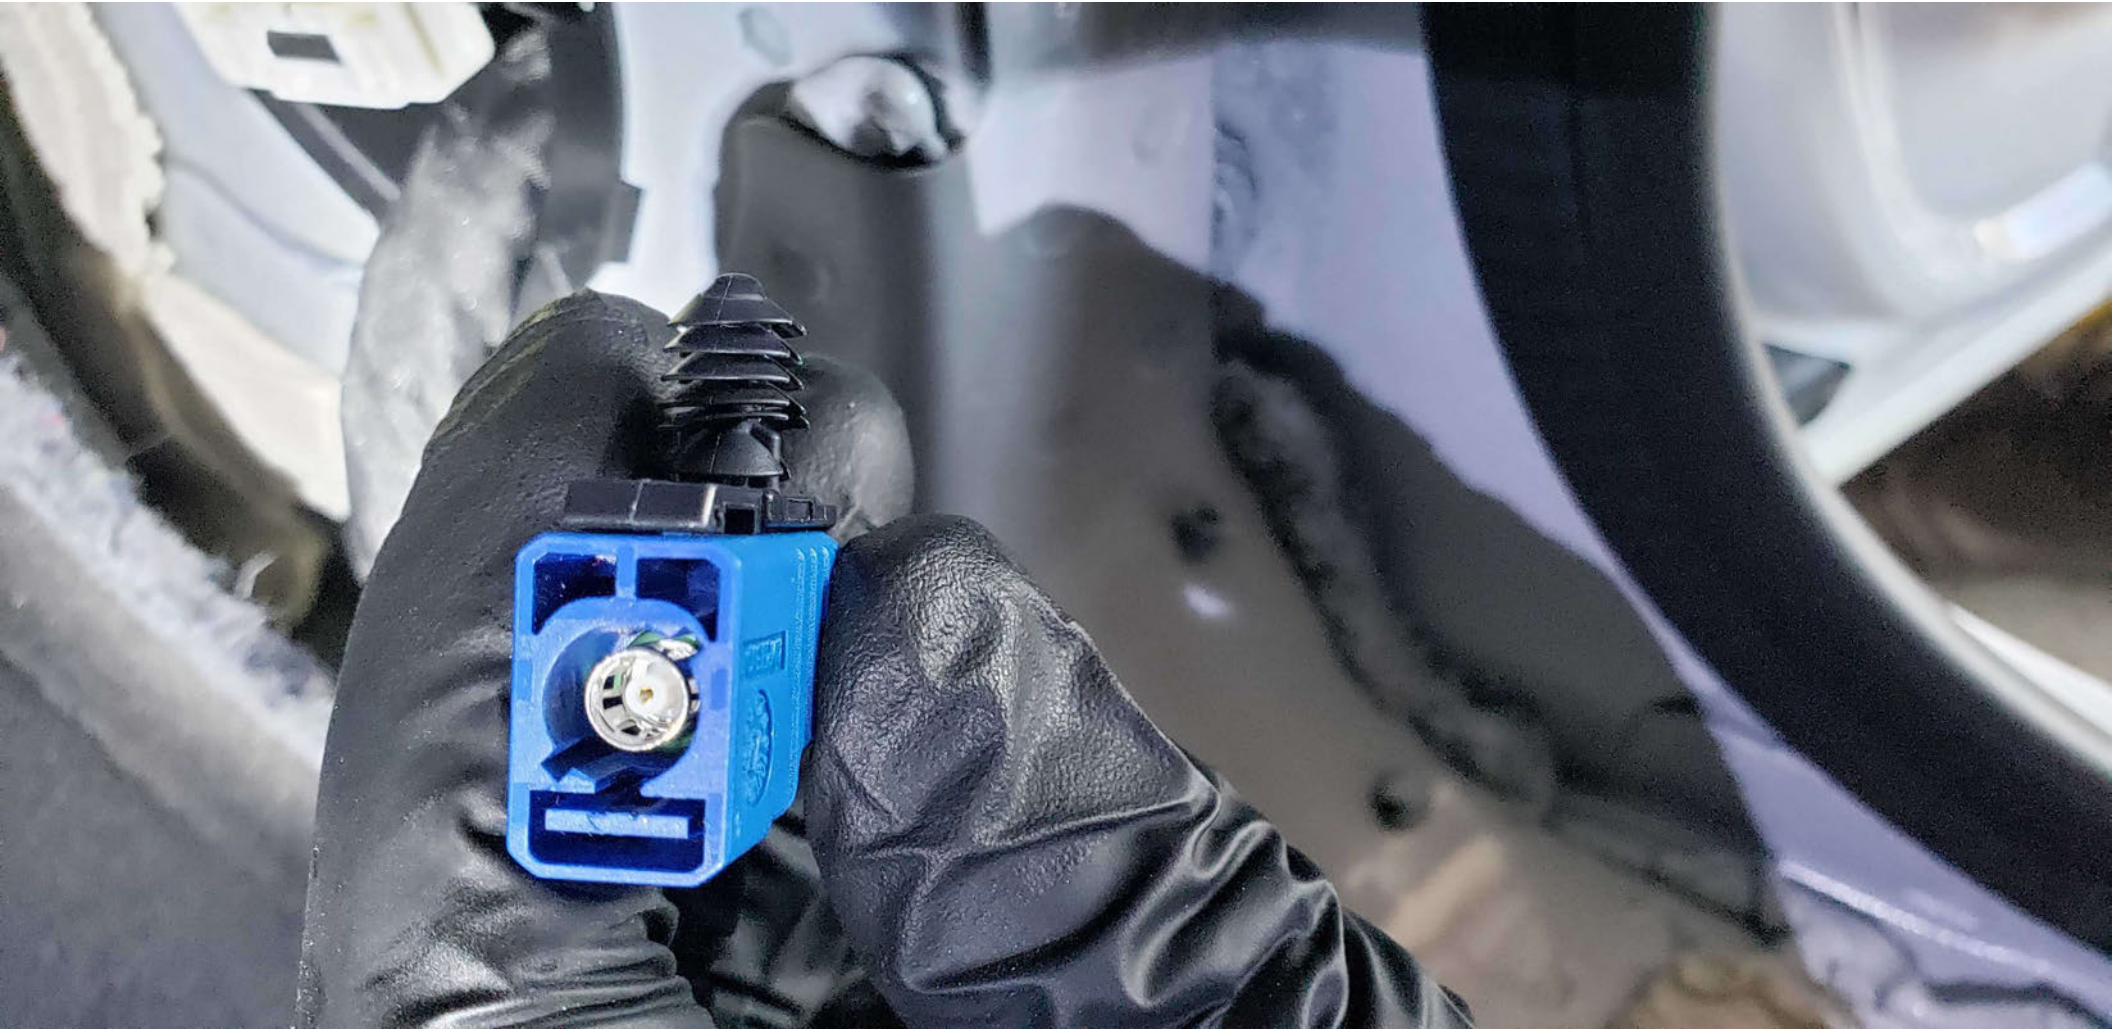
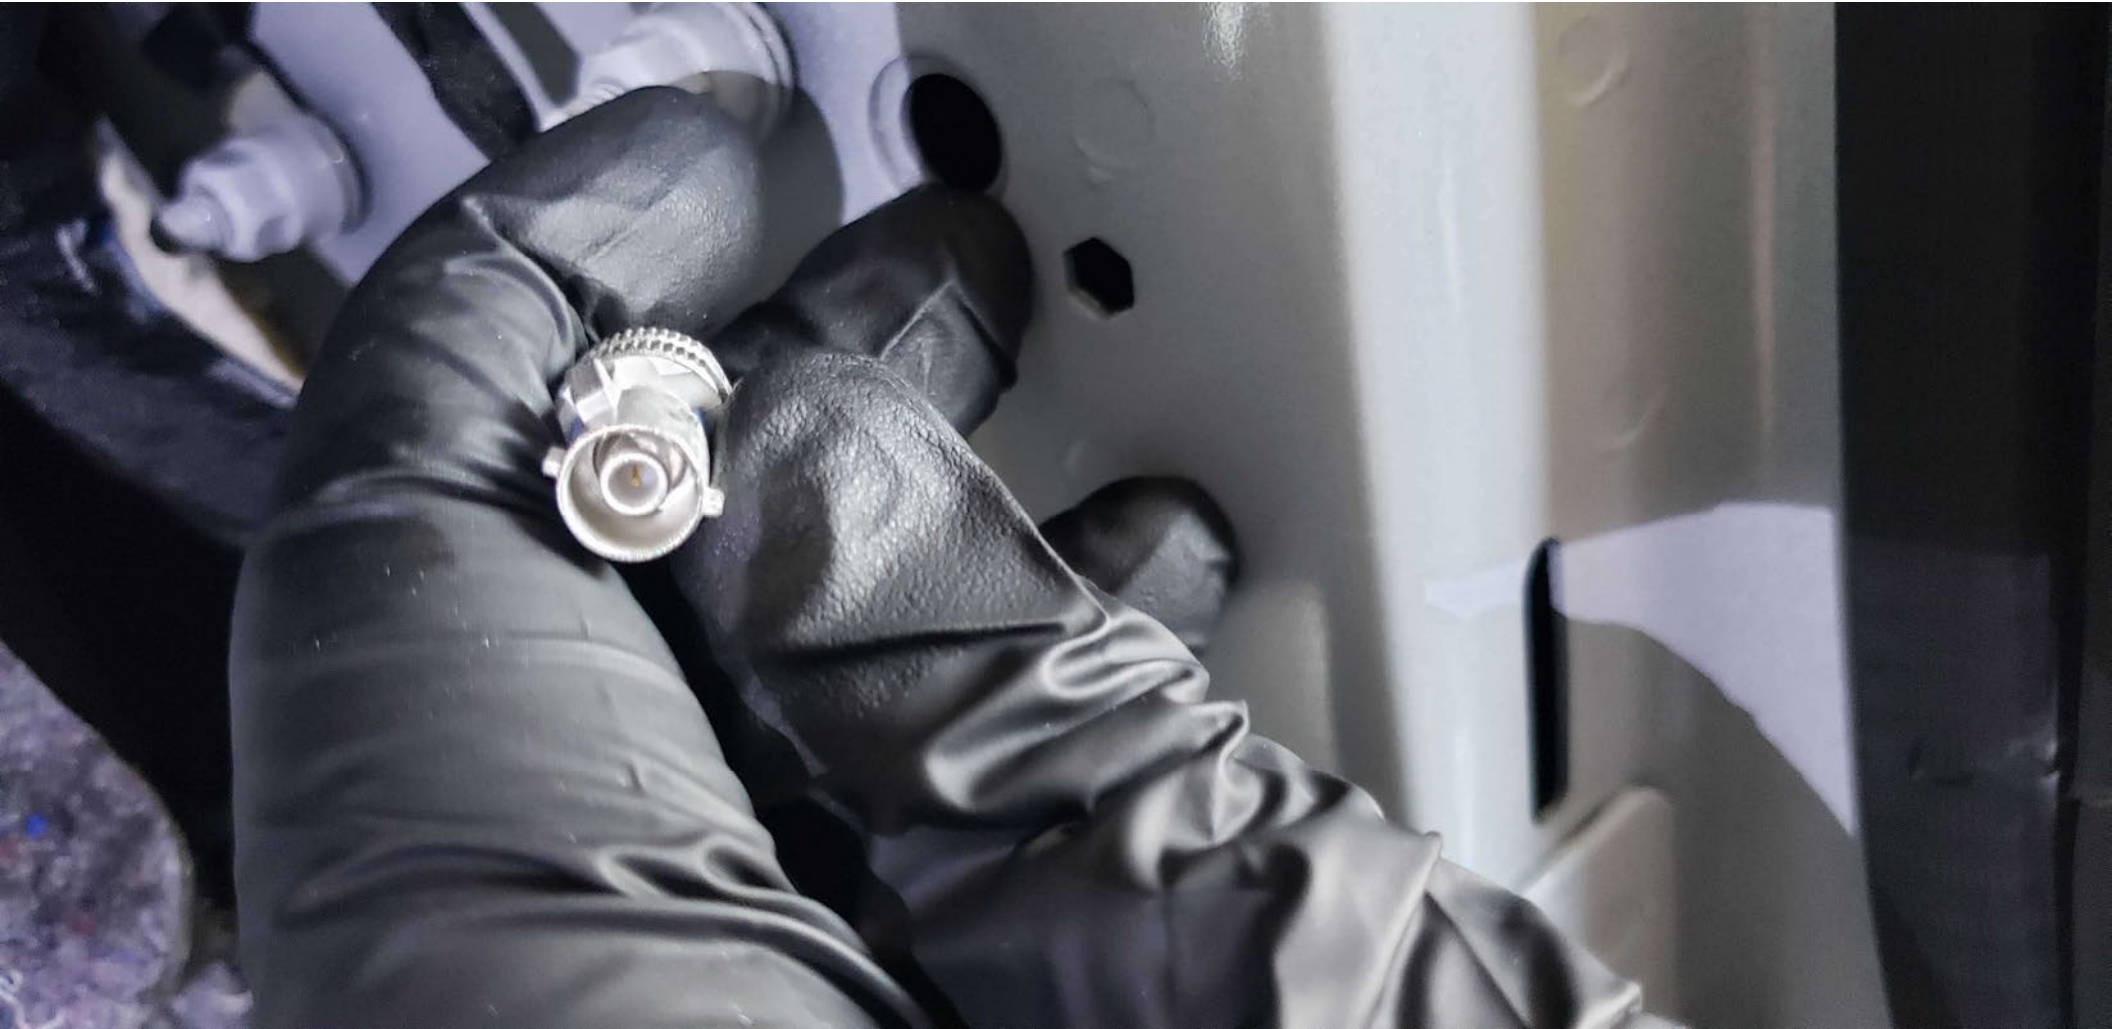
No codes stored in radio or VPCM when concern takes place. When performing initial inspection Foreman and I were able to duplicate concern with vehicle parked outside in the sun. Cabin temperature was very warm. Going over speed bumps did not effect concern. With vehicle parked inside shop where it was cool we were unable to duplicate the concern again until I tried to separate the X219 connector. When I tried to separate I was able to duplicate the blank screen concern twice. No dielectric grease was applied in the X219 connector. The Foreman was instructed to overlay the Coax cable between the VPCM and Radio. Note: When the K157 VPCM X3 connector is removed 2 codes will set reflecting the open circuit in the B87 Rearview Camera circuit. No codes will set pertaining to the open circuit between the VPCM and Radio. That would explain why no codes set pertaining to the customers concern.
