Document ID: 5757463

This bulletin replaces PIC6420D. Please discard PIC6420D.

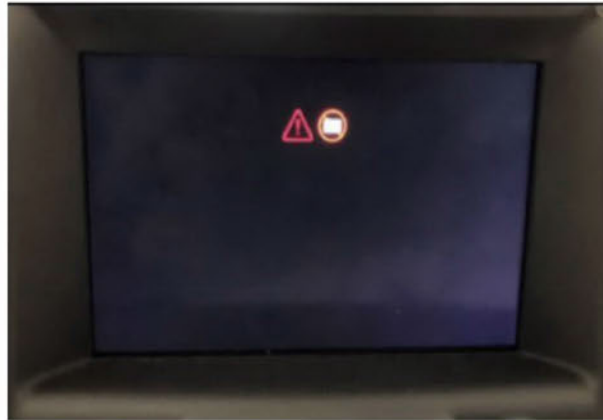
Some customers may comment on seeing a black screen with red triangle and red camera with a circle and slash through it when vehicle is in Reverse. This condition may be intermittent.

Cause	The cause of the condition may be that the crimping of the coaxial cable connectors to the cable is causing an excessive resistance that interrupts the video signal and causes the black screen.
Correction	Note: Verify the Condition, then depending on Model and Year, follow the appropriate repair in the list of Repair Procedures below.

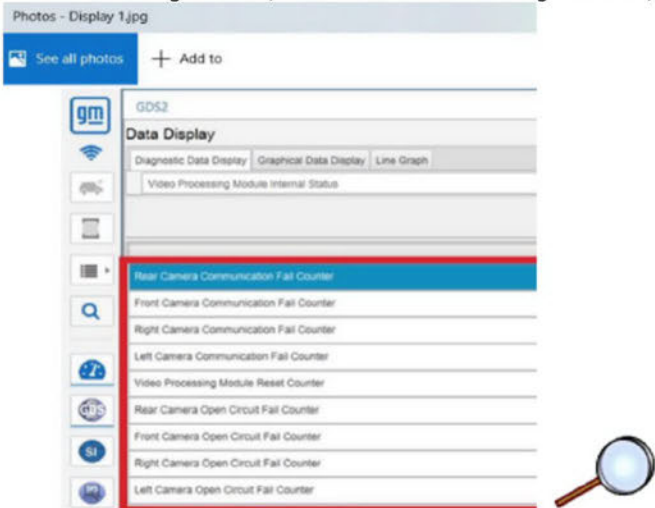
1. Connect the scan tool to the vehicle's data link connector and open GDS2 in the Techline Connect application and write down all DTCs stored in the vehicle.
2. Navigate to the VPM Module to observe the Fail Counters:
Module Diagnostics / K157 Video Processing Module / Video Processing Module Internal Status.

3. The three most critical parameters to look at are:
 - a. Camera Communication Fail Counter
 - b. Video Processing Module Reset Counter
 - c. Camera Open Circuit Counter
4. Write down the counters found in the VPM using the scan tool.
5. Cross-reference the DTC's and counters with the trouble shooting table below to determine most probable cause.

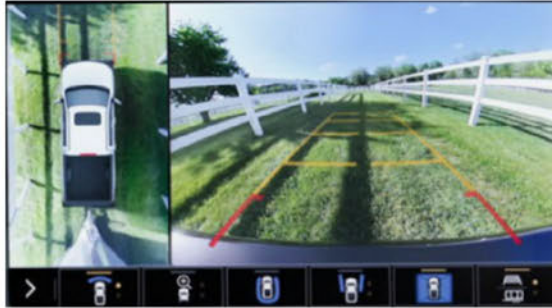
- If the "Cameras" Icon is greyed out and not working. The connection issue may be between the VPM and Radio.
- If the touch buttons are working properly, it could be an issue with the coax cable connection from the VPM to the Rear Vision Camera.

Note: Before testing the coax cable, check the cable's exterior for being pinched, cut, damaged, or having loose connections at the components, all of which can cause reception issues.
