Honda Motor Co. Light Vehicles	NHTSA Report for TREAD Act	NHTSA Reporting Period:
--	-----------------------------------	--------------------------------

Report ID : [REDACTED]	# of Attachments : 4	Zone / District : 03 / 03G
Report Method : V s t	Create Date : 06/20/2022 12:16:48	
Brief Description : Rear d fferent a eak

Make : Honda	Model Series : CR-V	Engine Number : L15BE6529417
NHTSA Model : CR-V	Model ID : RW2H9NKNW	Style :
Model Year : 2022	Mileage : 5750	Transmission : CVT
VIN : [REDACTED]	Unit Status : So d to Customer	Body : AWDTRG
	Date of Occurrence : 06/20/2022	Engine Type:

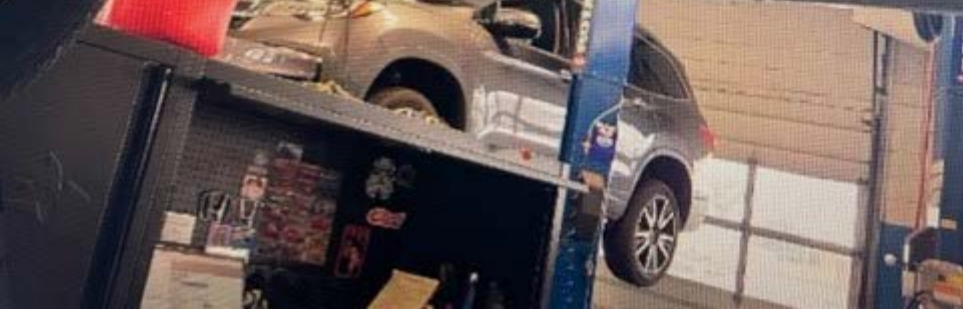
Customer states they heard a very oud noise whi e driving and then there was a message for AWD System Prob em

Inspected vehic e and found the rear differentia sea eaked out a the fluid causing damage to the rear differentia carrier. Checked and did not see any signs of impact at a .
