## Motor Vehicle Defect Petition to Recall All Tesla Vehicles Due to Sudden Unintended Acceleration

**Investigation:** DP 23-002  
**Prompted by:** DEFECT PETITION  
**Date Opened:** 06/29/2023  
**Investigator:** Tariq Bond  
**Approver:** Tanya Topka  
**Subject:** Sudden Unintended Acceleration  
**Reviewer:** Gregory Magno

**Manufacturer:** Tesla, Inc.  
**Products:** MY 2013 - 2023 Tesla Model 3, Model Y, Model S, Model X  
**Population:** 1,800,000 (Estimated)  
**Problem Description:** The petition alleges a theory that the subject vehicles contain a defect that can cause sudden unintended acceleration, which may result in crash and injury.

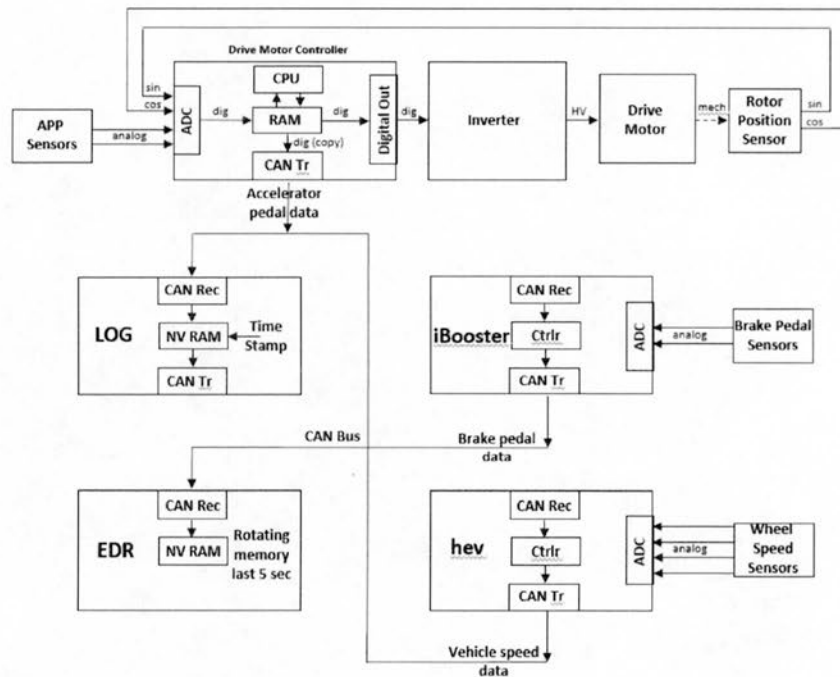
Figure 2. Data is transferred to the vehicle LOG and EDR via a single CAN bus.

- a. The lack of any missing data in either the vehicle speed LOG data or the vehicle speed EDR data suggest that the CAN bus is working normally [Footnote 1] at all times for all CAN messages from the hev brake module to either the vehicle LOG module or the EDR module. (The differences between the vehicle speeds in the vehicle LOG and EDR data; namely, the magnitudes and timing differences, are assumed to be slight and are thus ignored). Therefore, the CAN transmitter in the hev brake module and the CAN receivers in the vehicle LOG module and the EDR module must be operating normally at all times.[Footnote 2]

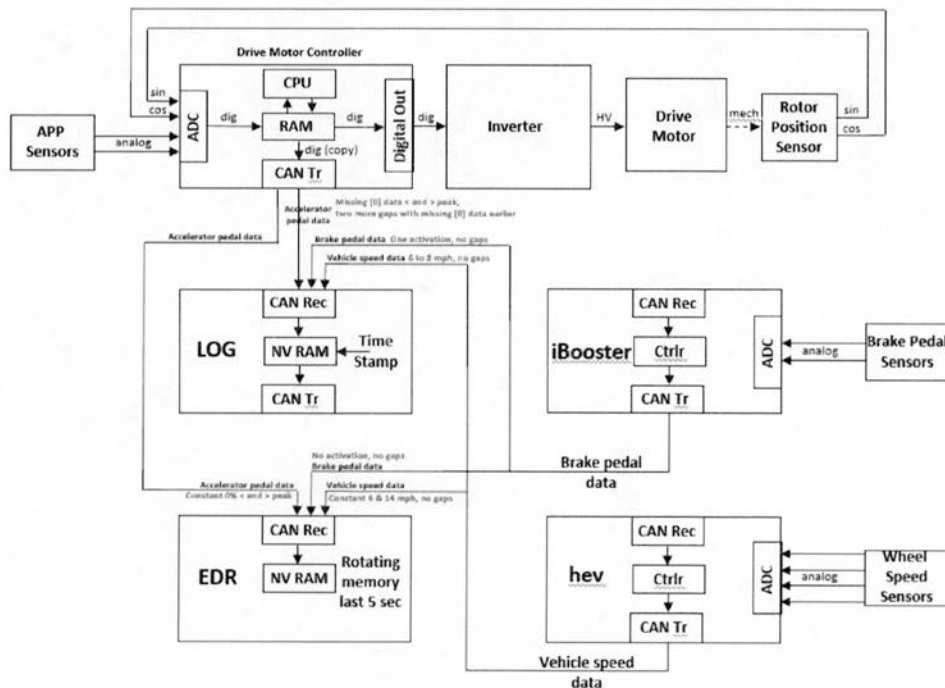
Figure 3. CAN bus messages interleave data between three data sources and the vehicle LOG or EDR.

- c. The messages from the three sources are interleaved as they are received by the vehicle LOG and the EDR at each point in time.
- 3) Examination of the data shows that there is no missing data either in the vehicle speed data, the driver brake apply data, or the accelerator pedal EDR data. However, there is missing data in the accelerator pedal vehicle LOG data.

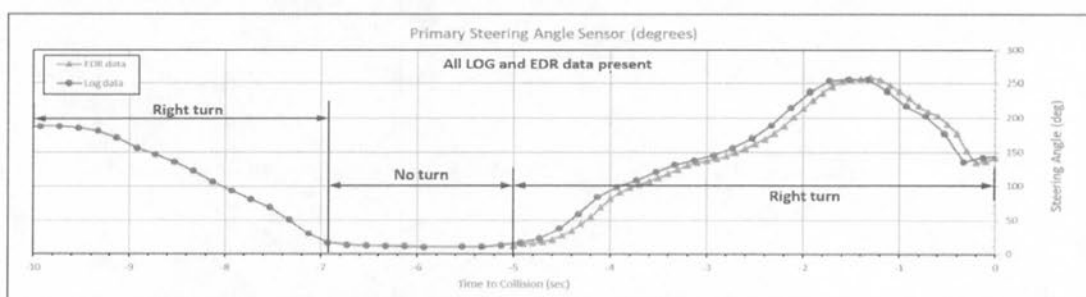
Figure 4. Steering angle for the first incident shows that two turns were made with a short path of no turn in between the two turns.

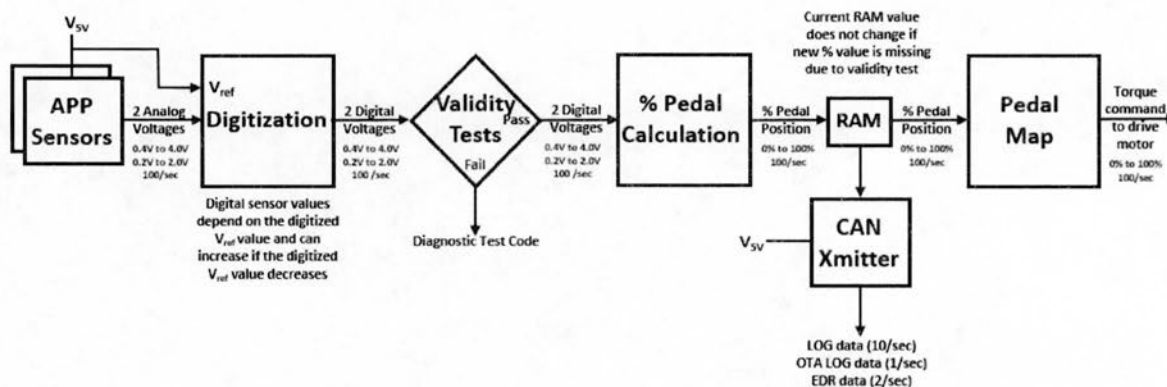
Figure B1. Signal chain for accelerator pedal data showing that the pedal data appearing in the EDR and vehicle LOG originates from a RAM location that serves as the input to the pedal map. If an error is detected in the sensor output, then a DTC is posted and the % pedal value is not calculated. But if an APP sensor output is missing because the sensor supply voltage is not present, then no DTC is posted because there is nothing to test, and the % pedal value is not calculated. This causes a missing % pedal value at the RAM input, which results in the current value of the RAM memory location remaining unchanged. This causes the torque command to the drive motor to remain unchanged by the missing sensor value. The RAM value at any time serves as the origin of the % pedal data sent to the EDR, the vehicle LOG and the OTA LOG via the CAN bus. Before

the CAN data is transmitted, the DSP down-selects the samples from the RAM operating at 100 samples/second to create the lower data rates required for the three data destinations shown in Table B1. However, if the CAN transmitter is non-functional because its 5V supply is not present, then missing % pedal values will be included in the data stream to the vehicle LOG, the OTA LOG, and the EDR.

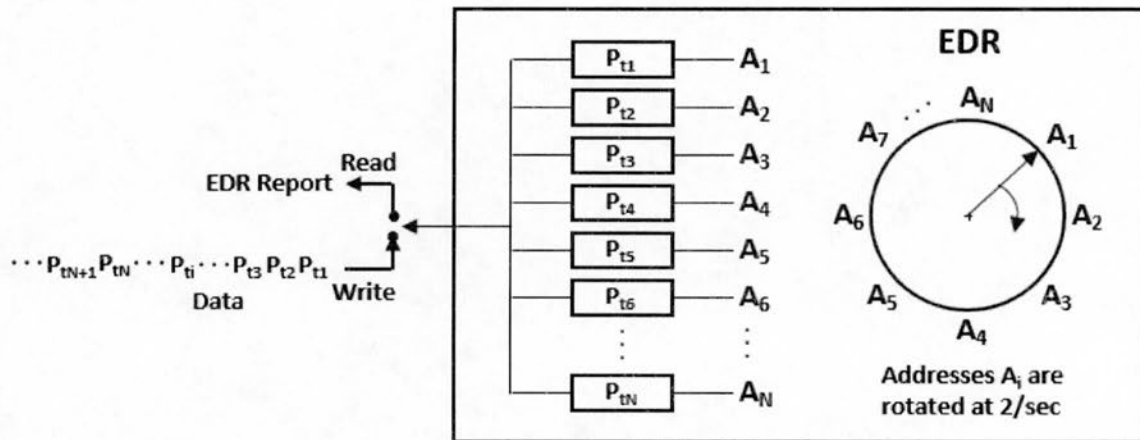
Figure B2. The EDR operates by writing the incoming accelerator pedal % values into successive memory locations whose addresses change in a rotating fashion. If a point  $P_{ti}$  is missing in the incoming data stream, the value stored in the EDR remains the current value  $P_{ti} = P_{ti-N}$ .

The memory capacity of the EDR is very small compared to the amount of data in the incoming data stream. This means that data coming into the EDR must continually overwrite the data already in the EDR. If a new data value  $P_{ti}$  is missing in the incoming data stream, then the value at address  $A_i$  in the nonvolatile RAM remains at its current
