# **2.7L Nano Intake Valve Failures**

## **U725 Warranty Claims and ERA proposal**

<b>Issue Title:</b>	Intake Valve Failures at 3 <sup>rd</sup> keeper groove on 20-21MY 2.7L / 3.0L Engines.			<b>Champion:</b>	Dave Simon / Jeff Bautz	
<b>Source:</b>	PT Current Model Quality Engine Exchange List.			<b>Team:</b>	B. Rhude, P. Adam, J. Kolodziejczyk, G. Pearson, Z. Ward T. Knott, M. Hewlett, T. Strand	
<b>Issue Description:</b>	2020 - 21MY 2.7/3.0L Nano engine failures due to 3 <sup>rd</sup> keeper groove fracture on left bank intake valves occurring at low time in service.					
<b>Containment:</b>	Implement micro indent core hardness checks, increase frequency of coolant flow and position checks at grinding operation, Increased visual inspection.					
<b>Root Cause:</b>	Side loading of the valve tip from rocker arm tipping as a result of valvetrain dynamics caused by increased lash in the system.					
<b>Corrective Action:</b>	Implement following ERA's: Increase frequency core micro hardness checks and control plan update. Including batch and hold Change valve material to Silchrome 1 for improved robustness to side loading and significantly higher high temperature fatigue strength pr

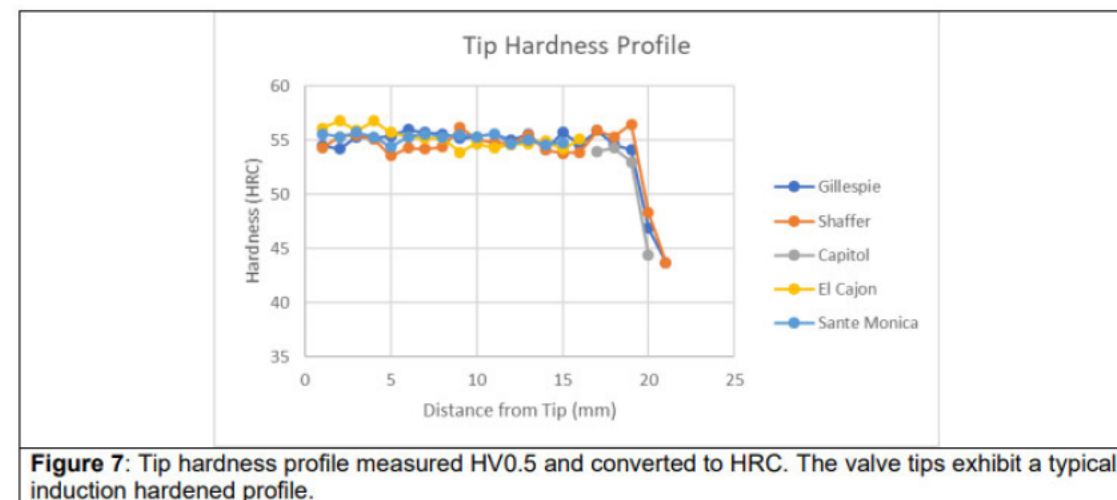
- All returned valves show evidence of side loading / impact.
- Witness marks of RFF side wall contact & RFF tipping. Significant wear depth at witness marks.
- Chamfer impact damage aligning with crack initiation point on fractured surface.
- RFF side wall broken or damaged in some cases.
- Parts within specification. Hardness 50-57 HRC

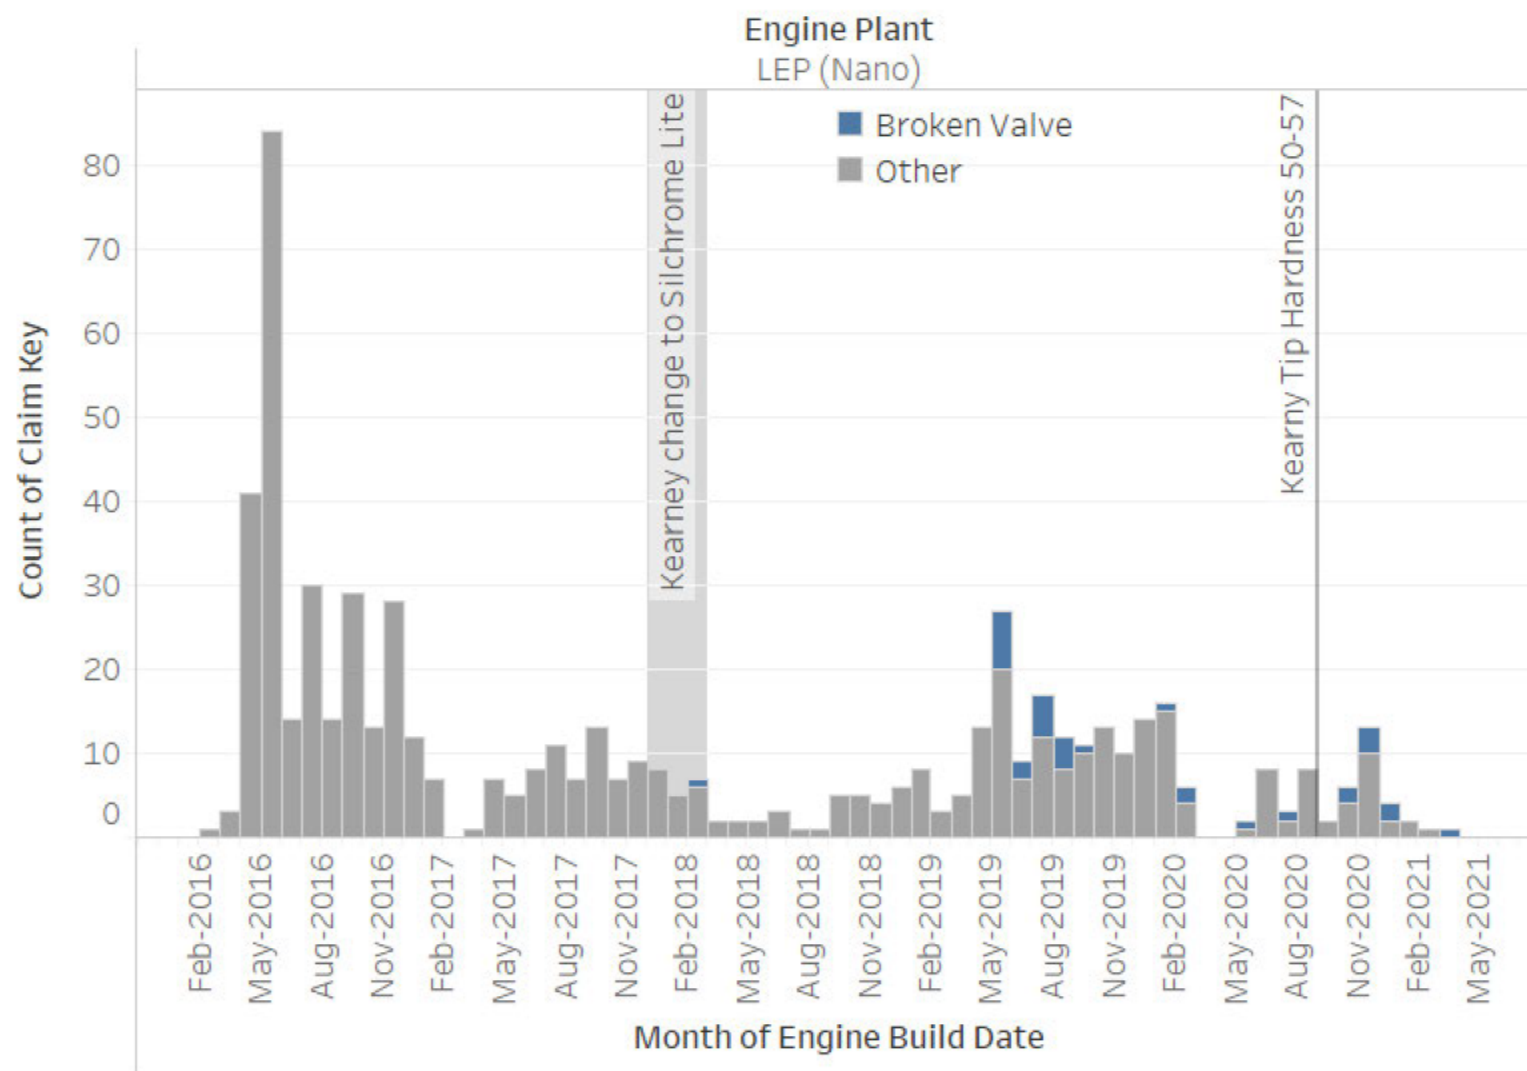
#### Nano QB Tracked Engine Exchanges (~ first 10 MIS)

- 25 intake valve 3<sup>rd</sup> keeper groove claims in 2020MY
- 10 claims in 2021MY
- 1 claim prior in 2018MY
- FT4E-6507-CA –
  - Original MY 2015 Production Launch Intake Valve
  - Silchrome 1 Material
  - Tip Hardness 50 MIN
  - Scraper groove on stem
- JT4E-6507-AA
  - SOP September of 2016.
  - MY upgrade. Only change from FT4E design is the absence of a scraper groove
  - Silchrome 1 material
  - Tip Hardness 50 MIN
- JT4E-6507-AB
  - SOP Q1 of 2018.
  - TVM action material change to Silite
  - Launched with tip hardness spec of 50MIN
  - Tip hardness spec changed to 50-57 HRC in October 2020.

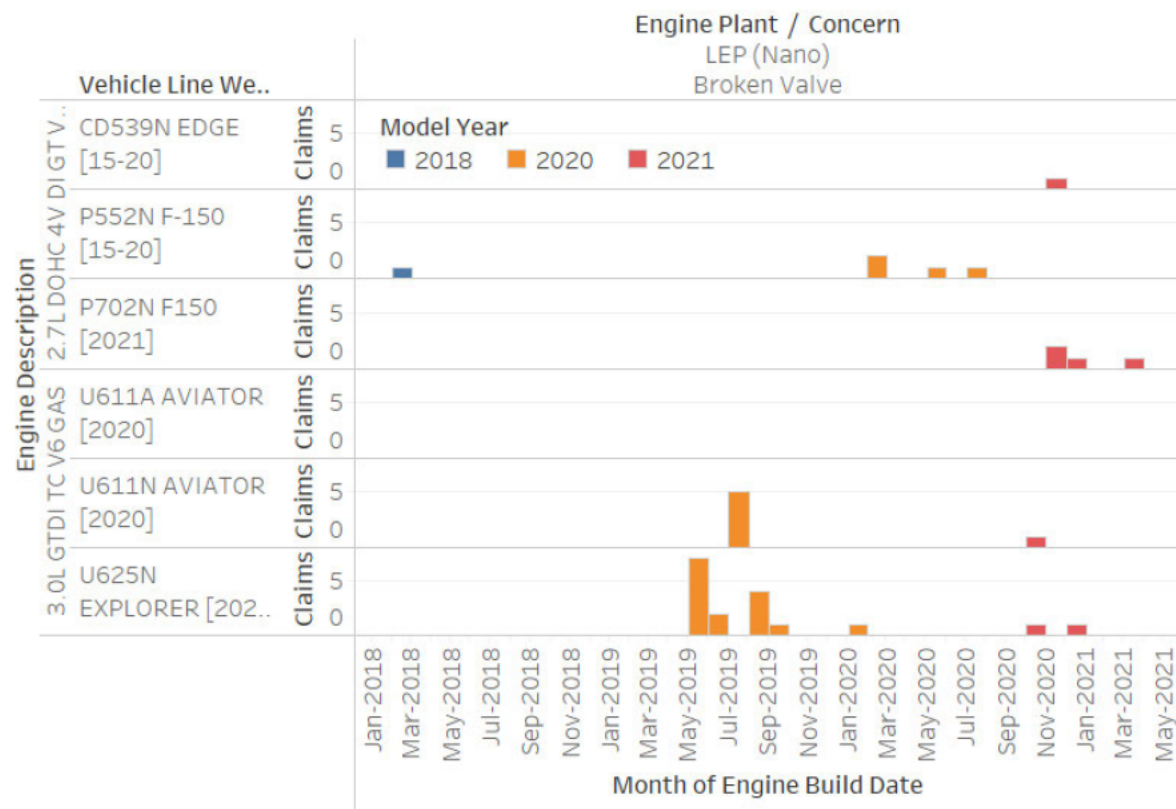
### Nano 3rd Keeper Groove Failures

Claims on both 2.7L & 3.0L. Truck and car  
1 claim prior to 2020 MY on 2.7L F150

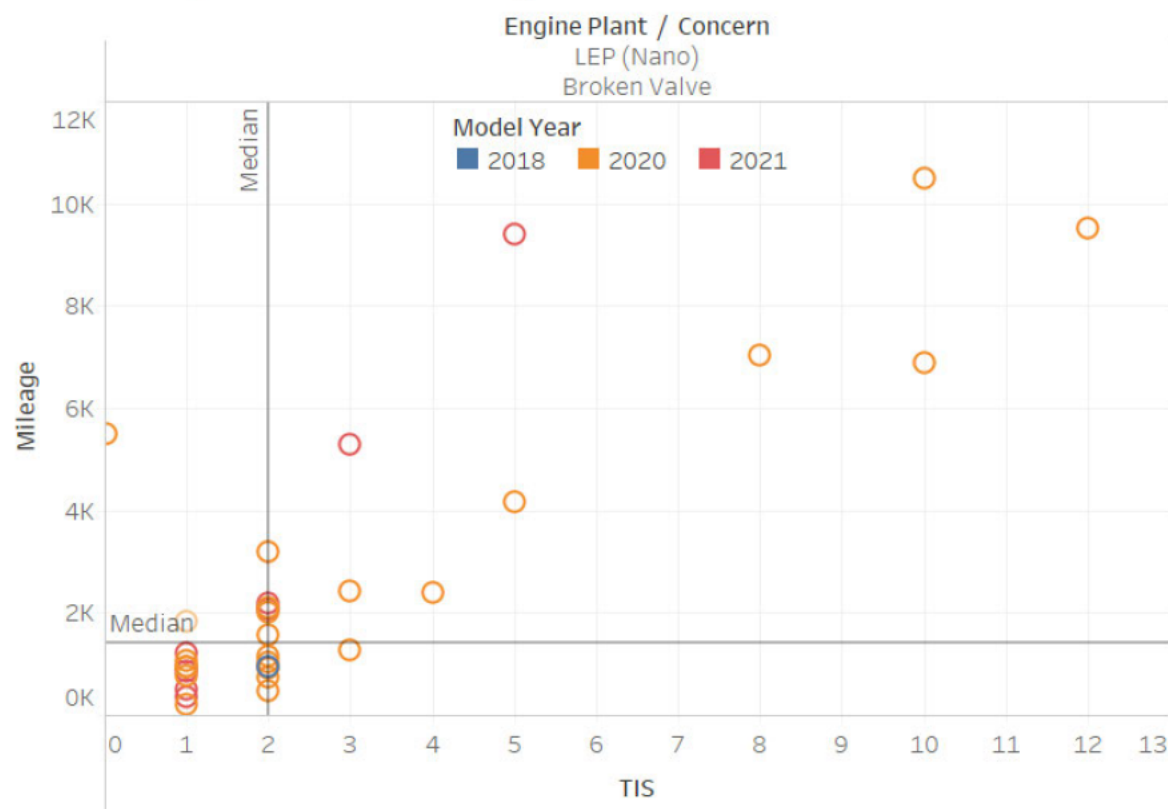
### Nano 3rd Keeper Groove TIS & Mileage

Failures occur at low time in service

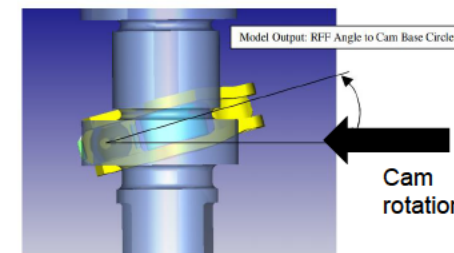
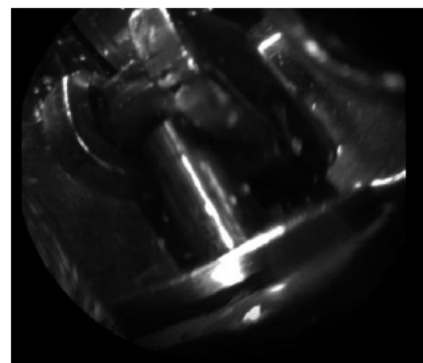
Slow motion video with lash in the system show tipping and side loading of valve tip.

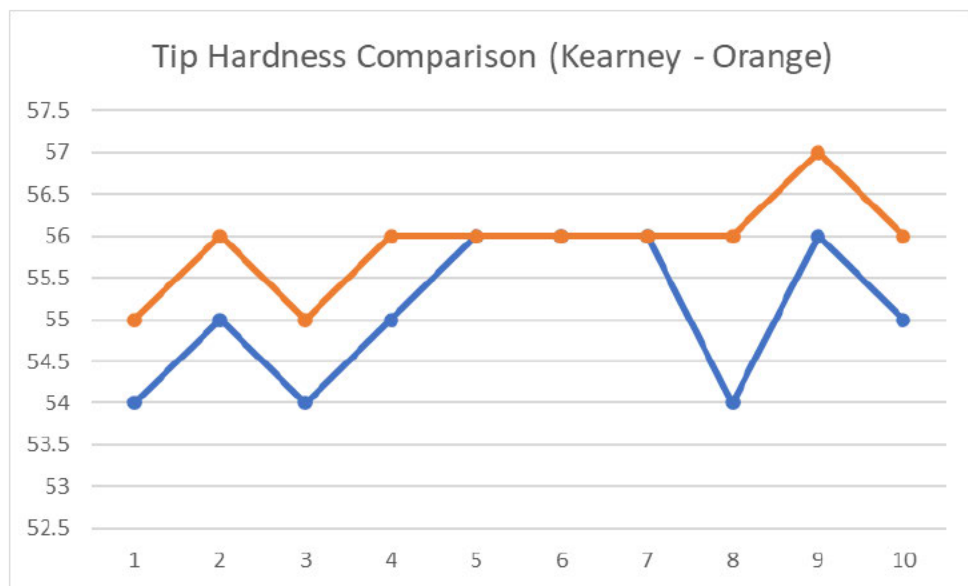
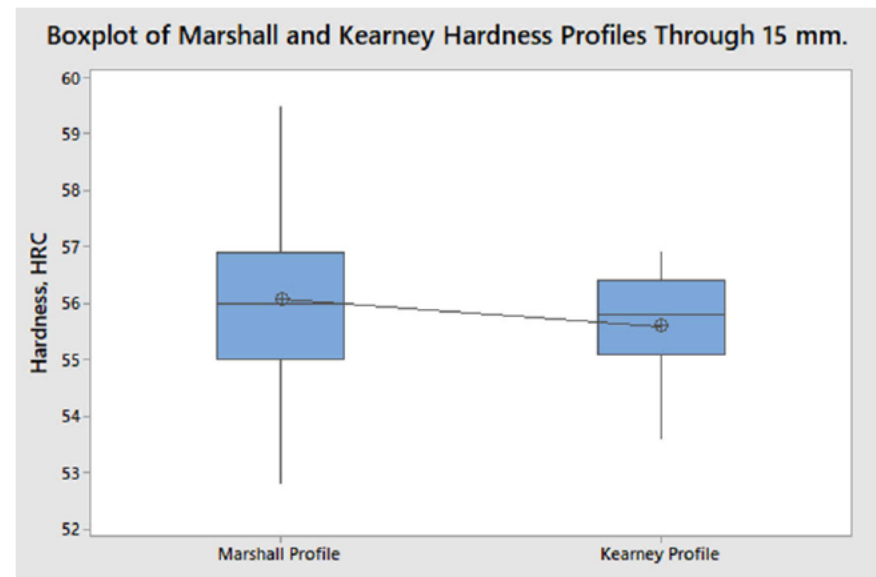
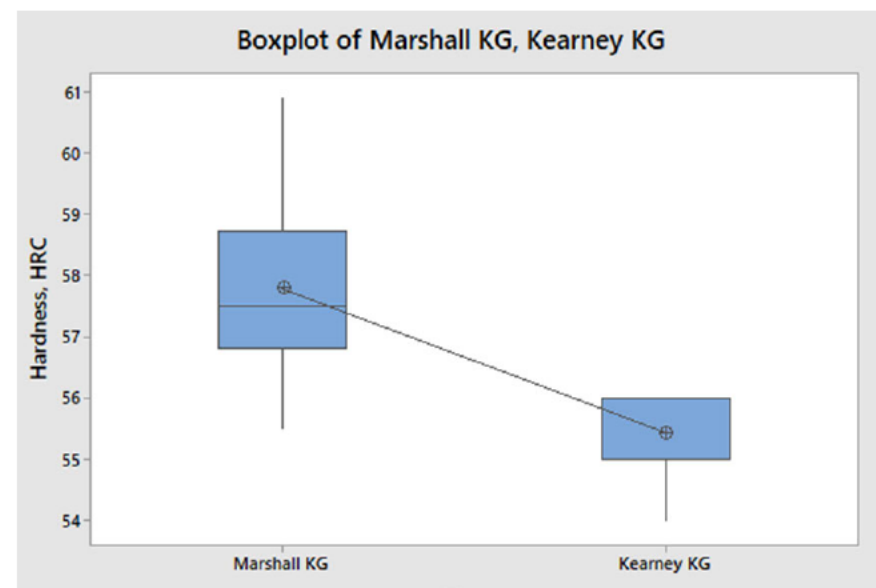
- Standard Hardness Tester: Hardness were mostly within one point of each other.
- Microhardness Tester (profile): The bulk microhardness tests were similar through 15 mm (fully hardened area) which was selected for comparison purposes.
- Microhardness Tester (Keeper Groove hardness): The microhardness measurements were found to be +2.4 HRC (on average) in Marshall vs. Kearney. This difference is not fully understood at this time.

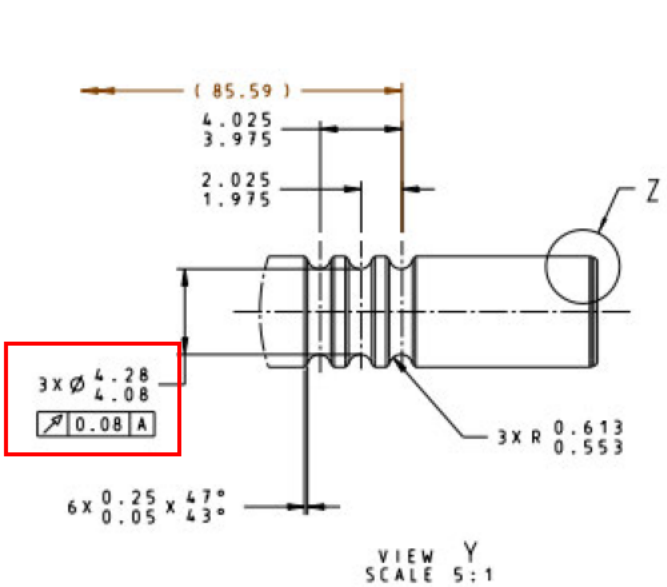
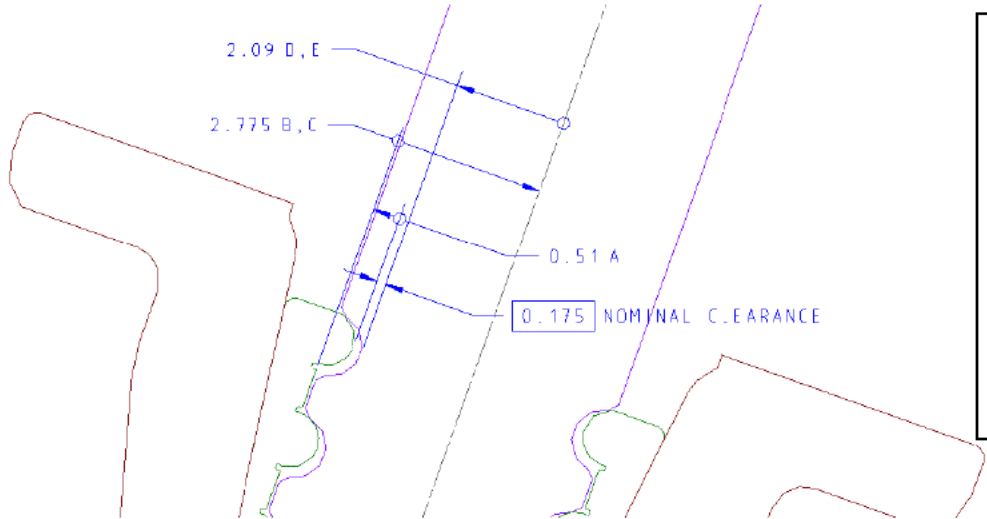
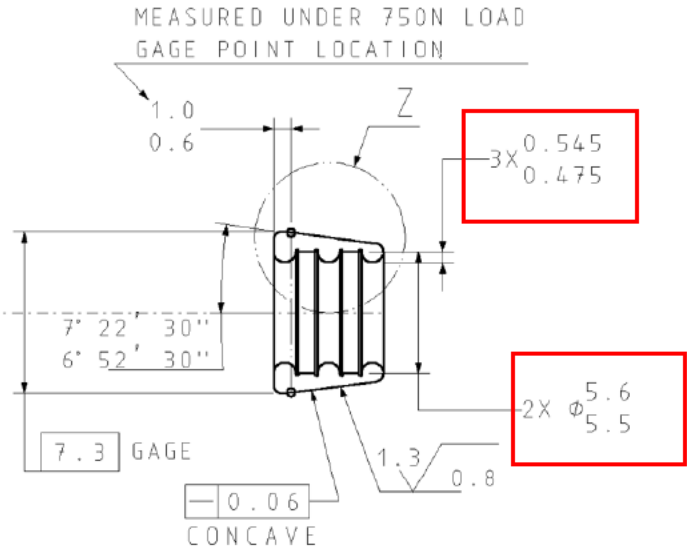
# Keeper Groove Root Diameter Increase

Arithmetic	
Key Flat to Key ID:	0.545
Key flat to Axis Key:	-2.750
Key-Valve Aligned	0.000
Valve Axis to KG ID:	2.140
Valve Runout:	0.040
Clearance	0.025

Benefit (X-Sectional Area)	
Nominal Dia. Today:	4.18mm
Nominal Area Today:	13.72mm <sup>2</sup>
Nominal Dia. Prop:	4.2mm
Nominal Area Prop:	13.99mm <sup>2</sup>
Area increase +1%

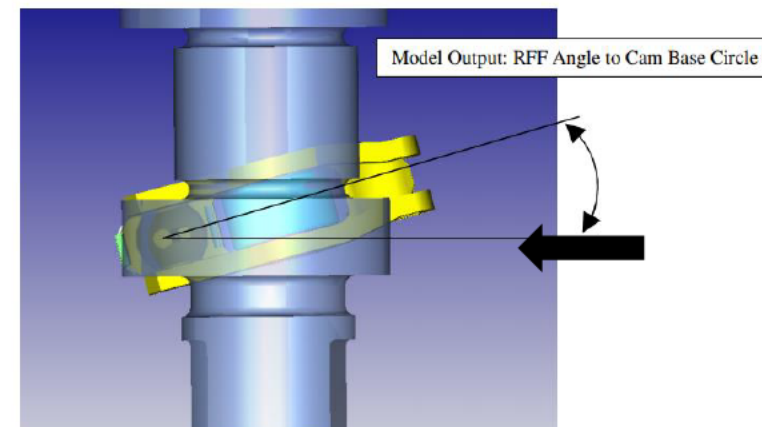
- VDOP Oil Pressure Increase.
  - High valve tip loading can result from RFF tipping / misalignment.
  - Worse on LH head due to cam rotation pushing RFF towards HLA. RH bank pulls away from HLA and naturally acts to align RFF.
  - Lash in the system increases misalignment and RFF side loading.
  - Oil pressure is main factor in loss of lash control.
  - Oil pressure also acts to improve compressibility of aerated oil and keep air in solution.
  - Proposing to increase oil pressure 40 kPa at idle -1000 RPM region as robustness to hardware / lube system variation.
  - Data at 95 C oil temp and above the LH HLA gallery could drop below min HLA requirement.

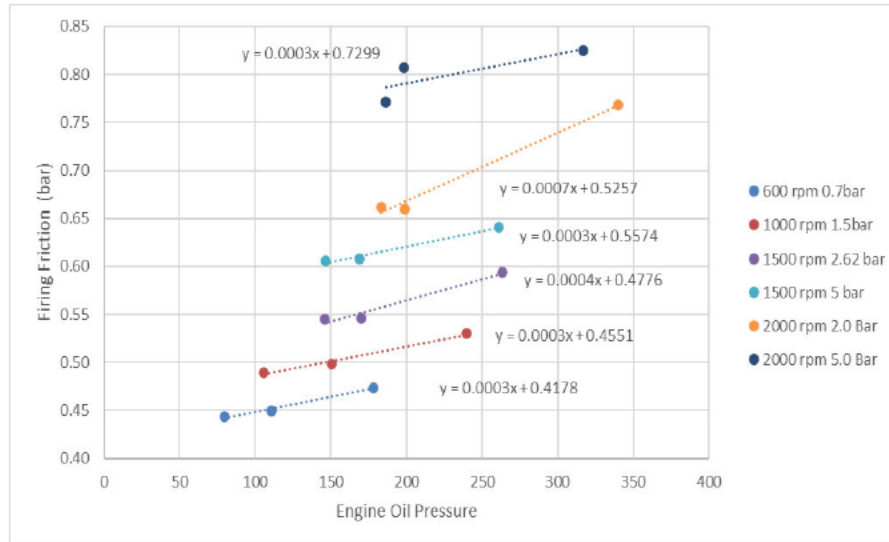
# 2021 2.7L U725 Oil Pressure Sweeps

Oil Pressure sweeps from dyno at 90c Oil Temp.  
Used to develop Friction sensitivity vs. oil pressure

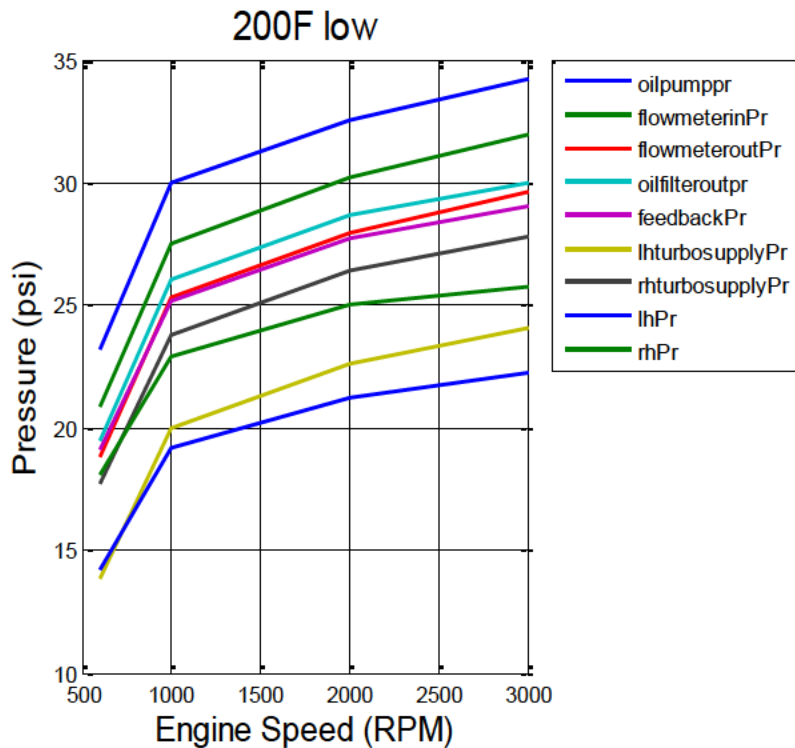
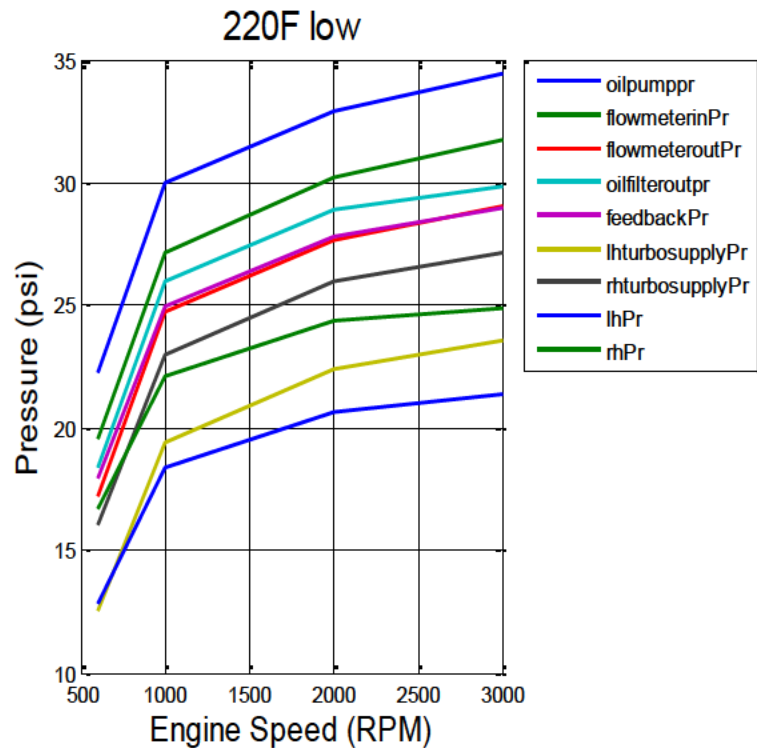
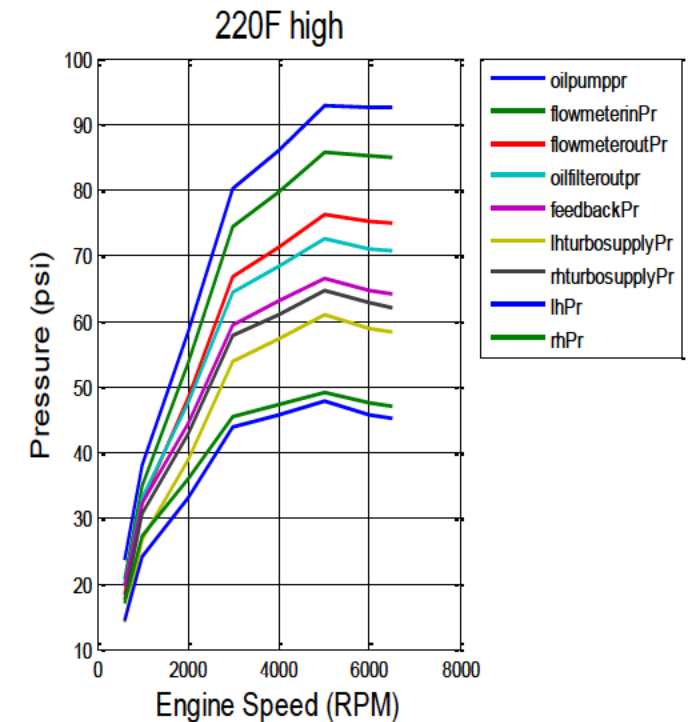
- Empirical data on 18MY 2.7L RWD shows lower oil pressure on LH vs RH cylinder heads (~4psi)

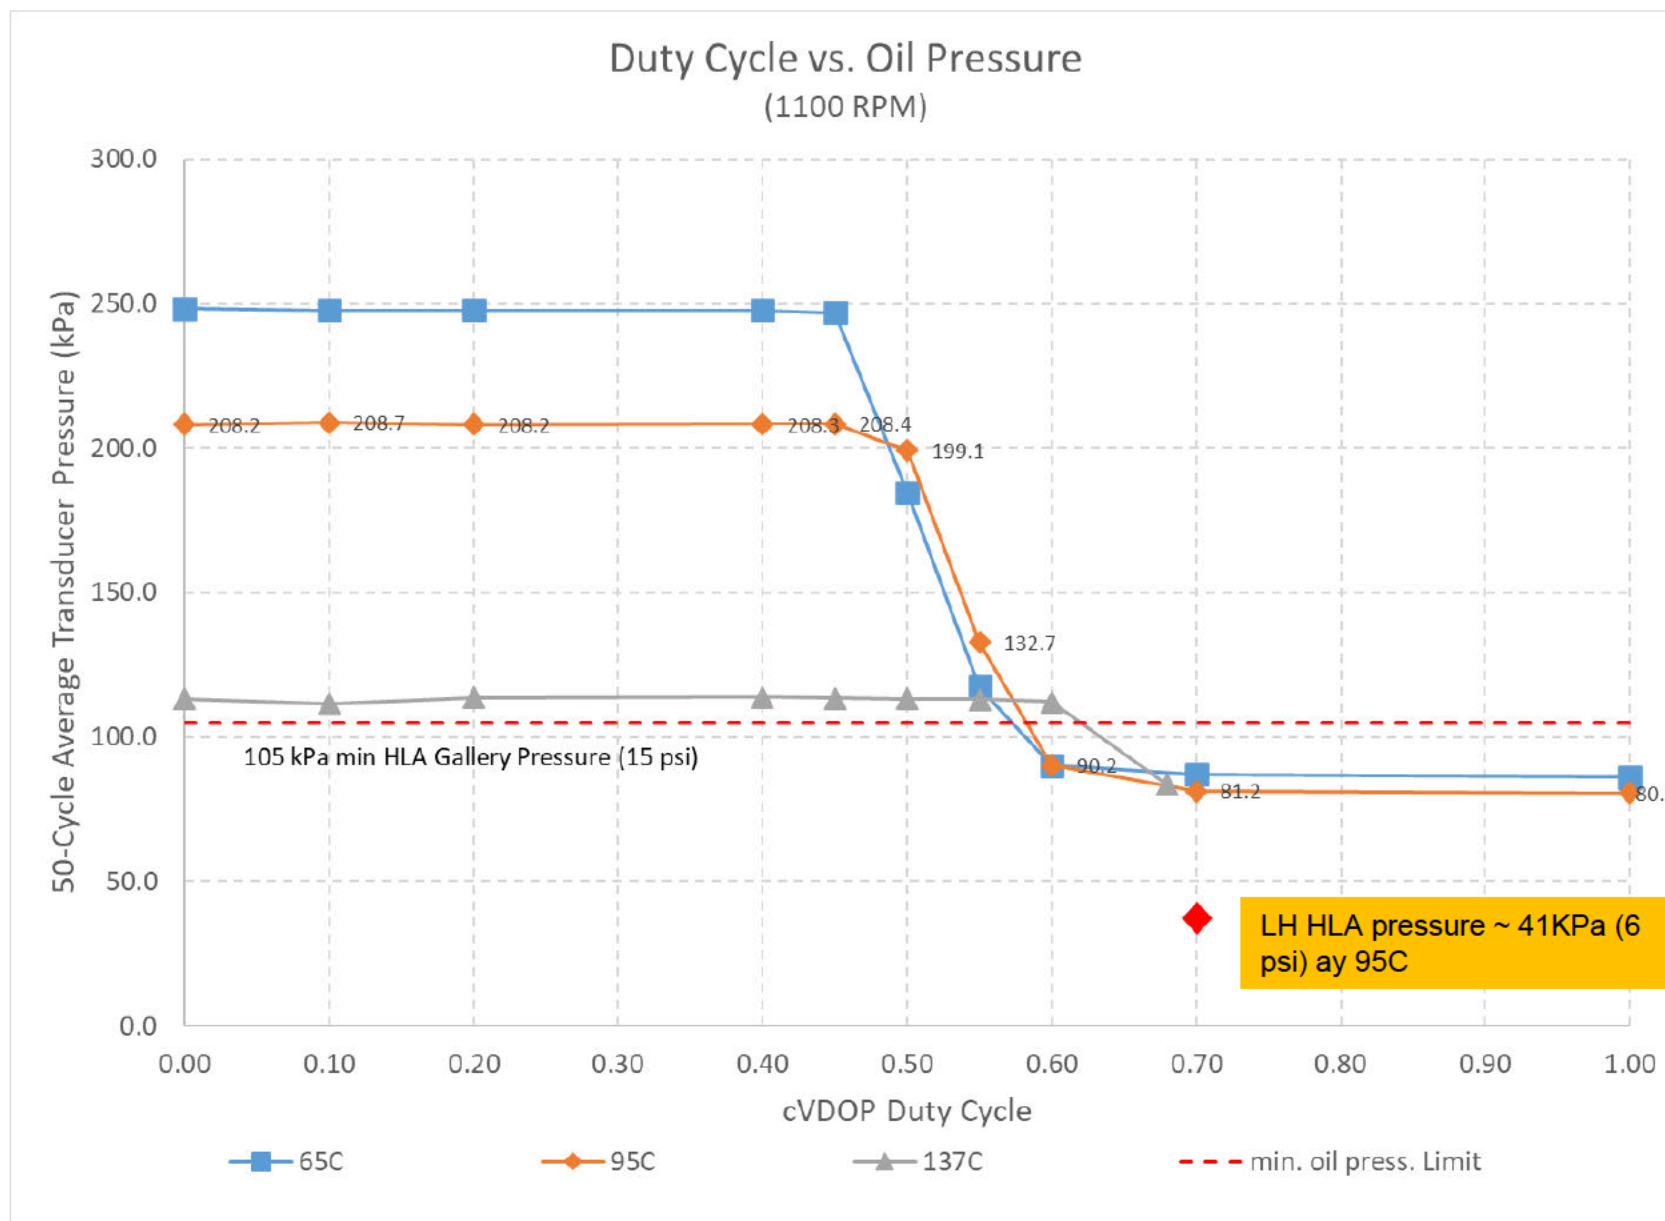
Based on 18 MY lube survey data LH HLA gallery has potential to drop below min pressure. ~ 30 kPa (4.5 psi)

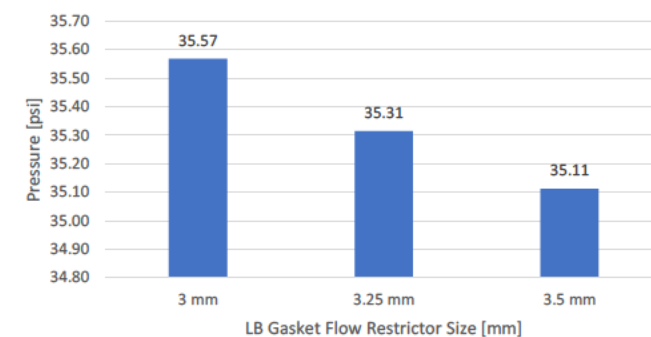
Impact to RH Intake Pressure

The biggest difference is close to 0.6 psi

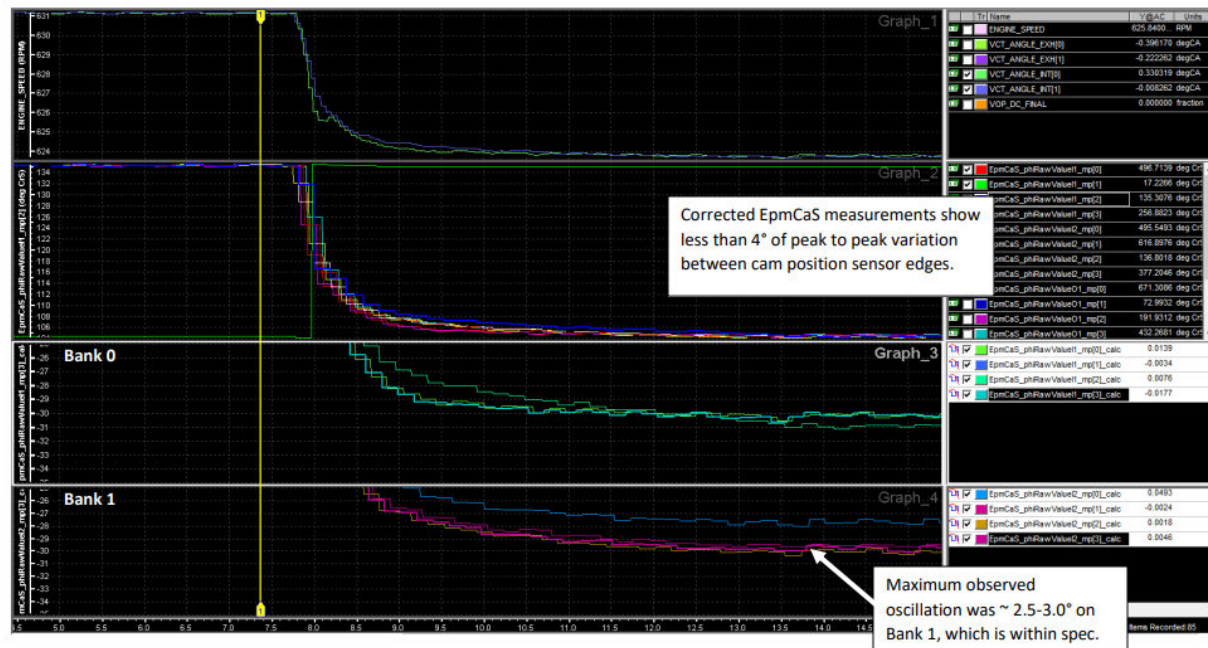
Condition:  
1000 RPM, 110 °C Oil Temperature, Scheduled VDOP, 0° to -30° intake VCT Shift  
3.5 mm orifice head gasket

- Both results showed oscillation within specification (max VCT spec is 4° peak to peak).
- Shift speed time differences are negligible
- Do not see any significant impacts to VCT performance between the 3.0 mm and 3.5 mm head gasket orifice.

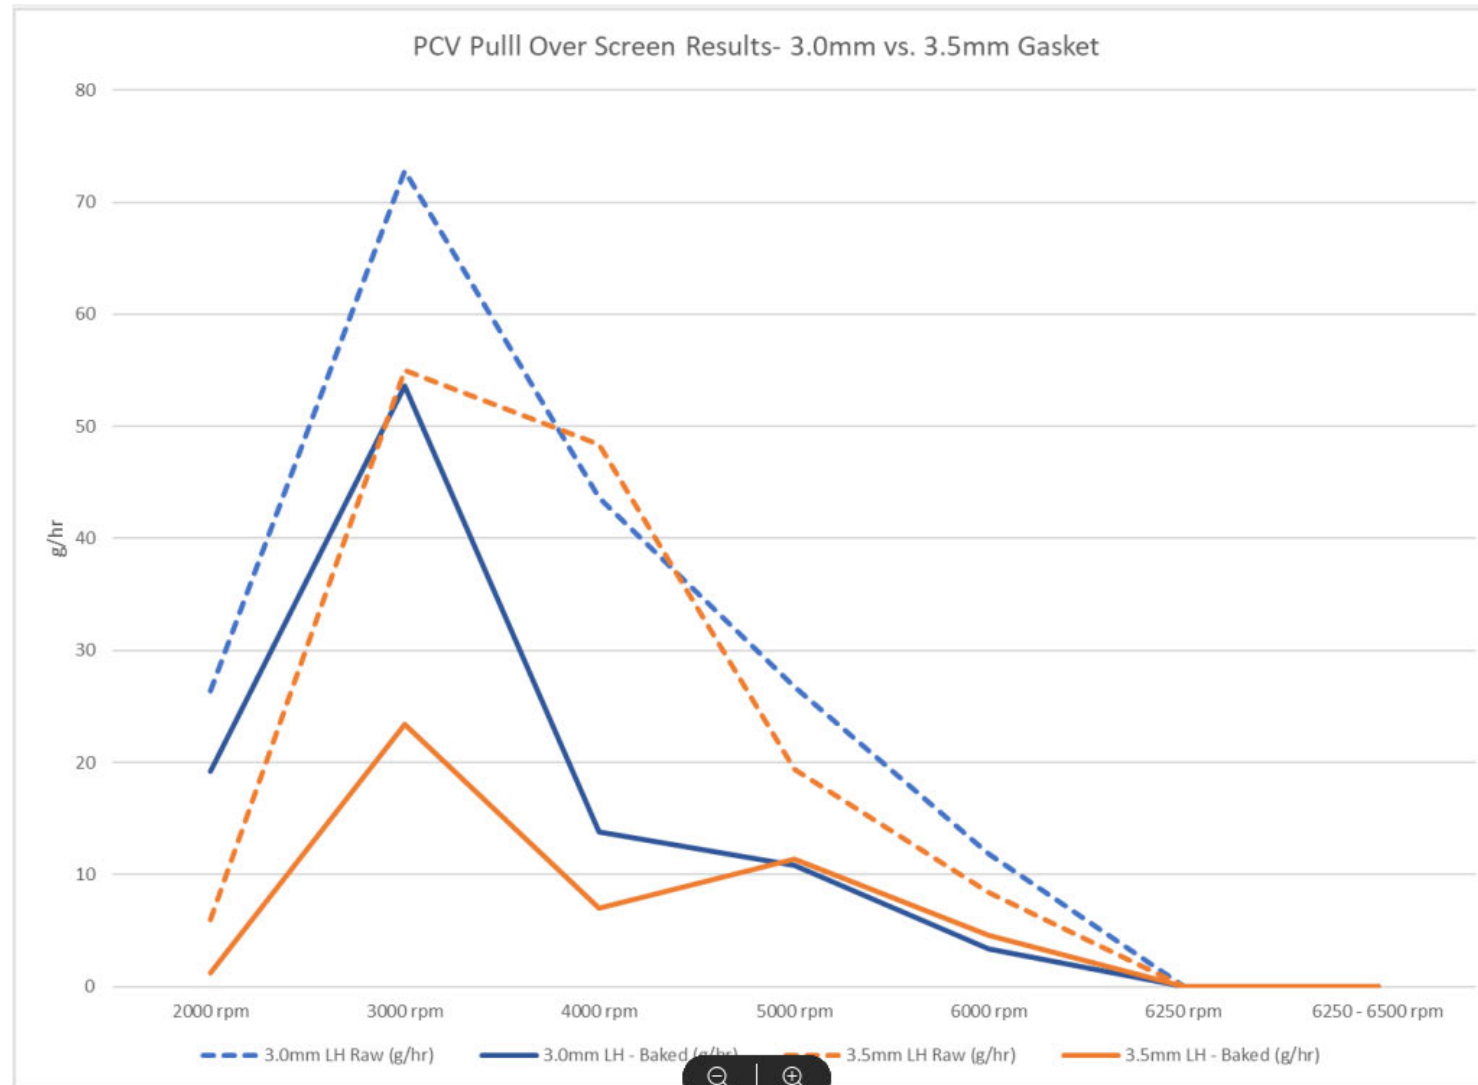
# PCV Screener Test Results

Negligible difference in oil separator performance between 3.0mm and 3.5mm restrictors.

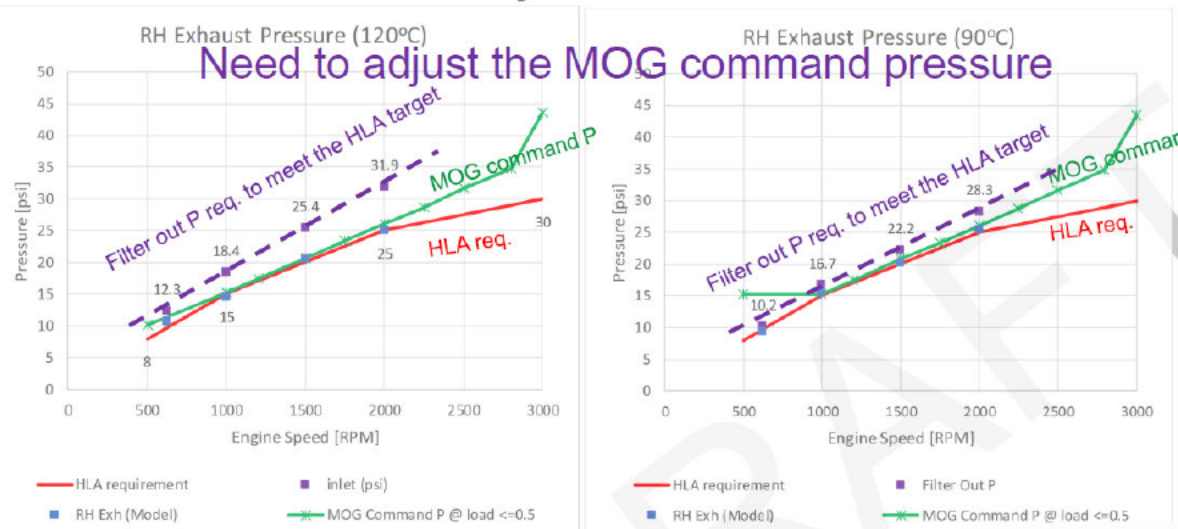
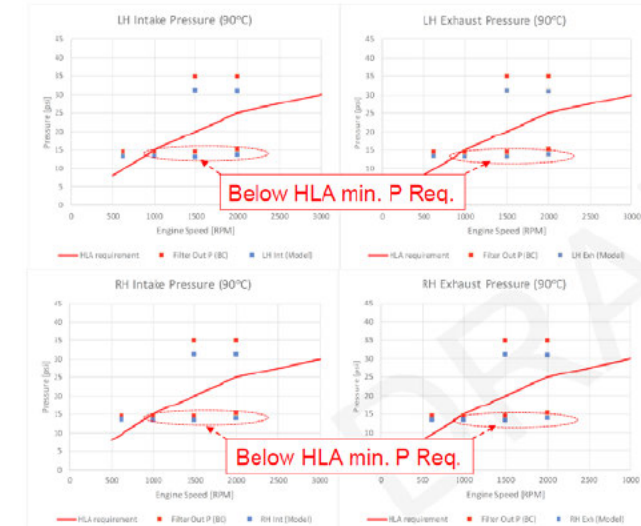
- 2022.5 MY 3.0L V6 Nano GTDI G U725 back correlated to 18MY M1 FWD AC4146
  - 18MY aeration and oil pressure data used
  - Model not run with 20MY 3.0L CD6 conditions
- Results show pressure below requirements

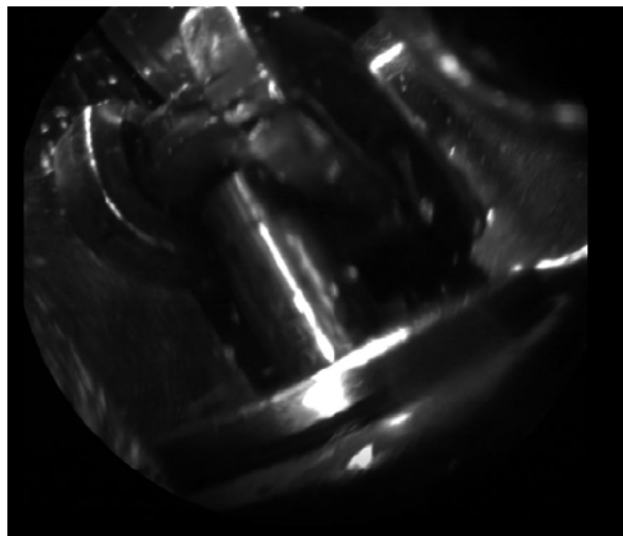
Slow motion video with lash in the system shows RFF tipping and side loading of valve tip.

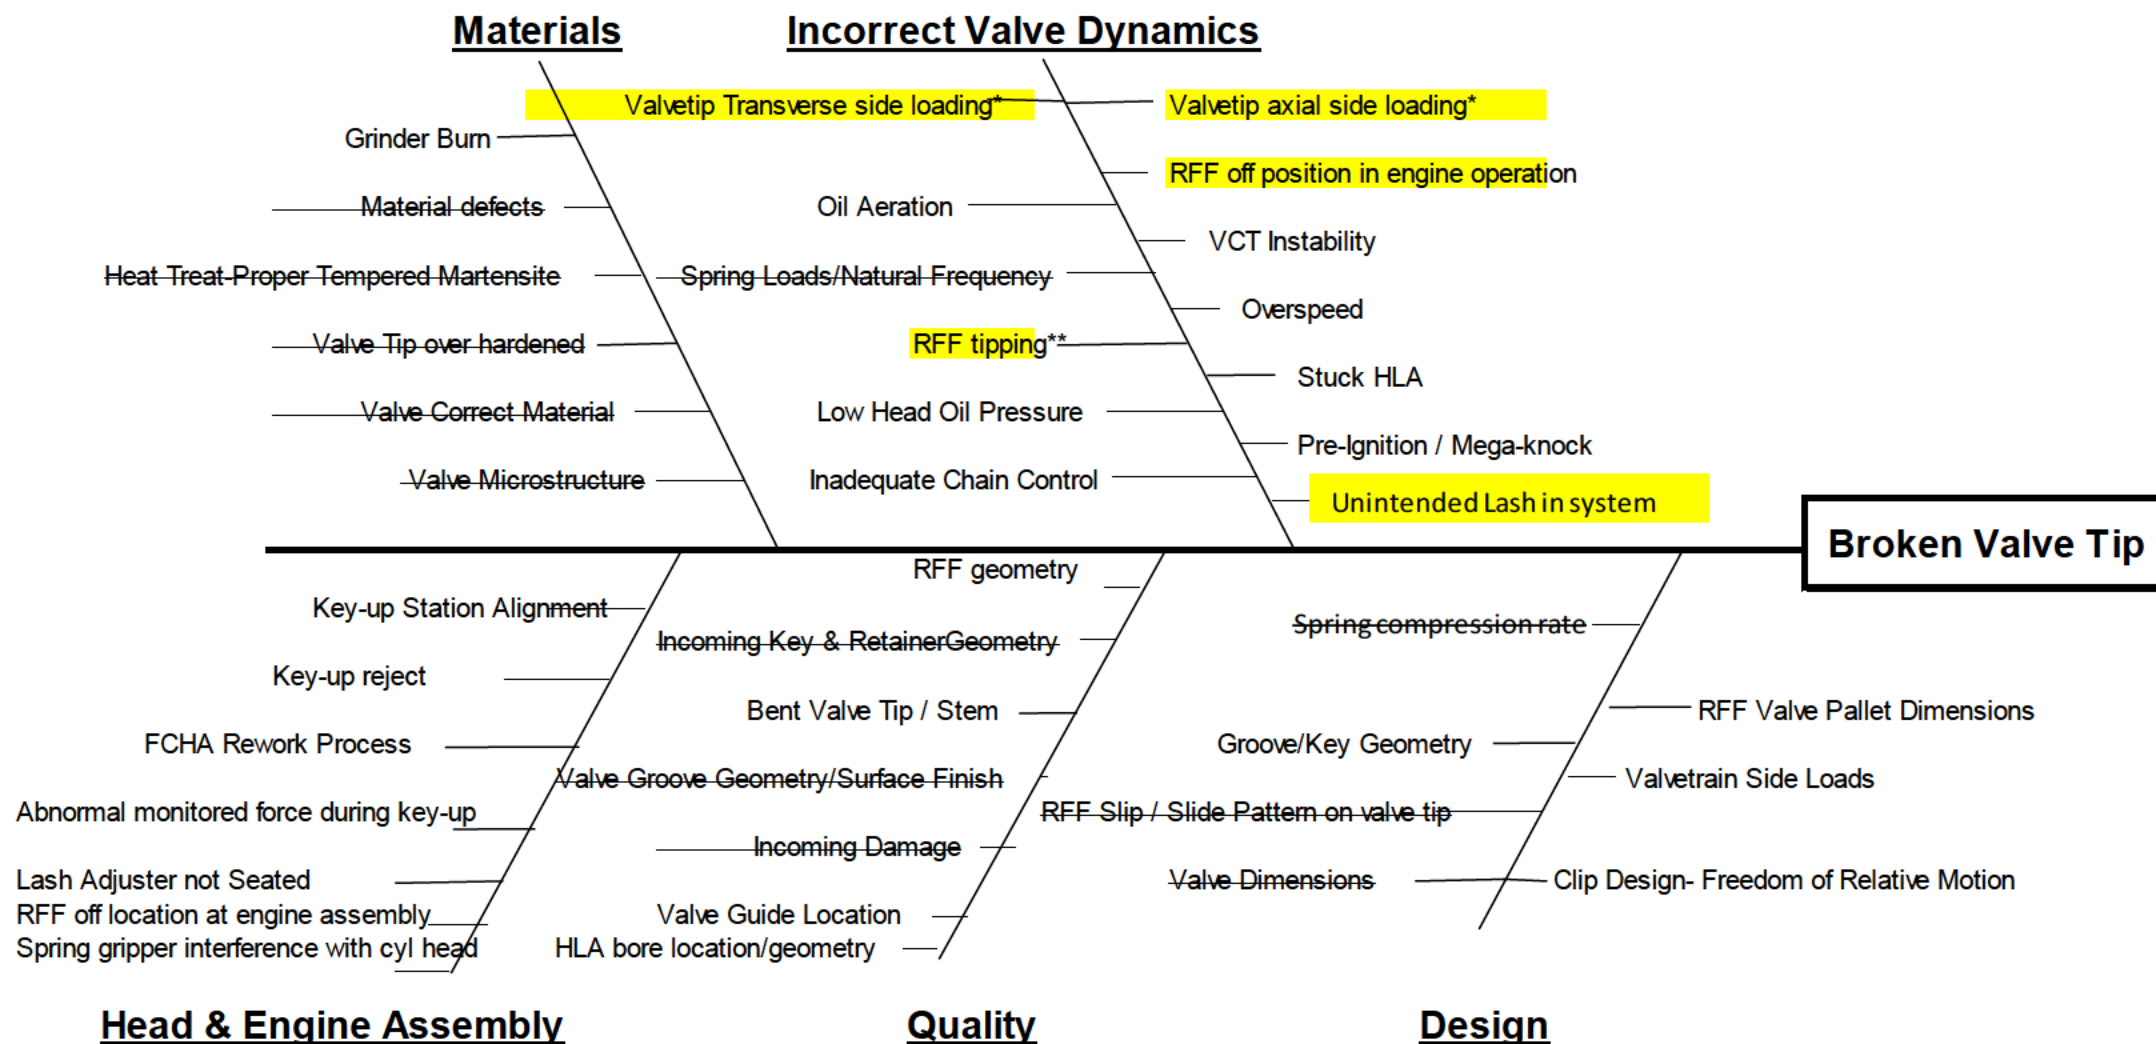
failures on Pre and Post MY21 F150, as well as CD6. Failures with and without MVP on the LHI cam

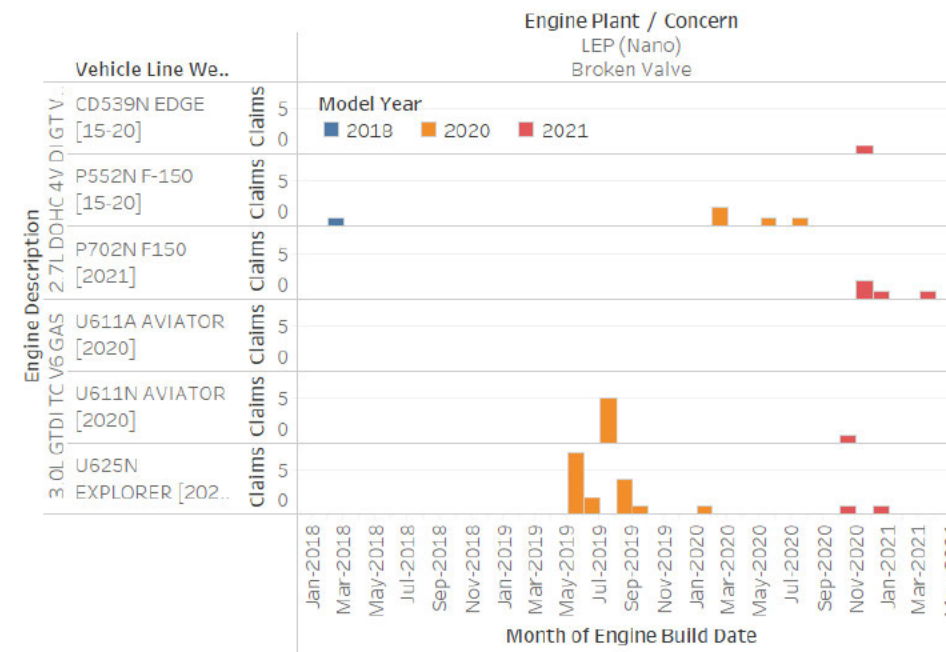
Nano 3rd Keeper Groove Failures

Vehicle	MVP Location
CD539N Edge (15-20)	LHI
P552N (15-20)	LHI
P702 (21)	N/A (MVP Delete)
U611A (20)	RHI
U611N (20)	RHI
U625N (20)	RHI

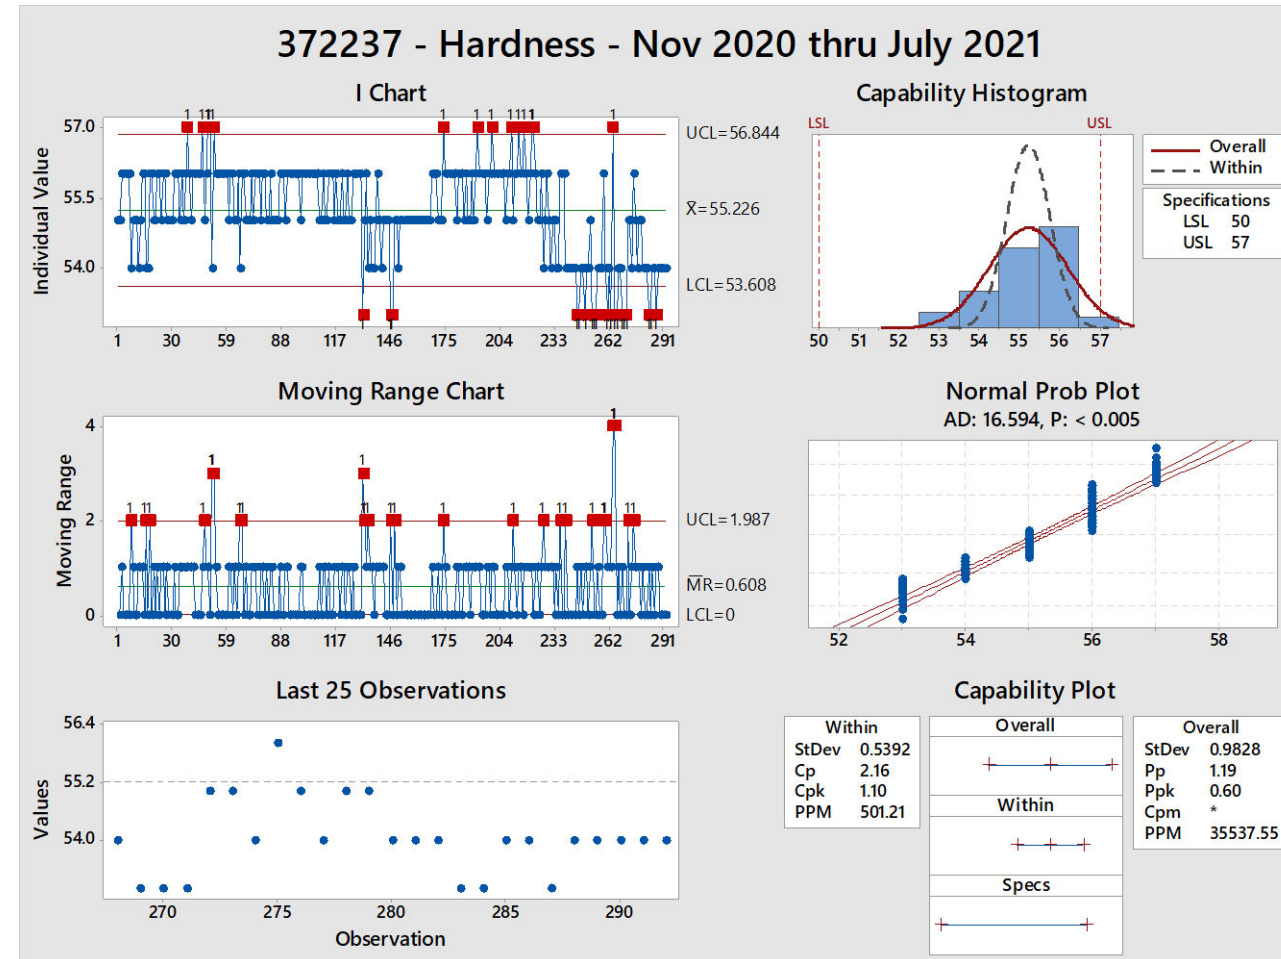
## Ford Nano JT4E-6507-BB (Eaton 372237) Data Request/Analysis

- Hardness data from Tip Harden Operation
- Minitab auto-calculates control limits which represents the red points being outside of what Minitab sets as a control limit
- All data points are within specifications
- Key point is the Cp value of 2.16

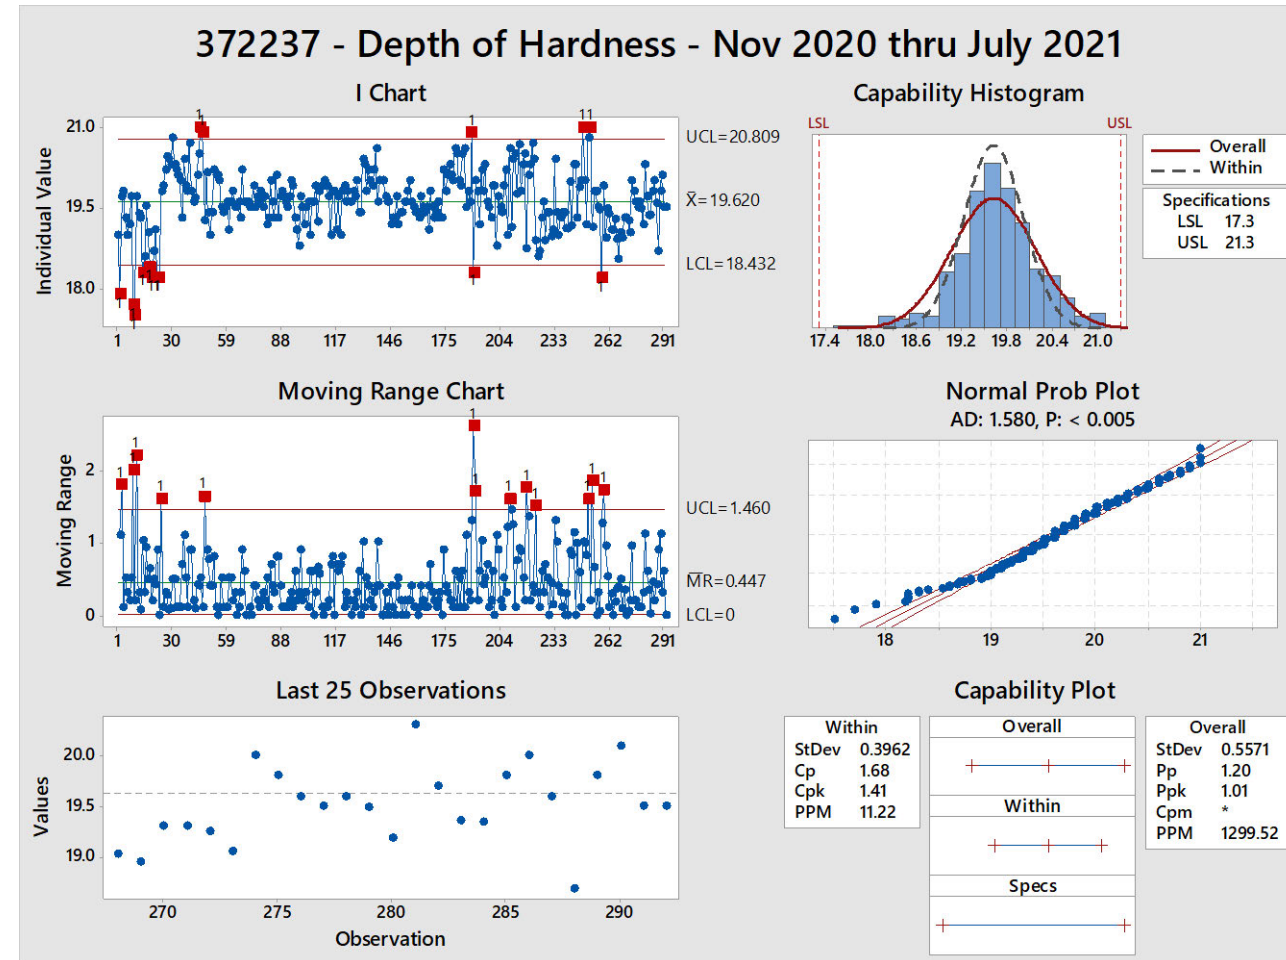
## Ford Nano JT4E-6507-BB (Eaton 372237) Data Request/Analysis

- Depth of Hardness data from Tip Harden Operation
- Minitab auto-calculates control limits which represents the red points being outside of what Minitab sets as a control limit
- All data points are within specifications
- Key point is the Cp value of 1.68
