# **2.7L Nano Intake Valve Failures**

## **U725 Warranty Claims and ERA proposal**

<b>Issue Title:</b>	Intake Valve Failures at 3 <sup>rd</sup> keeper groove on 20-21MY 2.7L / 3.0L Engines.			<b>Champion:</b>	Dave Simon / Jeff Bautz	
<b>Source:</b>	PT Current Model Quality Engine Exchange List.			<b>Team:</b>	B. Rhude, P. Adam, J. Kolodziejczyk, G. Pearson, Z. Ward T. Knott, M. Hewlett, T. Strand	
<b>Issue Description:</b>	2020 - 21MY 2.7/3.0L Nano engine failures due to 3 <sup>rd</sup> keeper groove fracture on left bank intake valves occurring at low time in service.					
<b>Containment:</b>	Implement micro indent core hardness checks, increase frequency of coolant flow and position checks at grinding operation, Increased visual inspection.					
<b>Root Cause:</b>	Side loading of the valve tip from rocker arm tipping as a result of valvetrain dynamics caused by increased lash in the system.					
<b>Corrective Action:</b>	Implement following ERA's: Increase frequency core micro hardness checks and control plan update. Including batch and hold Change valve material to Silchrome 1 for improved robustness to side loading and significantly higher high temperature fatigue strength pr

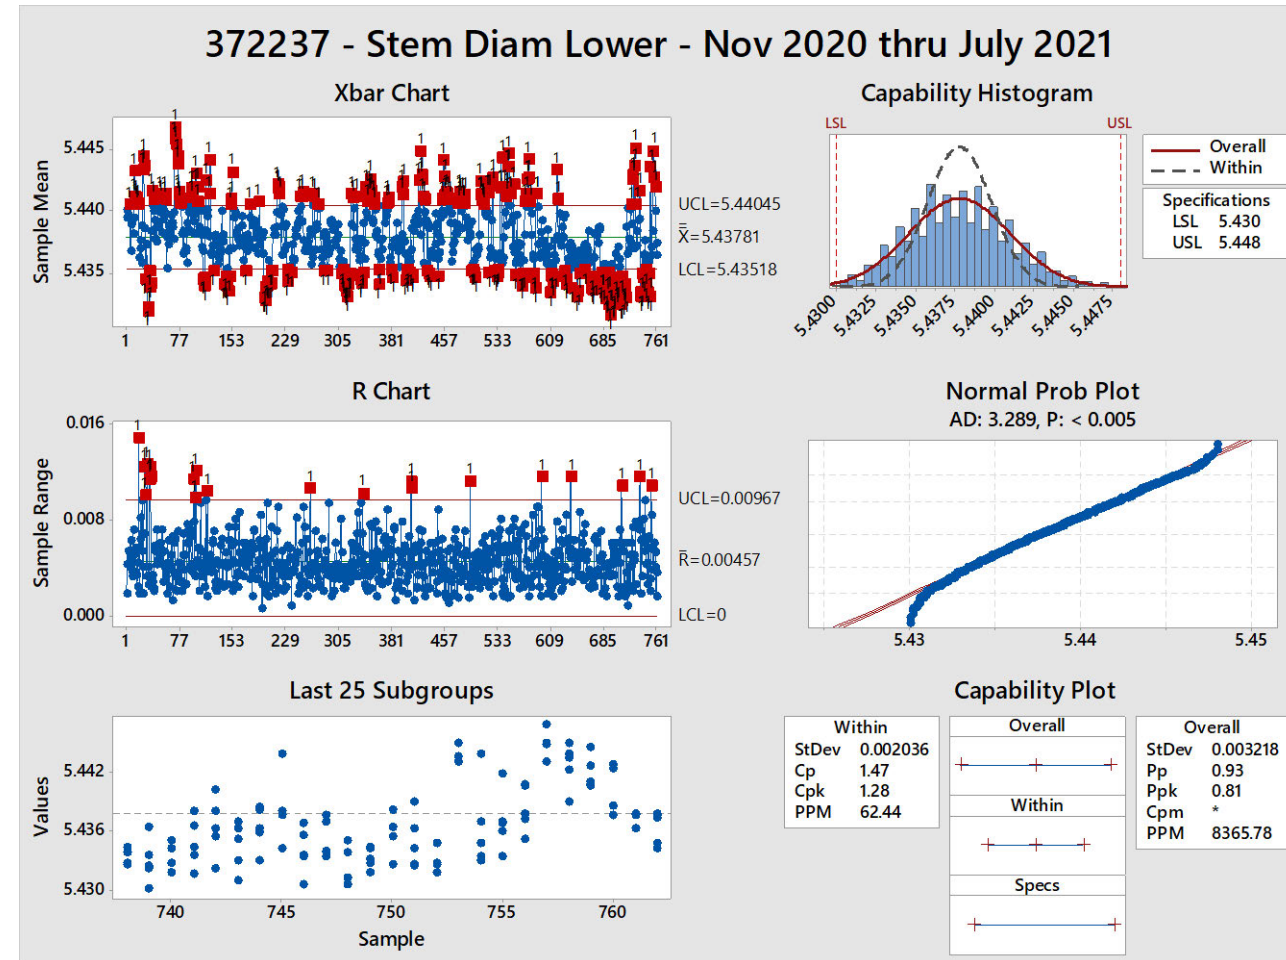
## Ford Nano JT4E-6507-BB (Eaton 372237) Data Request/Analysis

- Stem Diameter data from final audit, this data point from location closest to Keeper Groove
- Minitab auto-calculates control limits which represents the red points being outside of what Minitab sets as a control limit
- All data points are within specifications
- Key point is the Cp value of 1.47

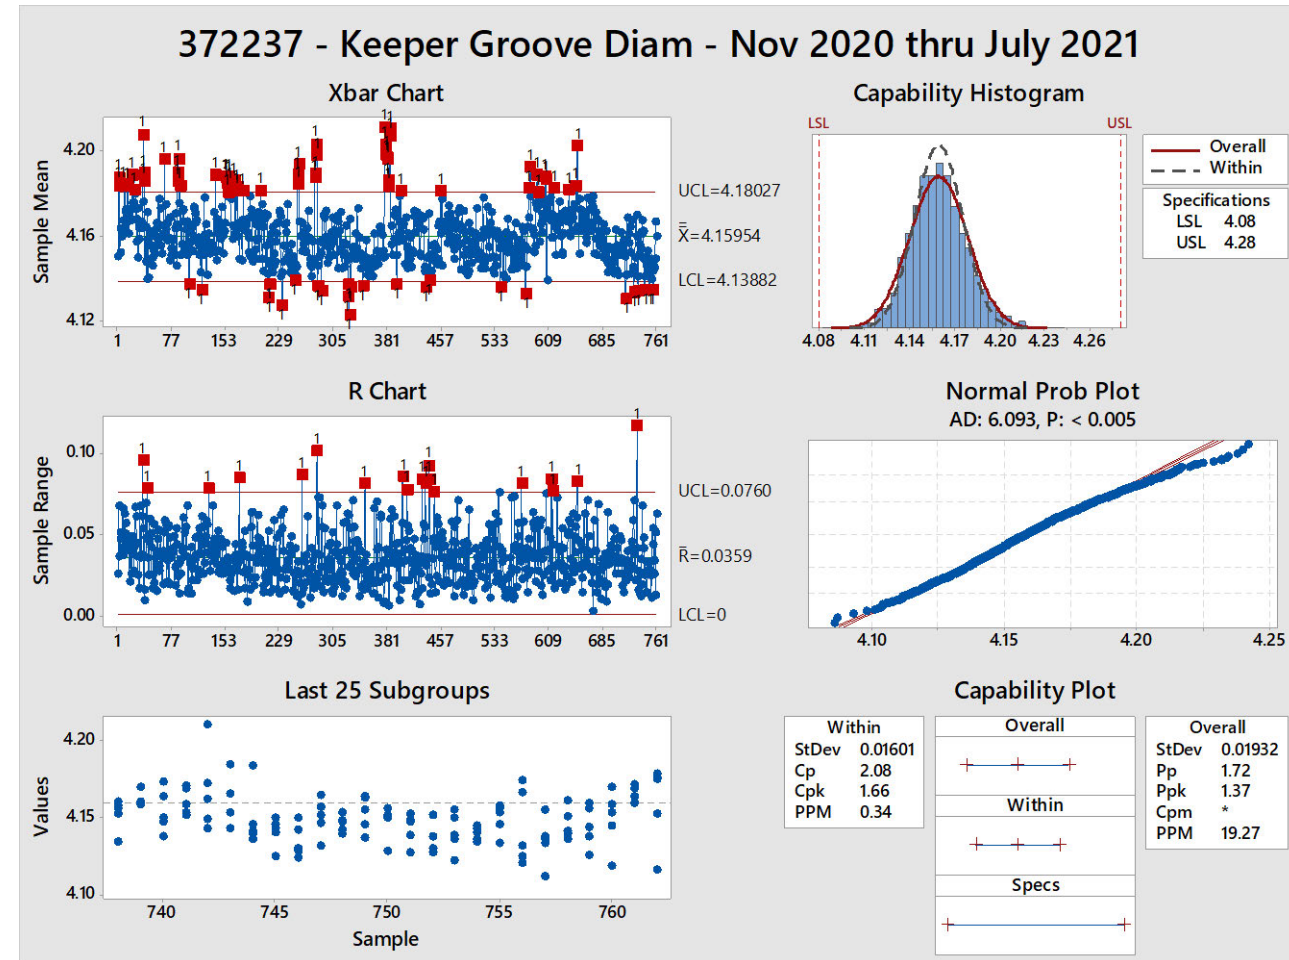
## Ford Nano JT4E-6507-BB (Eaton 372237) Data Request/Analysis

- Keeper Groove Diameter data from final audit
- Minitab auto-calculates control limits which represents the red points being outside of what Minitab sets as a control limit
- All data points are within specifications
- Key point is the Cp value of 2.08
