CQIS DETAIL REPORT

VEHICLE: 2021 BRONCO 4X4,4DR,MPV VIN: [REDACTED]
Engine : 2.7L DOHC 4V DI GT V6 GAS/FFV Odometer: 4,488 MILES
Operating Environ: WCC :
Vehicle Use : Rsp. Act:

SYMPTOM: 4 40 1 02 START/RUN/MOVE STARTING
NO CRANK ALWAYS

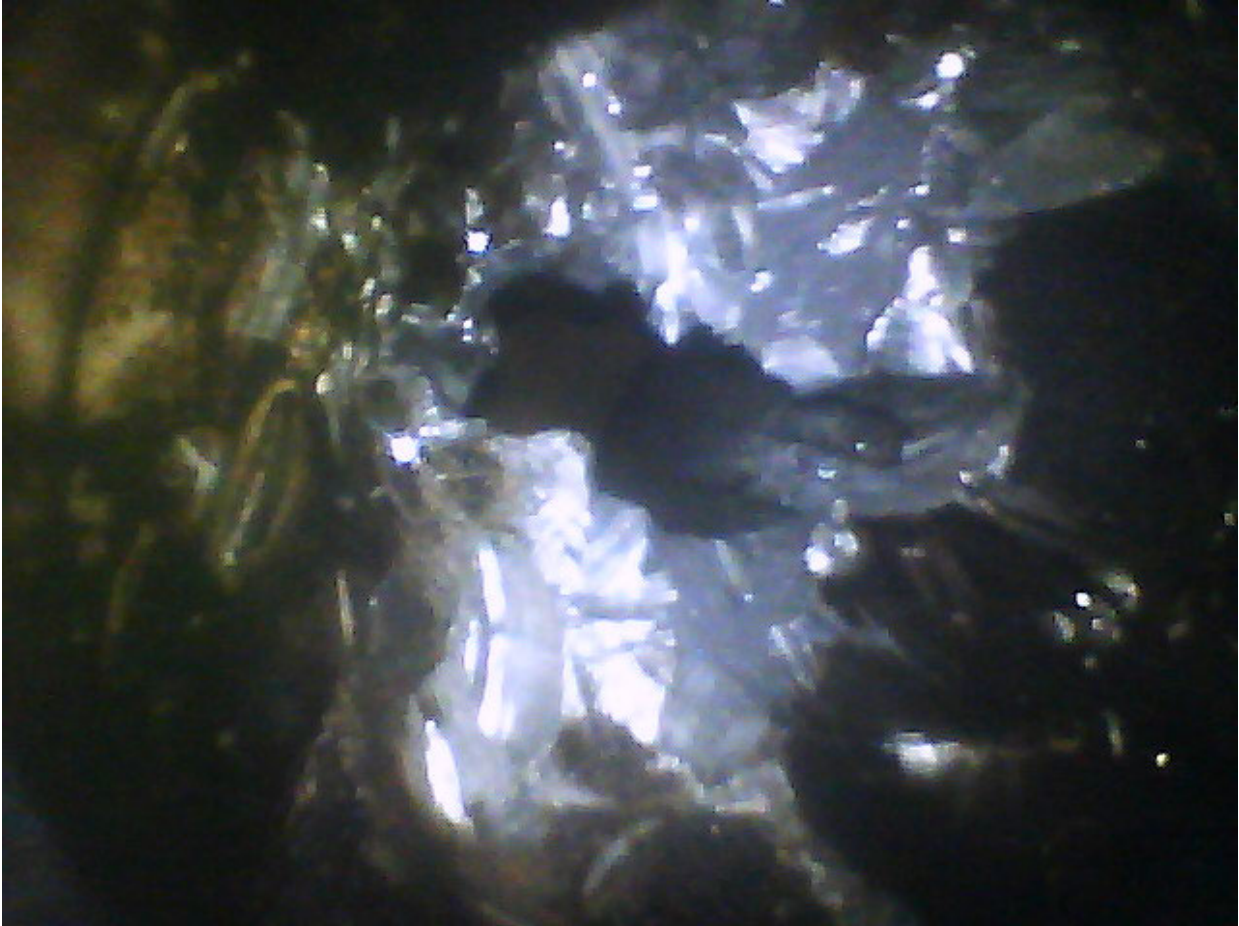
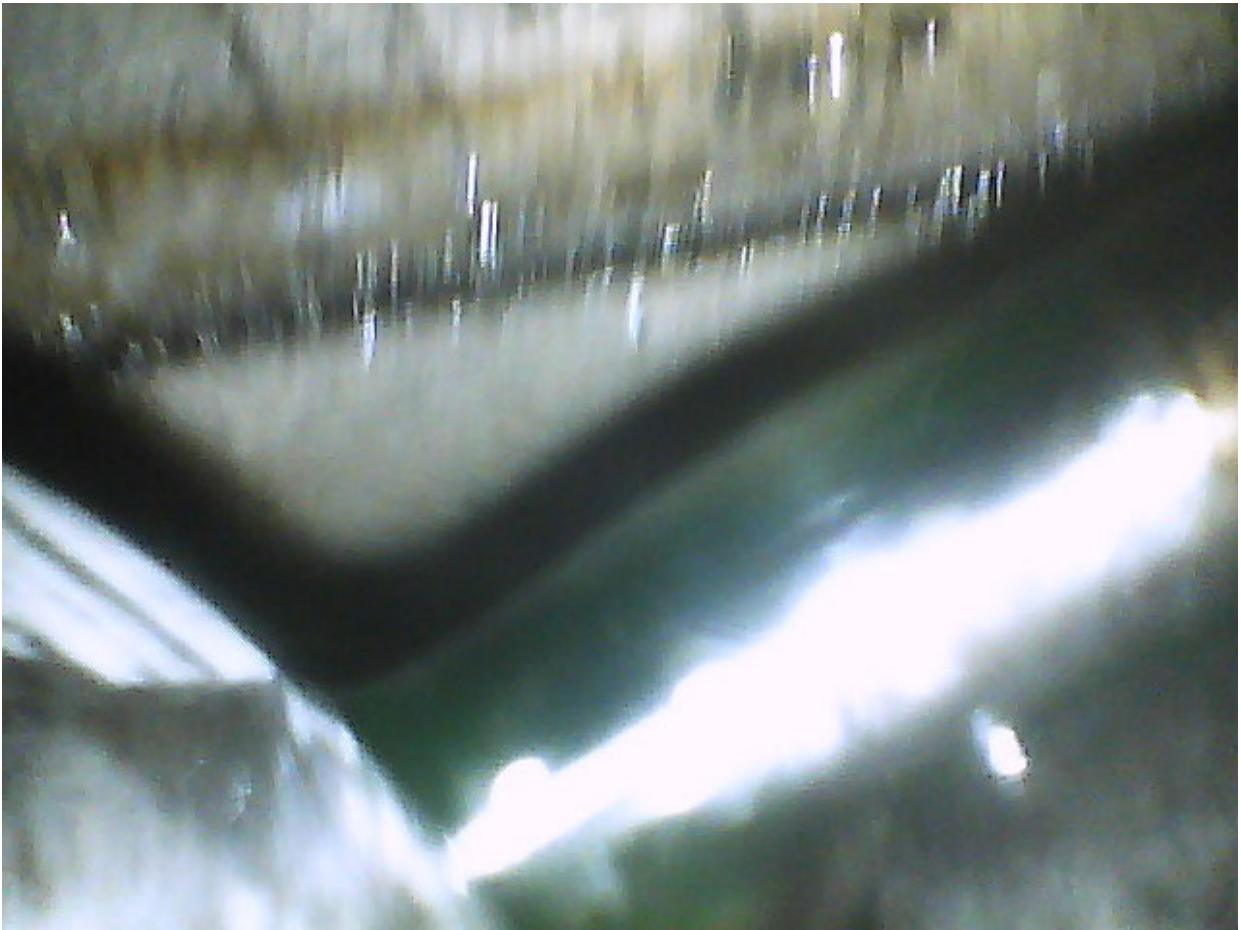
Causal Component: FT4Z 6108 A PISTON & PIN ASY
Causal Factor: Feature: Loc:
Causal Condition: Photo: YES Atchmnts: 2
Component Test Status: ---- Return Loc:
Vehicle Fixed?: Customer satisfied?: Repair Effectiveness (%):

CONCER 12/15/2021 09:54AM
vehicle died at hiways speeds.
TECH/C 12/15/2021 09:54AM
crankcase a milshake and one cyl is destroyed. piston top in pieces
and valve is loose inside combustion chamber #4

Repair Type	Component Number	Number	Description	Causal Comp.
RPL	FT4Z	6108 A	SERVICE PISTON & PIN ASY	YES
