FORD MOTOR COMPANY (FORD) RESPONSE TO REQUEST 13Request 13

NHTSA's Office of Defects Investigation (ODI) opened this Preliminary Evaluation based on "consumer complaints alleging engine failure due to loss of oil pressure in model year (MY) 2018-2021 Ford EcoSport vehicles". Ford has investigated this subject, including the cause of these reports, the circumstances under which they occur, and the anticipated performance of the subject and peer vehicles moving forward.

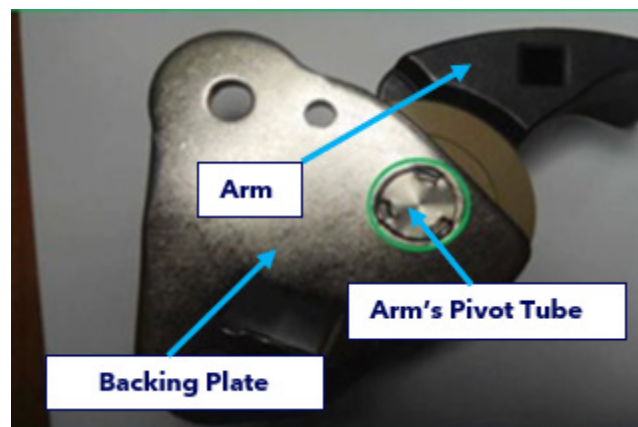
The engine's oil pump is driven via belt by the engine's crankshaft. This interaction also drives a balancer shaft in the engine. Due to the increased load requirements to drive the balancer shaft as well as the oil pump, an oil pump belt tensioner system is also used. The tensioner system consists of an arm retained to a backing plate via press fit of the arm's pivot tube into the plate. Components of the tensioner system are shown below.

The use of the balancer shaft and oil pump belt tensioner system are unique to 6F15 automatic transmission applications of the 1.0L Fox Classic engine (i.e., manual transmission vehicles do not have these components).

For tensioner arms separating from the backing plate, the press fit retention method of the arm to the backing plate does not appear robust to the torsional vibration experienced by the components over time. For broken tensioner arms, it appears excessive arm rotation about the arm's pivot point is leading to contact with the balancer shaft resulting in fracture. Oil pump drive belt degradation/missing teeth is believed to be caused by a greater than expected load on the belt, which may result in failure prior to the belt's 150,000 mile service interval. Rubber and debris from the degraded belt may clog the oil pump pickup filter, causing an eventual loss of oil pressure.
