1. Who directed the design change to the bend radius on the hitch that took effect 1/23/23?
  - Lippert Engineering team directed the change as an added precaution to increase the strength of that area of the hitch after learning of Thor's reported concerns. The original design met the requirements of 8000 pound towing / 800 pound tongue weight rating under SAE J684 testing.
2. Who applies the load limit sticker to the hitch (8,000 lb trailer max weight, 500 lb max tongue weight)? There were 2 instances where the pictures in the documentation show a sticker with a 800 lb max tongue weight, instead of the 500 lb max. All of Thor's production data details a 500 lb max tongue weight. Below are the 2 VINs with those stickers.

3. Question 16 – LCI responded that the hitch has a load limit of 8000 lb max trailer weight, and 800 lb max tongue weight. TMC states the hitch load limits are 8000 lb max trailer weight, and 500 lb max tongue weight. Can you explain the difference?

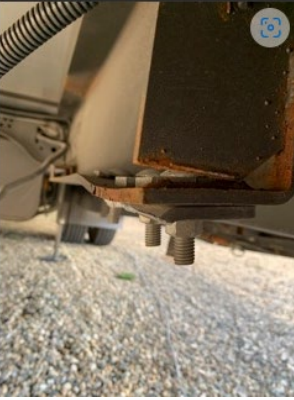
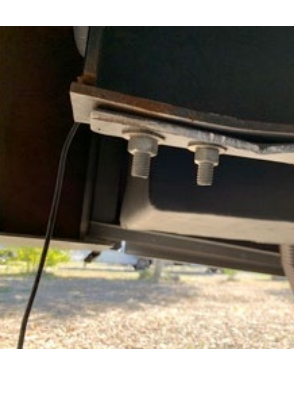
Hi we have a 2016 Thor Miramar. Yesterday we found that the hitch was splitting apart. Luckily we saw it before losing the car we were flat towing. I am not contacting you with the expectation of a repair, I just want you to know about it in case it's an issue with other rigs. We purchased the rv and car together from our sibling. So both of our families have towed the same car.. I cannot say what the original owners towed. Because I do not know. Our setup is 2016 Miramar 34.3 with 40,000 miles and the car we flat tow is a 2019 GMC Acadia. The Acadia should be around 5,000 lbs or less. The hitch is rated at 8,000.
