# Damage mechanisms in a short glass fiber reinforced polyamide under fatigue loading

**Keywords:** Short Fiber Reinforced Plastics, Damage Mechanisms, Fatigue, Electron Microscopy

This paper presents a damage investigation on a short glass fiber reinforced polyamide (PA66-GF35) under fatigue loading. Plain and notched specimens were tested at room temperature and humidity with load ratio  $R = 0$ . Electron microscopy was used to analyze the fracture surface of failed specimens and the crack path of specimens subjected to interrupted fatigue tests. Damage mechanisms were studied investigating the following fractographic features: ductile / brittle matrix fracture behavior, fiber failure / pull-out, degree of fiber-matrix interfacial adhesion. The aim of the present paper is to understand the nature of damage initiation and propagation in order to lay the foundations for the development of a multi-scale, mechanism-based lifetime prediction model for short fiber reinforced plastics.

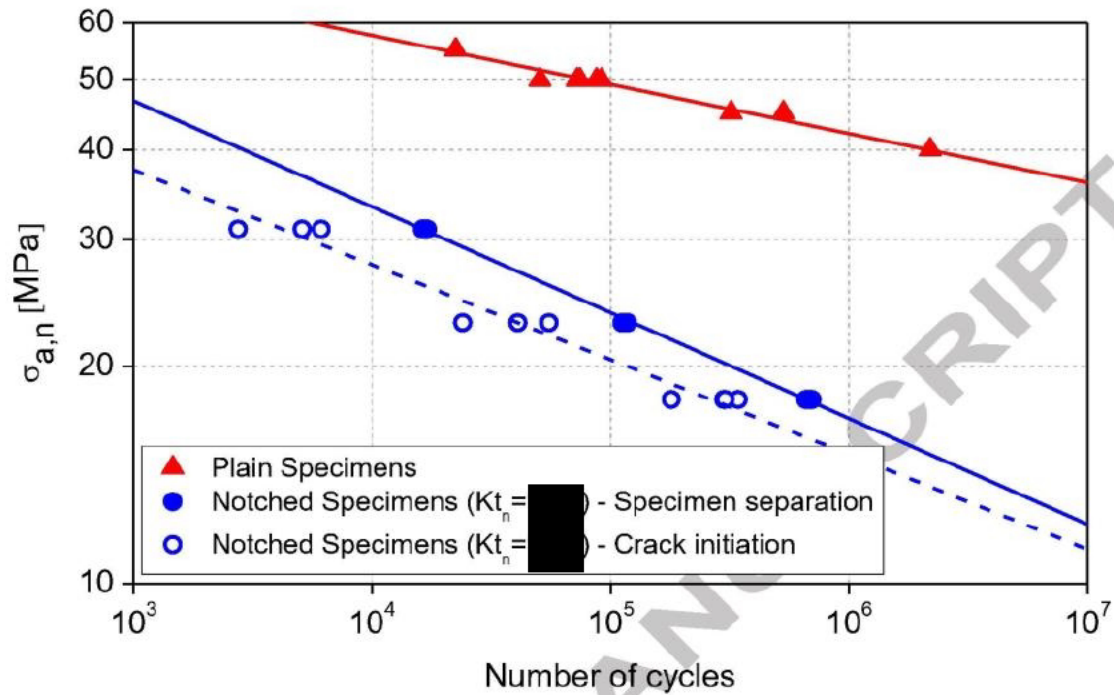
S-N curves to crack initiation and to failure (specimen separation) are shown in Figure 2. Fatigue data are represented in a double logarithmic diagram, plotting the net stress amplitude ( $\sigma_a$ ) against the number of cycles (N) to crack initiation / failure. Fatigue curves are plotted using eq. 1 for a survival probability of [REDACTED]

Where  $N_A = 1\text{E}6$  cycles and  $\sigma_A = \sigma_a(1\text{E}6)$ . The values of  $\sigma_A$ ,  $k$  and the scatter index  $T_\sigma = \sigma_{a,10\%}/\sigma_{a,90\%}$  are reported in Table 1. Plain specimens failed suddenly by unstable crack propagation. Hence, life to failure corresponds to life to crack initiation. Instead, notched specimen exhibit stable FCP. In [37] it was found that the amount of lifetime spent in the crack initiation depends on the fiber volume fraction. For PA66-GF35 notched specimens, the crack initiation takes some [REDACTED] of the total lifetime. The rest of the lifetime is spent in stable FCP.

**Figure 2.** S-N curves up to crack initiation and up to failure of plain and notched specimens,  $T = RT$ ,  $R = 0$ .
