# SET 881 Diagnostics

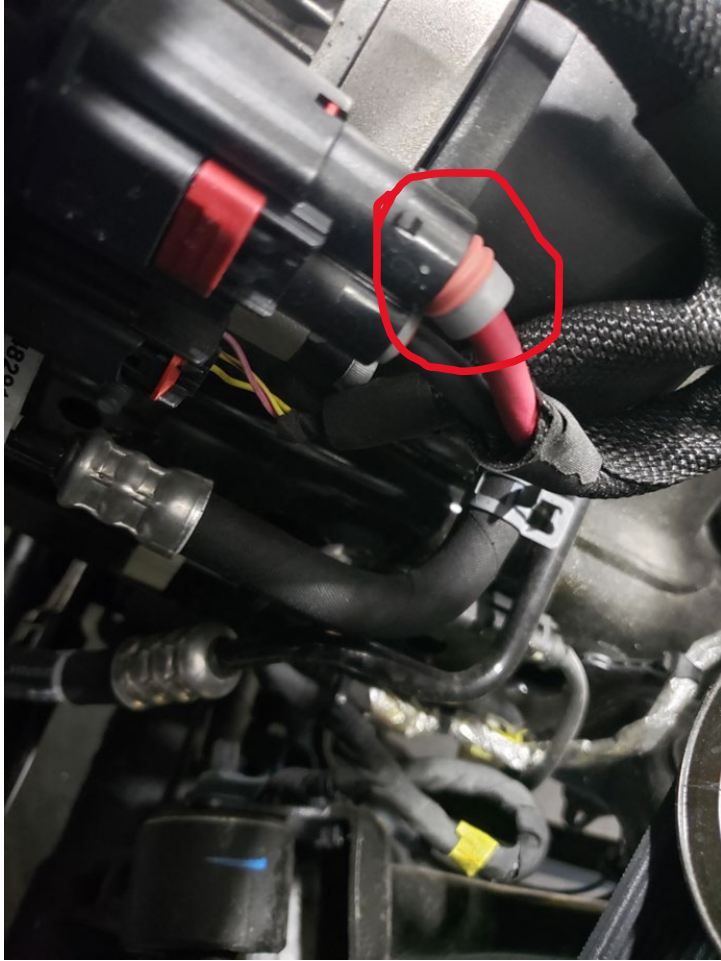
- Verify the connection between pump and wire connectors is firm and steady.
- Check if the wiring harness is pulling the connector, allowing to expose the seal on the wire insertion side. If it is, replace the damaged connector.

- Verify you have good wiring power at B+ with a voltmeter. Black lead to a good ground and red lead to B+ you should see battery voltage. If not, Repair circuit problem.
- Clear diagnostics trouble codes from memory and see if U0131 code returns.

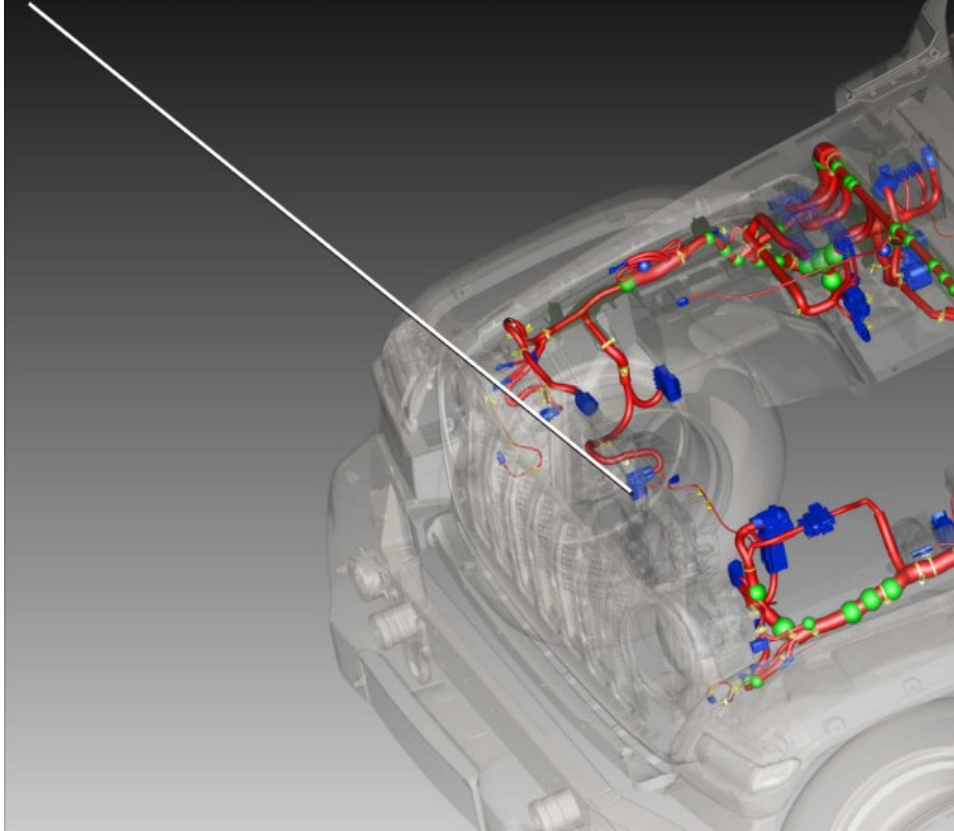
## MOTOR-POWER STEERING PUMP C2

- Check if the wiring harness is pulling the connector, allowing to expose the seal on the wire insertion side.
- With the key on, check the two communication circuits. With the black end of your voltmeter to a good ground and red end into CAN C+ you should see around 2.6 volts and fluctuating slightly. Next connect the red end to CAN C-, you should see around 2.4 volts and fluctuating slightly. If not, Repair circuit problem.
- Clear diagnostics trouble codes from memory and see if U0131 code returns.
