**NUMBER:** 25-003-18

**GROUP:** 25 - Emissions Control

**SUBJECT:**

Internal Catalytic Converter Damage

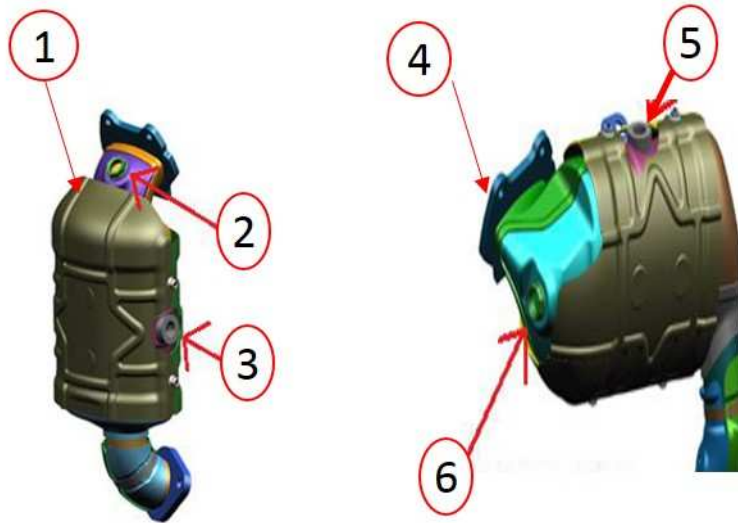
**Fig. 3**  
**Front and Rear Catalytic converters**

- 1 - Front converter  
2 - O2 Sensor Hole 1  
3- O2 Sensor Hole 2  
4- Rear converter  
5 - O2 Sensor Hole 2  
6 - O2 Sensor Hole 1

7. The internal inspection involves removal of the two O2 sensors on each of the front and rear catalytic converters (Fig. 3) , and the use of a borescope inserted into the O2 sensor holes to capture images of the condition of the catalytic substrates (catalyst bricks) in multiple places including the condition of the interface of the substrate to the surrounding insulated mat.
