**FORD Warranty Review**  
**Secondary Filters - Base Part 9150**

# Warranty Analysis Investigation

- [REDACTED] requested Sogefi [REDACTED] analyze and review 5 samples, Ford base Part Sogefi X [REDACTED] 33 Fine Filter.
- [REDACTED] has been reported with a leak. [REDACTED]

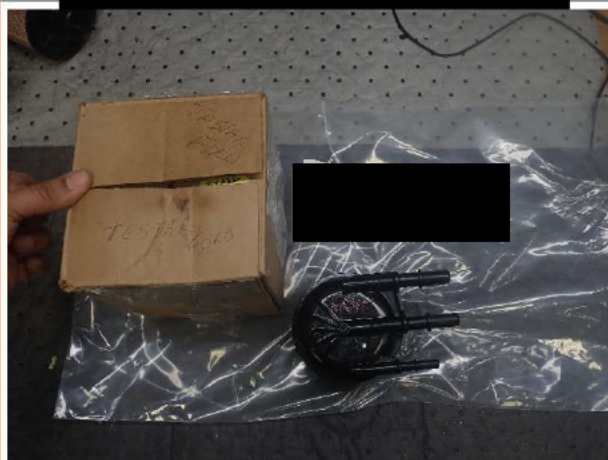
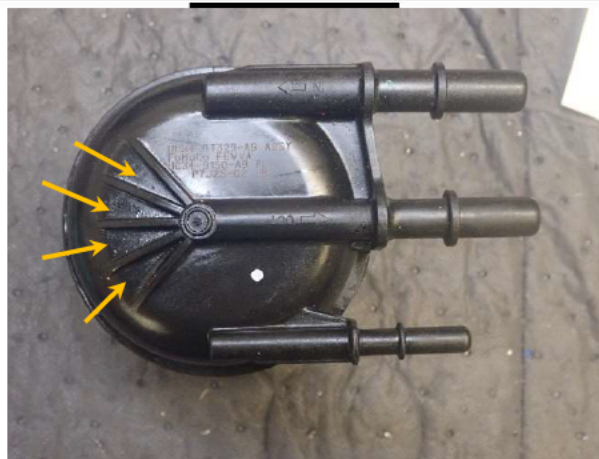
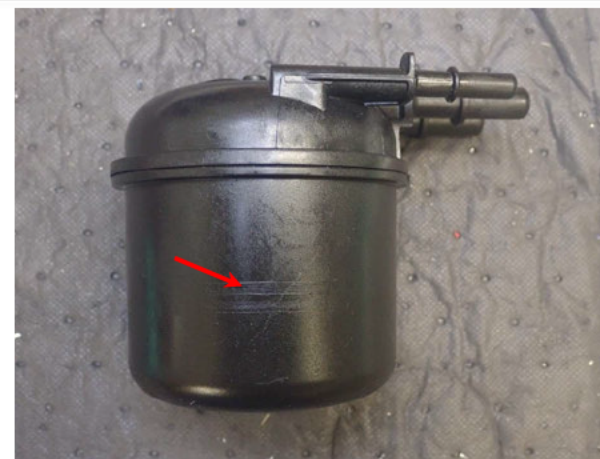
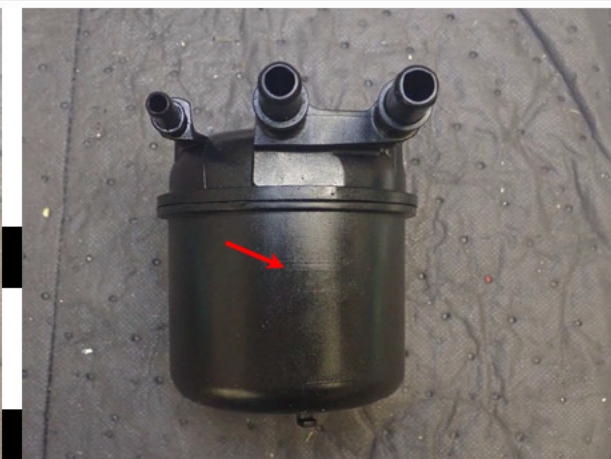
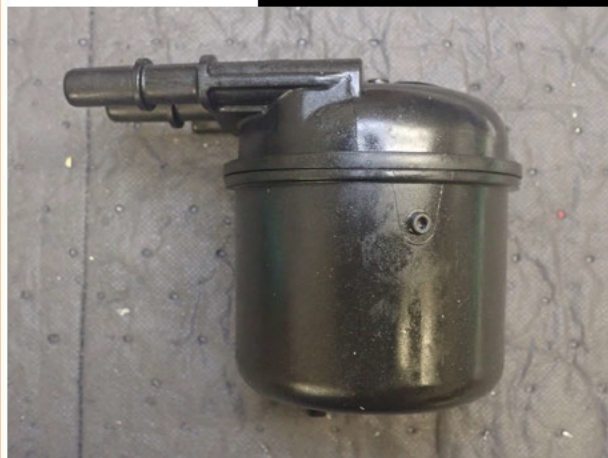
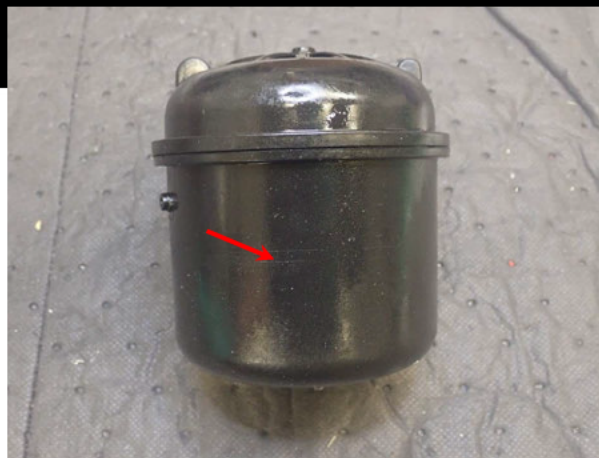
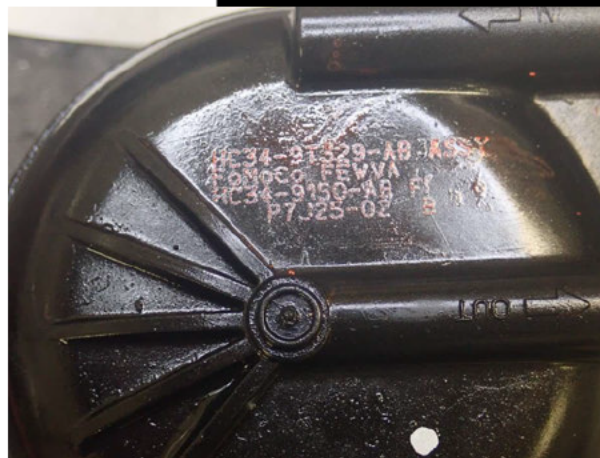
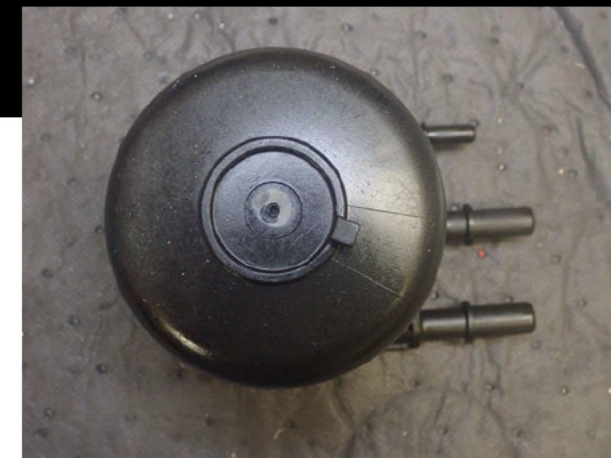
# Sample # 1 – VIN UNKNOWN

HC34-9T329-AB ASSY  
FoMoCo FEWVA  
HC34-9150-AB FI  
P7J2502 B [Aug 25<sup>th</sup> 2017, B shift]

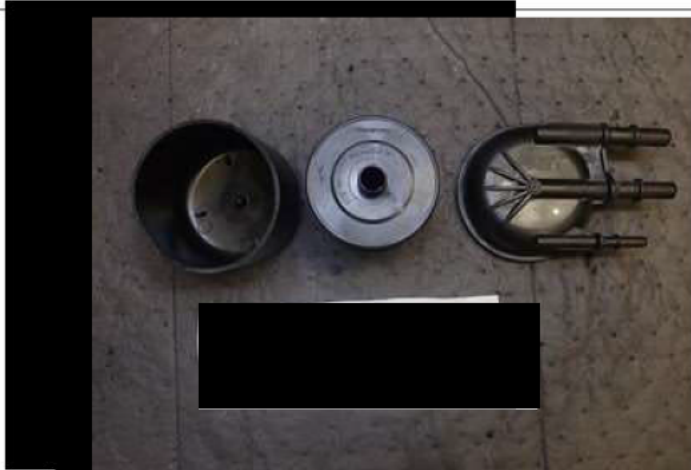
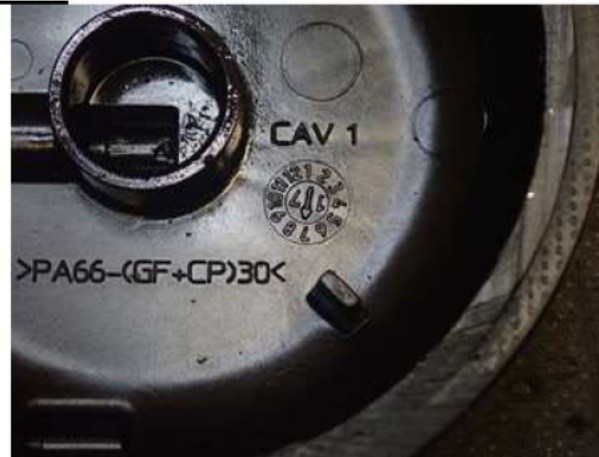
Sample # 1 – VIN UNKNOWN

- To get a better view of the leak source, white powder was sprayed over the cap.
- The filter was then pressurized with air.
- **The air exposed the leak area. There is a fracture in the top cover, at the base of the outlet port.**

| # | Vehicle | MY | Prichard Mfg. Date | Top Cover Cavity | Leak Test Results<br>NG | Leak Test Results<br>OK | Comments |
|---|---|---|---|---|---|---|---|
| 1 | VIN UNKNOWN | UNKNOWN | P7J2502 B<br>Aug 25 <sup>th</sup> , 2017 | Cav1 - 07/2017<br>(Mold Date) | Leak @ Fracture in the top<br>cover | --- | Fracture at the base of the outlet port.<br>Filter is very saturated with contamination. Filter is<br>collapsed. |

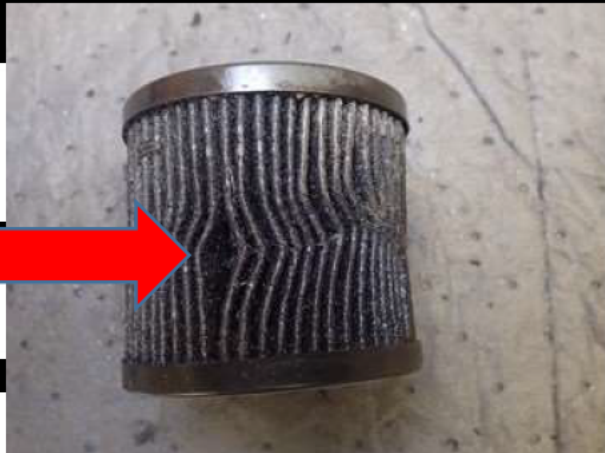
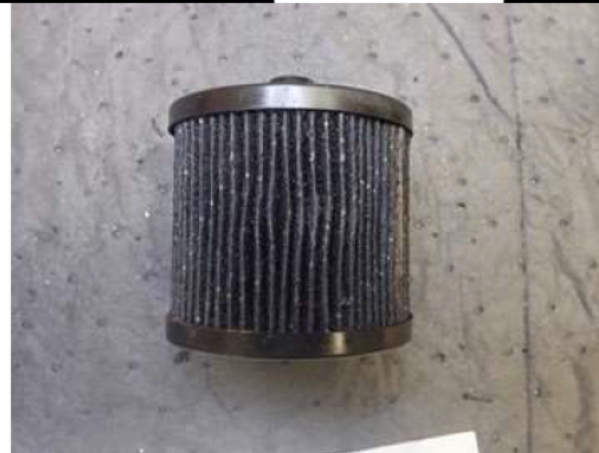
Visual inspection of the filter; There are some pleats that are collapsed, also the bottom end cap of the filter is deformed. We believe this was due to High Pressure Drop causing the filter to collapse.

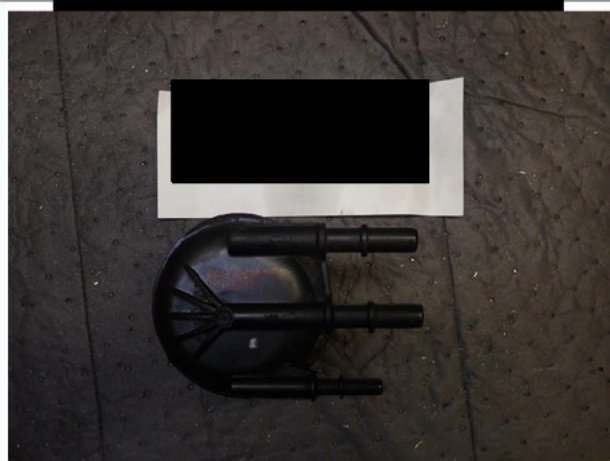
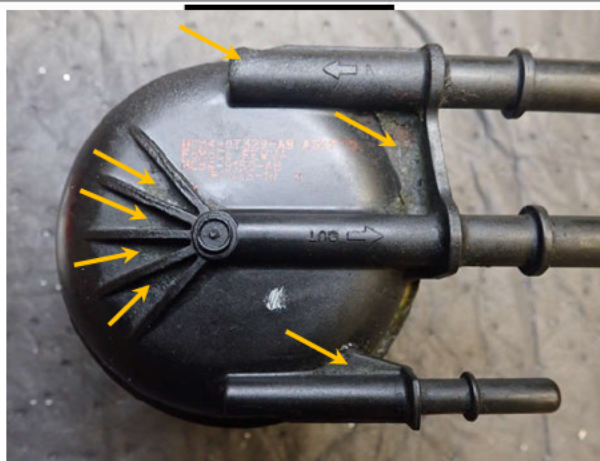
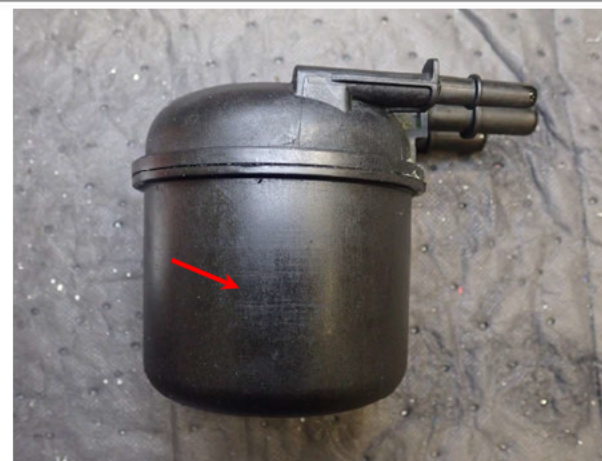
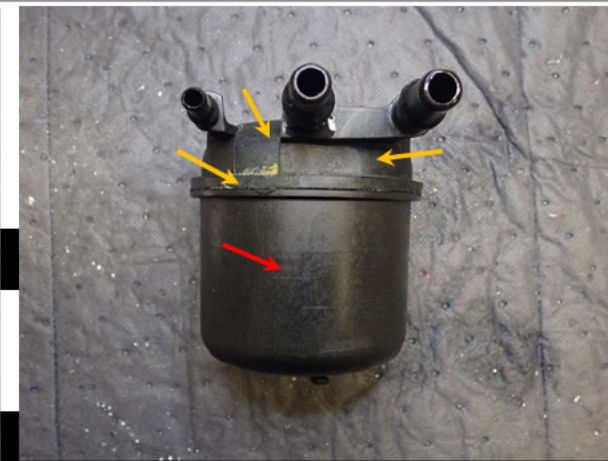
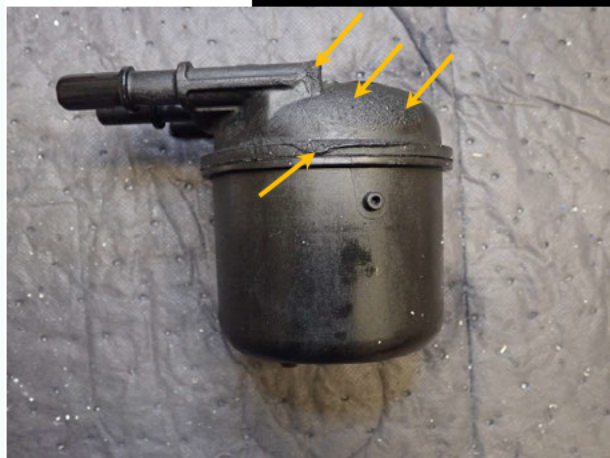
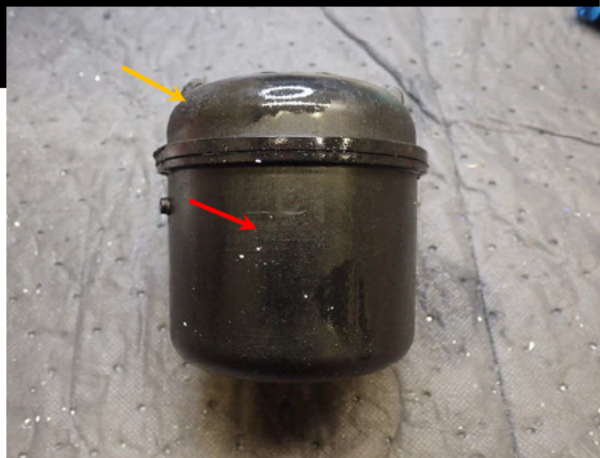
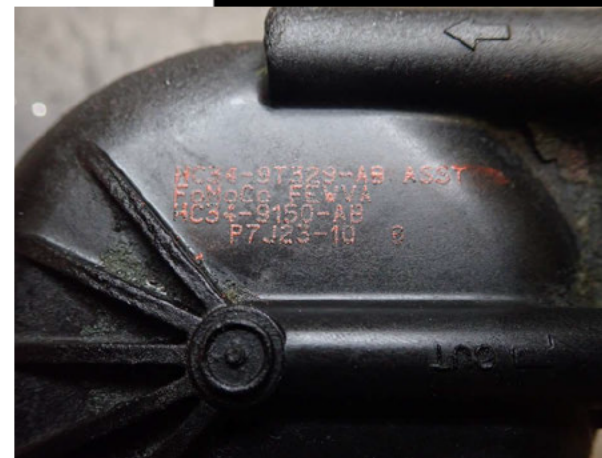
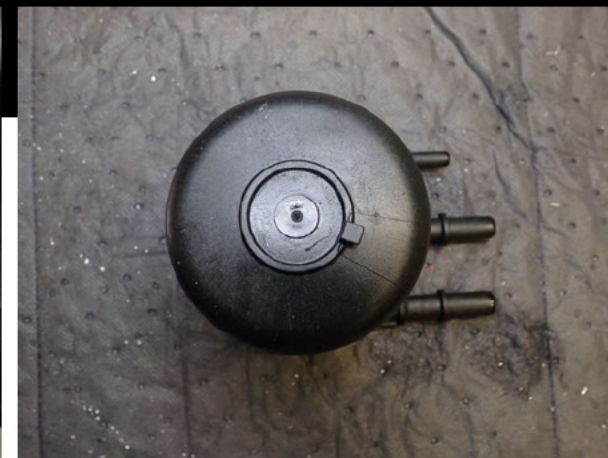
Sample # 2 – VIN [REDACTED]  
2017 F350

HC34-9T329-AB ASSY  
FoMoCo FEWVA  
HC34-9150-AB  
P7J23-10 B [Aug 23<sup>rd</sup> 2017, B shift]

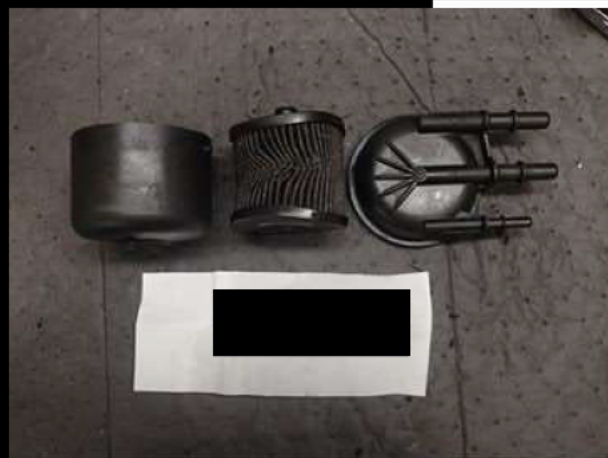
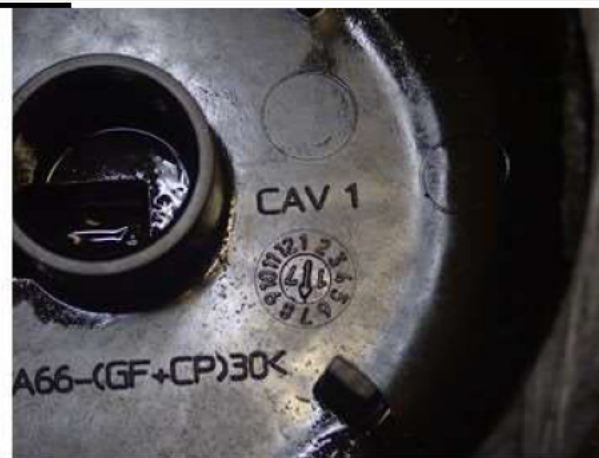
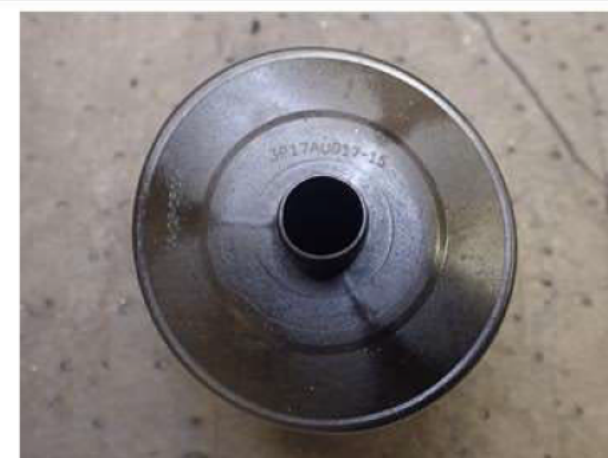
Sample # 2 – VIN [REDACTED]  
F2017 F350

- [REDACTED] of the leak [REDACTED]
- [REDACTED]
- The air exposed the leak area. There is a fracture in the top cover, at [REDACTED] the outlet port.

| # | Vehicle | MY | Prichard Mfg. Date | Top Cover Cavity | Leak Test Results<br>NG | Leak Test Results<br>OK | Comments |
|---|---|---|---|---|---|---|---|
| 2 | [REDACTED] F2017 F350 | 2017 | P7J23-10 B<br>Aug 23 <sup>rd</sup> , 2017 | Cav1 - 07/2017<br>(Mold Date) | Leak @ Fracture in the top<br>cover | --- | Fracture at the base of the outlet port.<br>Filter is very saturated with contamination. Filter is<br>collapsed. |

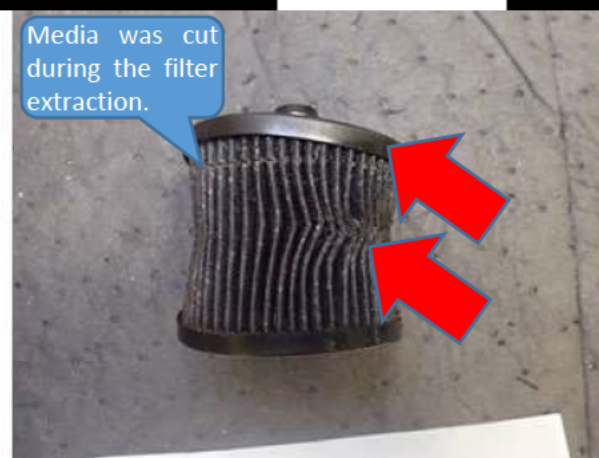
Visual inspection of the filter; There are some pleats that are collapsed, also the bottom end cap of the filter is deformed. We believe this was due to High Pressure Drop causing the filter to collapse.

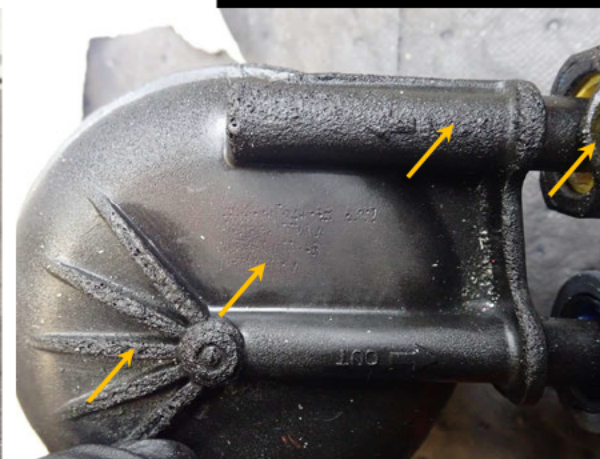
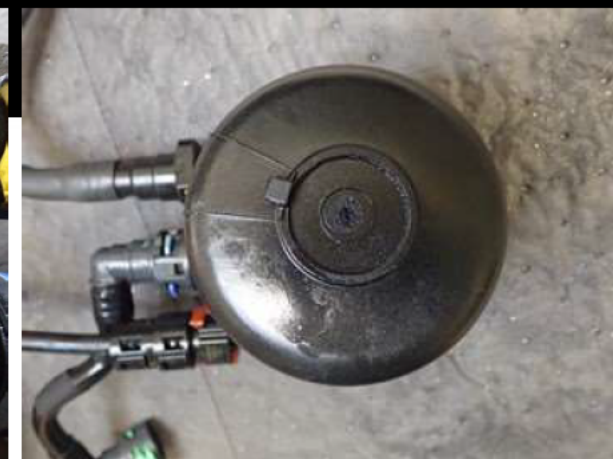
Secondary Filter was visually inspected, some minor scratches and multiple molten plastic areas were found.

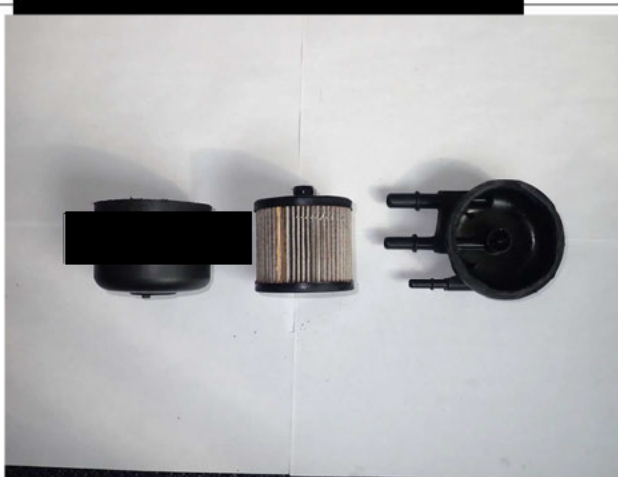
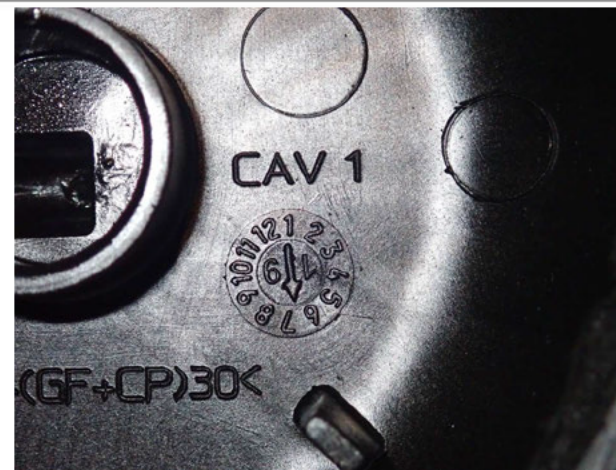
Sample # 3 – VIN [REDACTED]  
2019 MEDIUM DUTY (F650/F750) 6.7L

- [REDACTED] air pressure and underwater.
- To get a [REDACTED] over [REDACTED]
- The filter was then pressu [REDACTED]
- The air did NOT expose any leaks.

| # | Vehicle | MY | Prichard Mfg. Date | Top Cover Cavity | Leak Test Results<br>NG | Leak Test Results<br>OK | Comments |
|---|---|---|---|---|---|---|---|
| 3 | [REDACTED]<br>MEDIUM DUTY<br>(F650/F750) 6.7L | 2019 | UNREADABLE /<br>ILLEGIBLE. | Cav1 - 07/2019<br>(Mold Date) | --- | <b>DID NOT LEAK</b> | Filter with low contamination. Filter is not collapsed. |

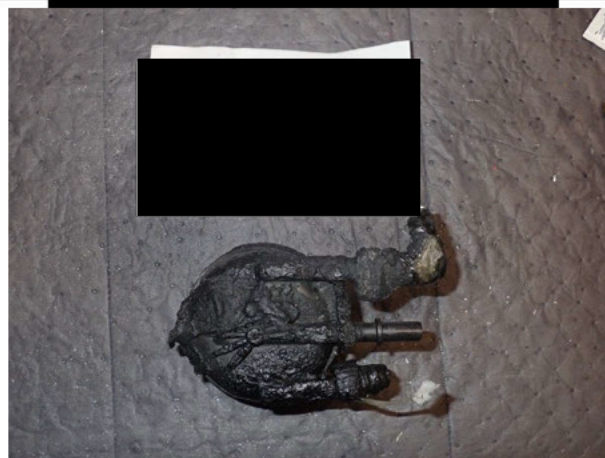
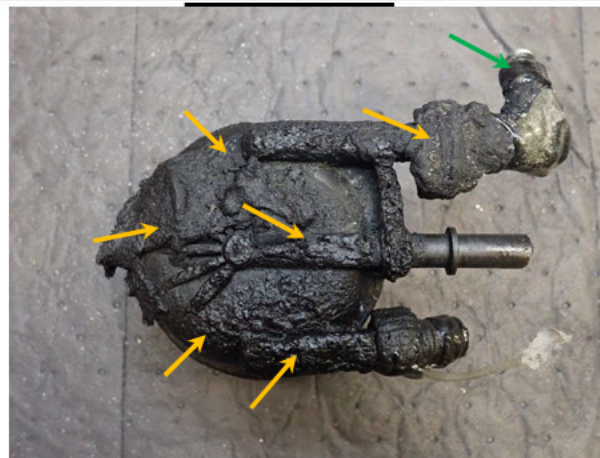
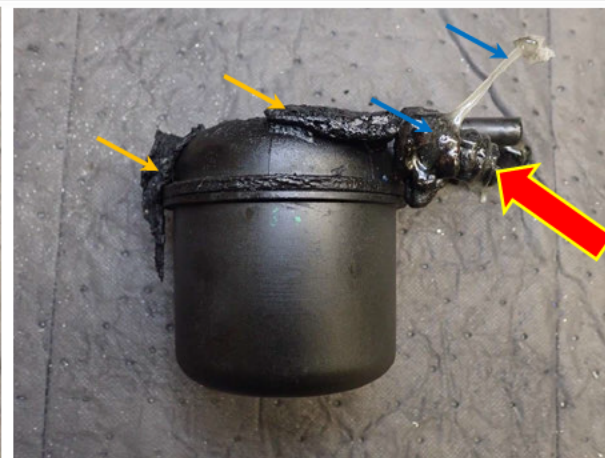
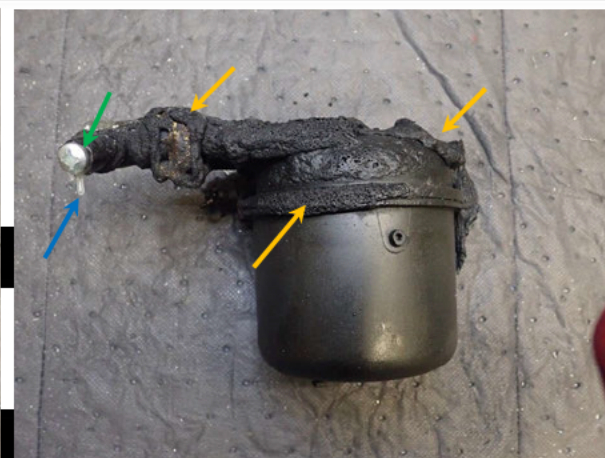
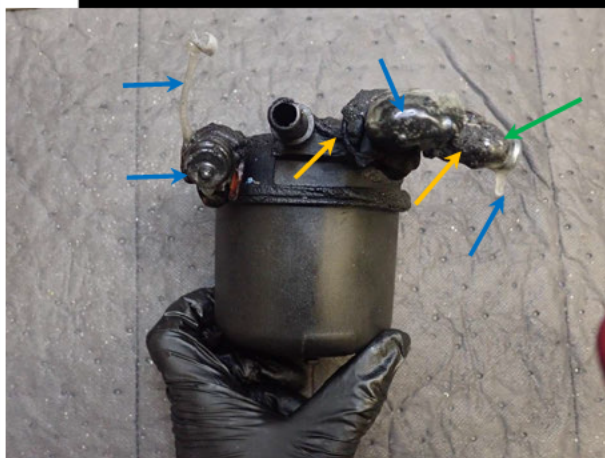
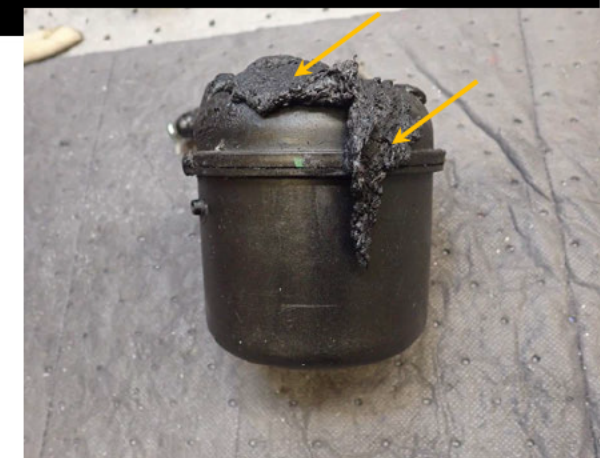
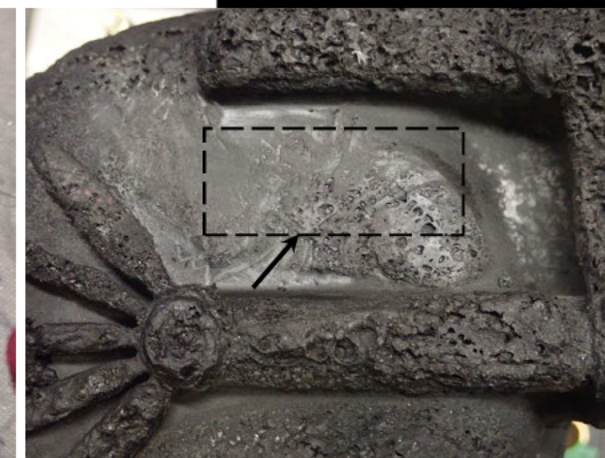
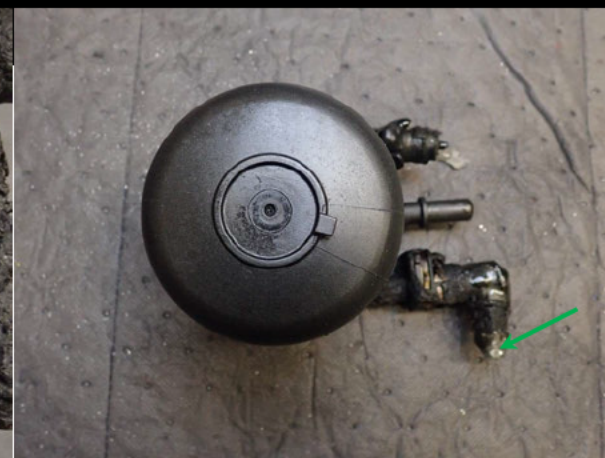
Sample # 4 – VIN [REDACTED]  
2019 F250 6.7L

Molten Plastic was removed to obtain  
Manufacturing information.  
UNREADABLE / ILLEGIBLE.

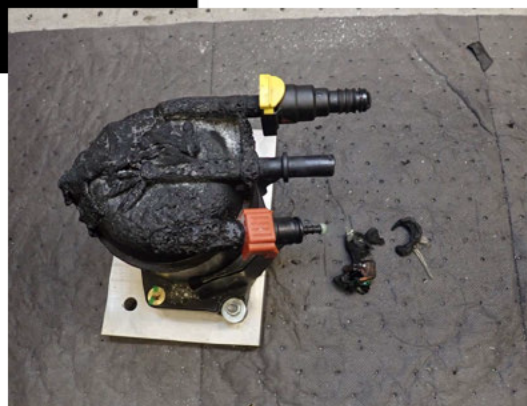
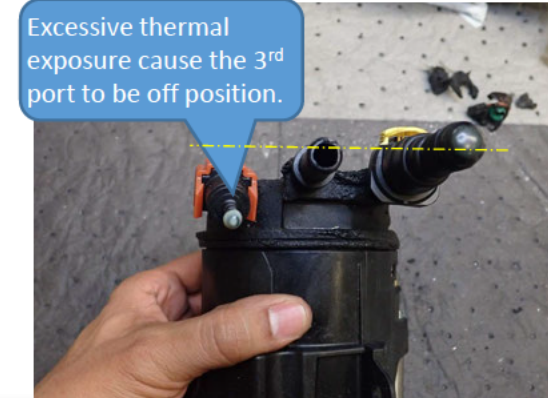
Sample # 4 – VIN [REDACTED]  
2019 F250 6.7L

- [REDACTED], white powder is sprayed
- [REDACTED] pressed with [REDACTED]
- [REDACTED] break area. There is a fracture [REDACTED] the base of the [REDACTED]

| # | Vehicle | MY | Prichard Mfg. Date | Top Cover Cavity | Leak Test Results<br>NG | Leak Test Results<br>OK | Comments |
|---|---|---|---|---|---|---|---|
| 4 | [REDACTED]<br>F250 6.7L | 2019 | UNREADABLE /<br>ILLEGIBLE. | Cav1 - 02/2019<br>(Mold Date) | Leak @ Fracture in the top<br>cover | --- | Fracture at the base of the outlet port.<br>Filter is very saturated with contamination. Filter is<br>collapsed. |

- To obtain a better seal, the molten connectors were milled on the [REDACTED] new fuel connectors were placed.

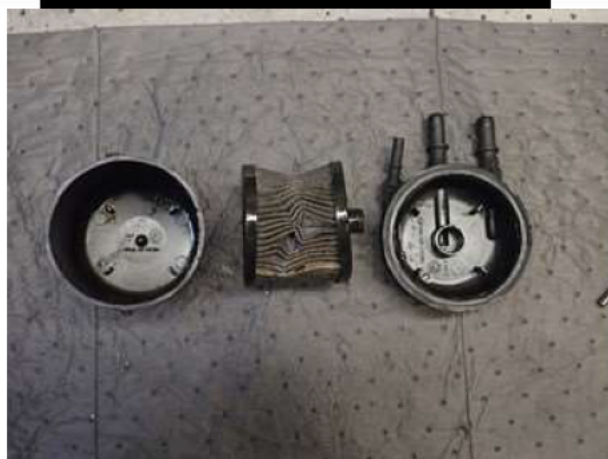
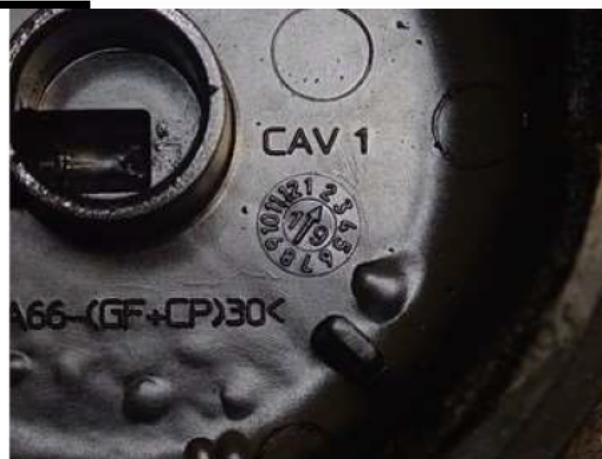
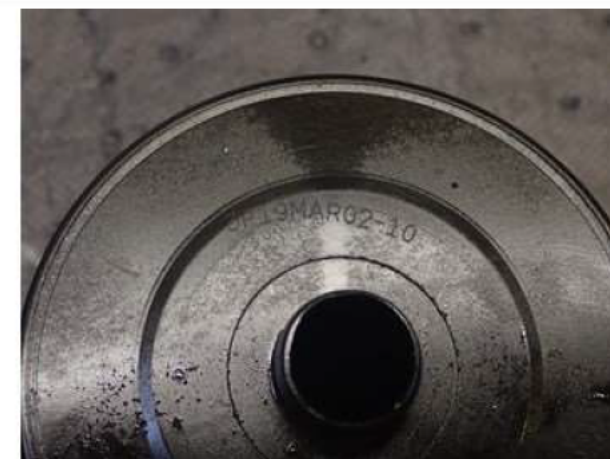
Sample # 4 – VIN [REDACTED]  
2019 F250 6.7L

[REDACTED]  
date

[REDACTED] the inner  
[REDACTED] ring date of

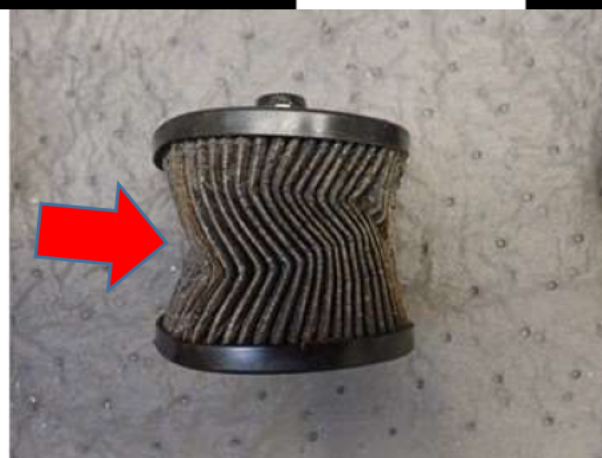
Visual inspection of the filter; There are some pleats that are collapsed, also the bottom end cap of the filter is deformed. We believe this was due to High Pressure Drop causing the filter to collapse.

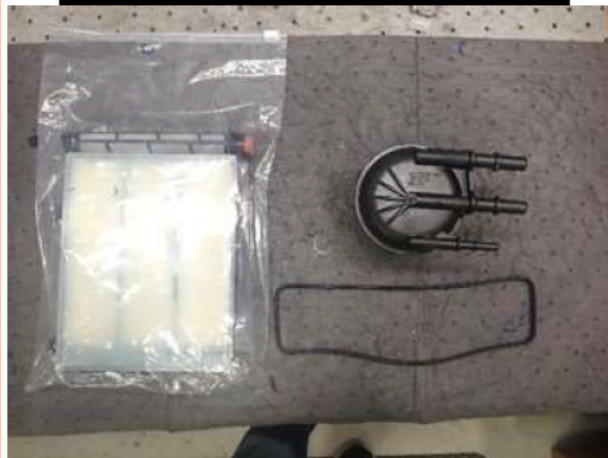
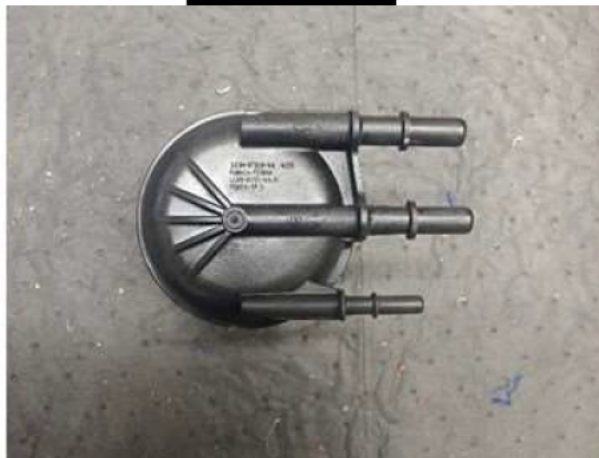
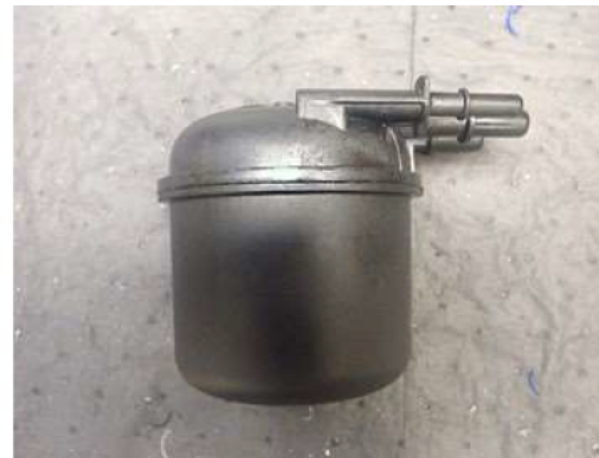
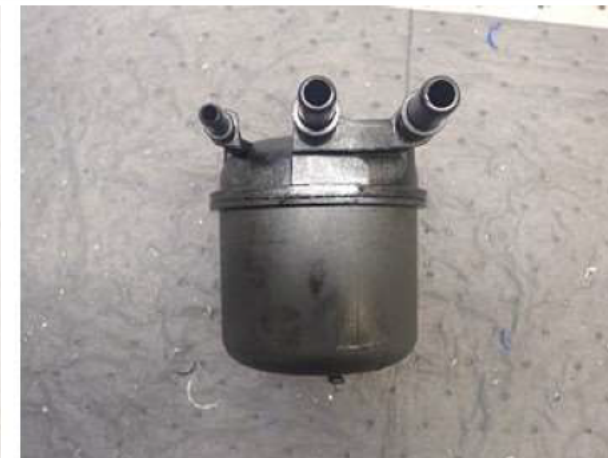
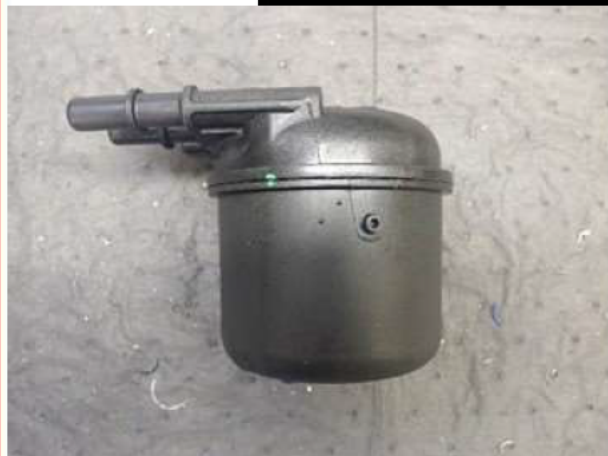
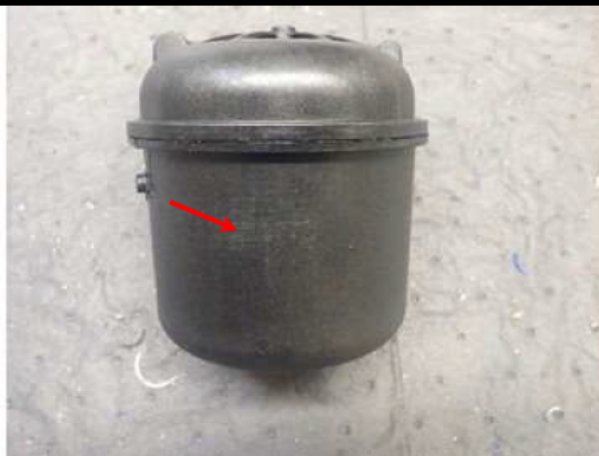
Sample # 6 – [REDACTED]  
MY2021 - F250

[REDACTED] inspected, some scratches [REDACTED]

HC34-9T329-AA ASSY  
FoMoCo FEWVA  
LC34-9150-AA FI  
POM14-18D [Nov 14<sup>th</sup>, 2020]

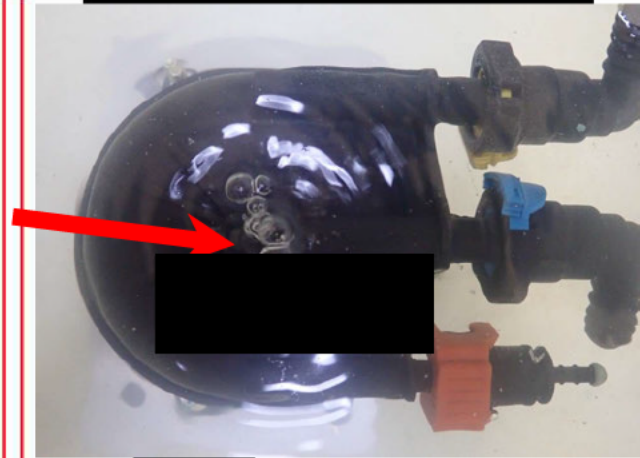
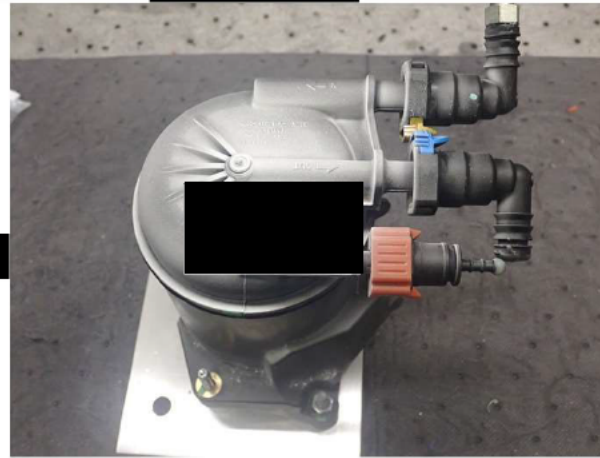
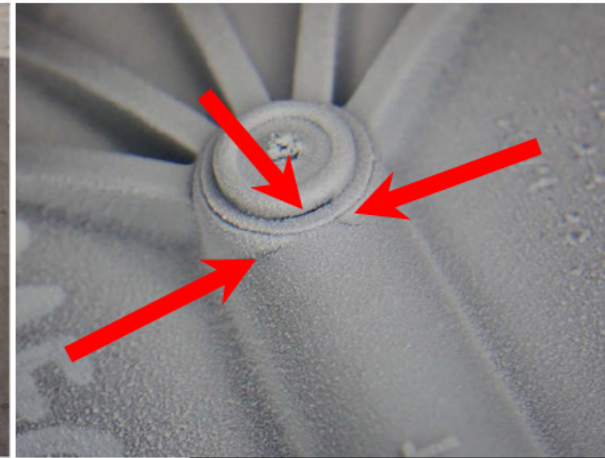
Sample # 6 – [REDACTED]  
MY2021 - F250

To get a better view of the leak source, white powder was sprayed [REDACTED] the cap.

The [REDACTED]  
with air [REDACTED]  
un [REDACTED]  
source was located in  
the top cover, at the  
base of the outlet port.

- The filter was then pressurized with air.
- **The air exposed the leak area. There is a fracture in the top cover, at the base of the outlet port.**

| # | Vehicle | MY | Prichard Mfg. Date | Top Cover Cavity | Leak Test Results<br>NG | Leak Test Results<br>OK | Comments |
|---|---|---|---|---|---|---|---|
| 6 | [REDACTED]<br>- F250 SERIES | 2021 | P0M14-18D<br>Nov 14 <sup>th</sup> , 2020 | Cav1; 10/2020<br>(Mold Date) | Leak @ Fracture in the top<br>cover | --- | Fracture at the base of the outlet port.<br>Filter with low contamination. Filter is not collapsed.<br><b>Claim did not come from a THERMAL EVENT.</b> |

| # | Vehicle | MY | Prichard Mfg. Date | Top Cover Cavity | Techmer Resin Lot Number | Techmer Conclusions |
|---|---|---|---|---|---|---|
| 6 | [REDACTED] -<br>F250 SERIES | 2021 | P0M14-18D<br>Nov 14 <sup>th</sup> , 2020 | Cav1; 10/2020<br>(Mold Date) | NE2007243144 | There were no obvious causes for the cracking found in our analysis. Internal investigation confirmed this lot of 1722101-08 NE1705140011 ran on the usual equipment, processing, setup, and passed QC specifications. |

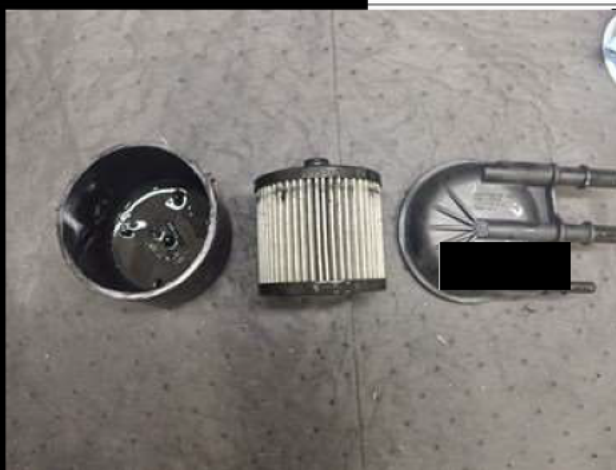
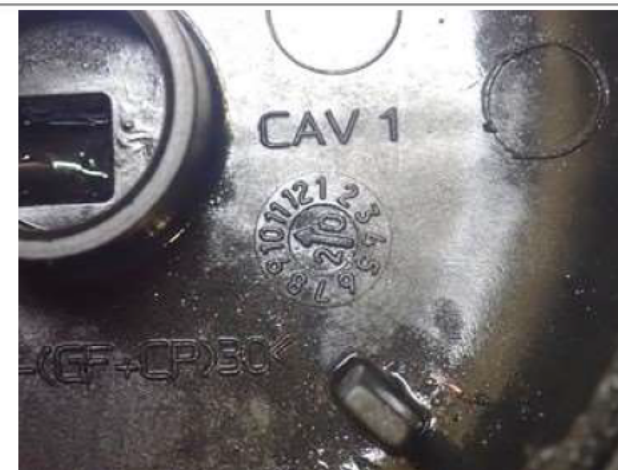
Sample # 6 – [REDACTED]  
MY2021 - F250

[REDACTED] e [REDACTED] the inner [REDACTED]  
with [REDACTED]

The Filter has a manufacturing date of 3P20NOV10-04. Visual inspection of the filter; Low contamination saturation, due to low miles.

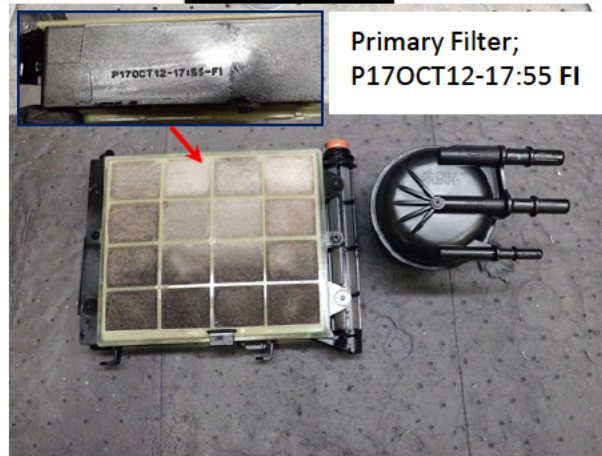
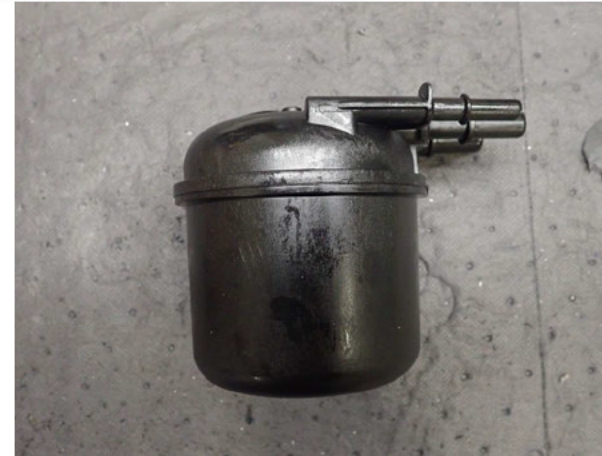
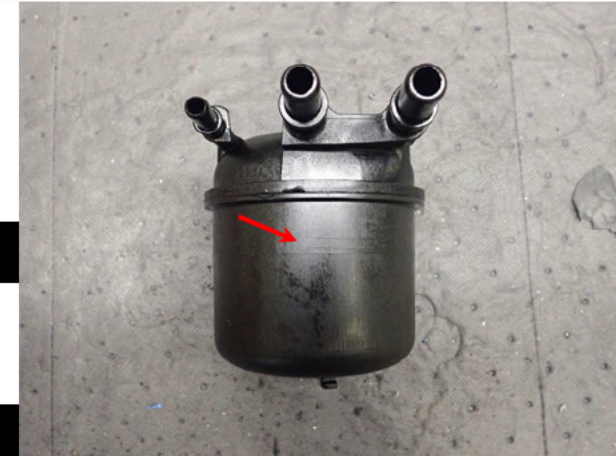
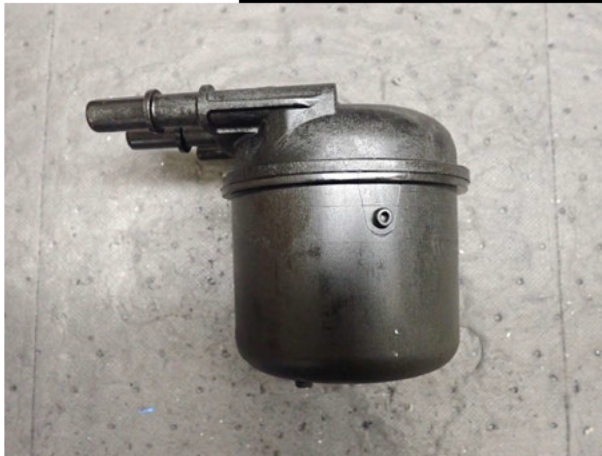
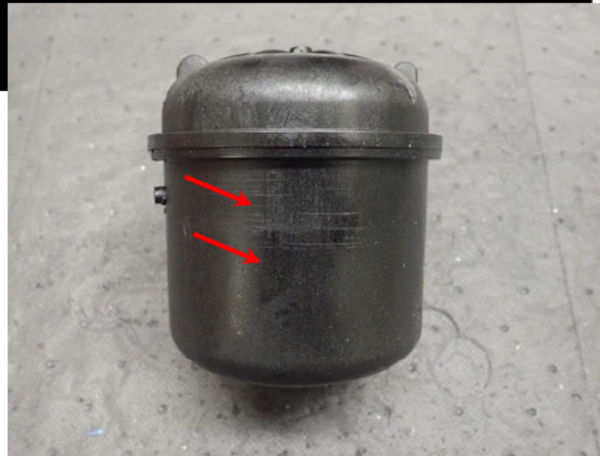
Sample # 7 – [REDACTED]  
MY2021 – F450

[REDACTED] contamination  
[REDACTED] inspected, some [REDACTED]

HC34-9T329-AB ASSY  
FoMoCo FEWVA  
HC34-9150-AB FI  
P7M26-19 A [Nov 26<sup>th</sup>, 2017]

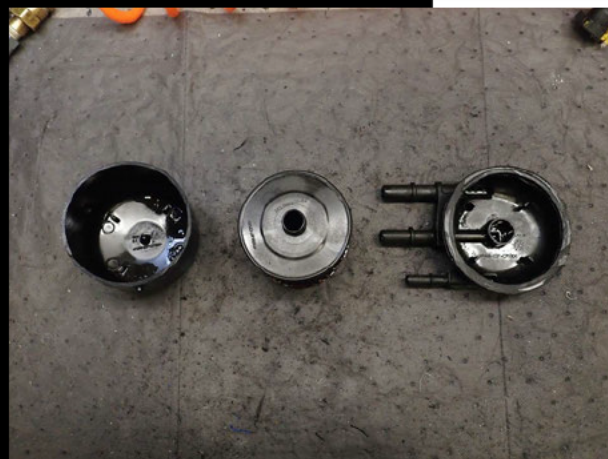
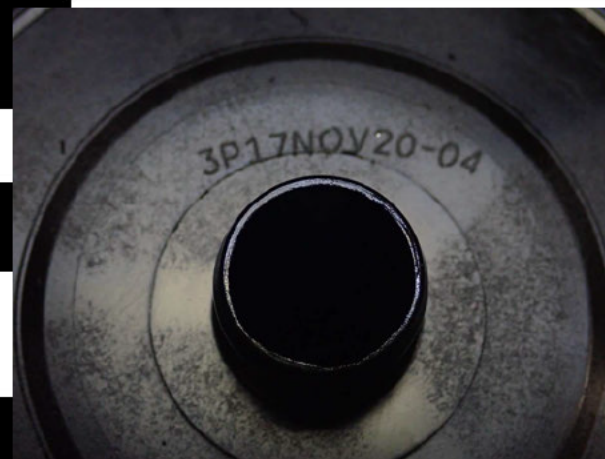
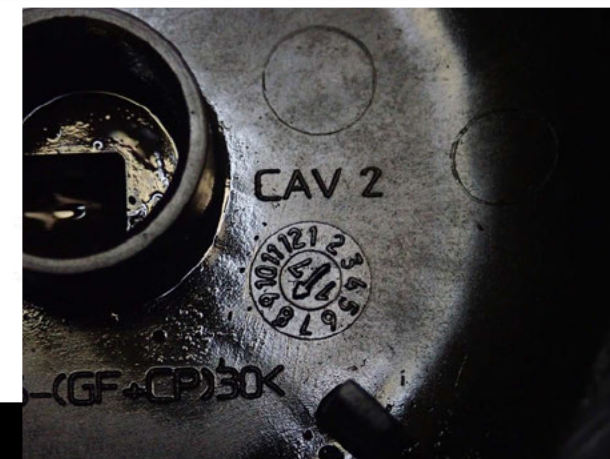
Sample # 7 – [REDACTED]  
MY2021 – F450

date

CAV2

ct the inner  
ring date of

| # | Vehicle | MY | Prichard Mfg. Date | Top Cover Cavity | Leak Test Results<br>NG | Leak Test Results<br>OK | Comments |
|---|---|---|---|---|---|---|---|
| 7 | [REDACTED]<br>MY2021 – F450 | 2021 | P7M26-19 A<br>[Nov 26 <sup>th</sup> , 2017] | <b>CAV2</b><br>08/2017 | Leak @ Fracture in the top<br>cover | --- | Fracture at the base of the outlet port.<br>Filter is very saturated with contamination. Filter is<br>collapsed.<br><b>Claim did not come from a THERMAL EVENT.</b> |

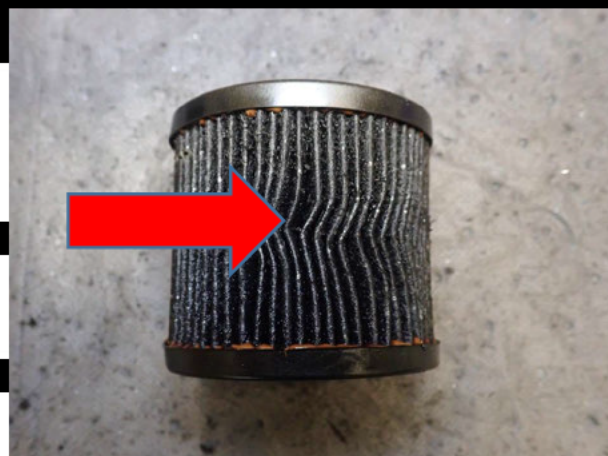
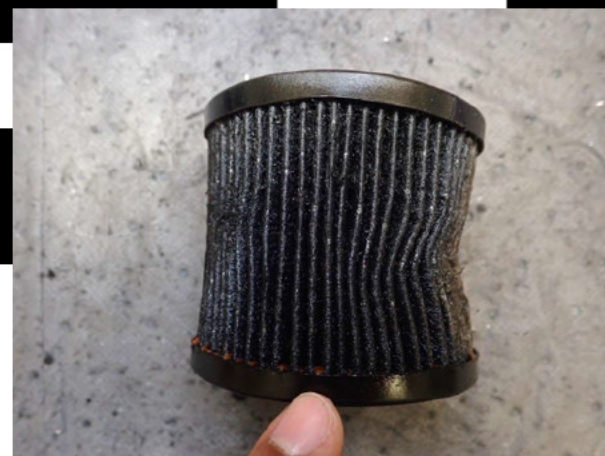
Visual inspection of the filter; There are some pleats that are collapsed, also the bottom end cap of the filter is deformed. We believe this was due to High Pressure Drop causing the filter to collapse.
