GROUP Safety Recall Campaign	MODEL 2011-2014MY Optima (QF/TF) 2012-2014MY Sorento (XMa) 2011-2013MY Sportage (SL)
	NUMBER SC147 (Rev 4, 08/07/2017)	DATE June 2017
SAFETY RECALL CAMPAIGN		
SUBJECT: THETA II ENGINE INSPECTION AND/OR REPLACEMENT

This bulletin provides the procedure to inspect, and if necessary, replace the engine long block assembly on the following vehicles:

Metal debris may have been generated from factory machining operations of the engine crankshaft and may not have been completely removed from the crankshaft's oil passages during the cleaning process. It was also determined that the additional machining processes of the crankpins may have caused uneven surface roughness. These combined conditions can restrict oil flow to the bearings increasing the potential for premature bearing wear.

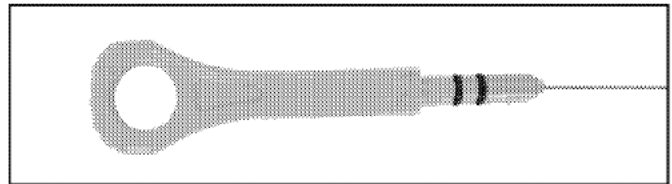
Yellow Dipstick (P/N: 26611 2G020)

21. Disconnect the engine noise tester from the KDS and carefully remove the adapter (B) from the dipstick tube by grasping the engine noise tester adapter.
22. For 2011-2013MY vehicles only: If the vehicle is equipped with a **YELLOW** dipstick, discard the dipstick and replace it with a new **ORANGE** one.
