GROUP Safety Recall Campaign	MODEL 2011-2014MY Optima (QF/TF) 2012-2014MY Sorento (XMa) 2011-2013MY Sportage (SL)
	NUMBER SC147 (Rev 5, 09/01/2017)	DATE June 2017
SAFETY RECALL CAMPAIGN		
SUBJECT: THETA II ENGINE INSPECTION AND/OR REPLACEMENT

This bulletin provides the procedure to inspect, and if necessary, replace the engine long block assembly on the following vehicles:

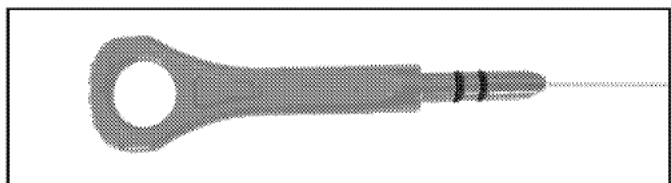
Orange Dipstick (P/N: 26611 2G050QQK)

21. Disconnect the engine noise tester from the KDS and carefully remove the adapter (B) from the dipstick tube by grasping the engine noise tester adapter.
22. For 2011-2013MY vehicles only: If the vehicle is equipped with a **YELLOW** dipstick, discard the dipstick and replace it with a new **ORANGE** one.

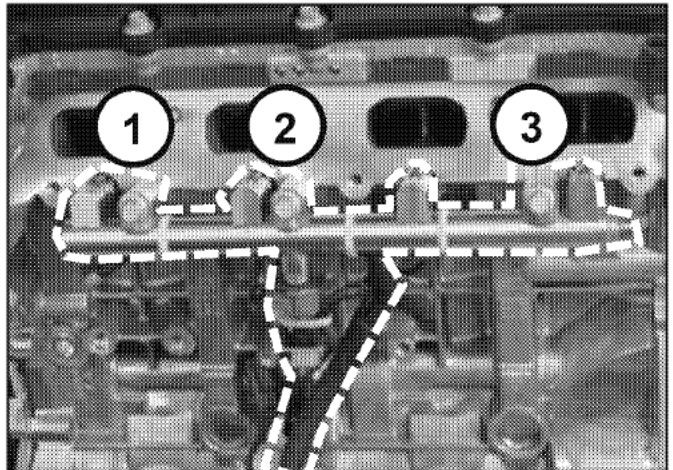
- Refer to TSB ENG083 for special attention and handling procedures of GDI-specific components.
- Prior to installing the delivery pipe, be sure to replace all of the injector O-rings and injector retainers.
- Prior to installing the delivery pipe, apply engine oil to the injector O-rings.
- When installing the delivery pipe, use caution not to damage the tip of the injector.
- Be sure to replace the delivery pipe retaining bolts and torque them in the sequence shown.

Tightening torque of bolts:
 13.7 – 17.4 lb.ft (18.6 – 23.5 N.m,
 1.9 – 2.4 kgf.m)

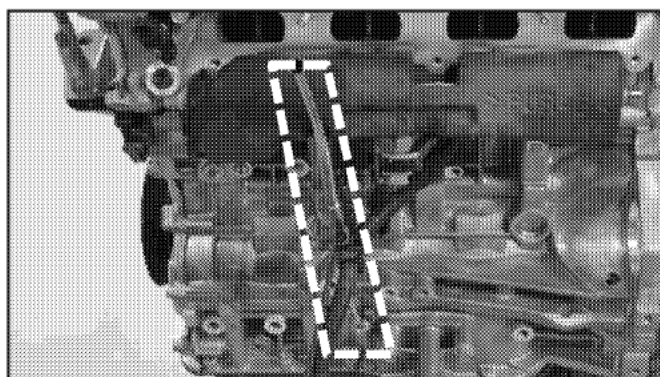
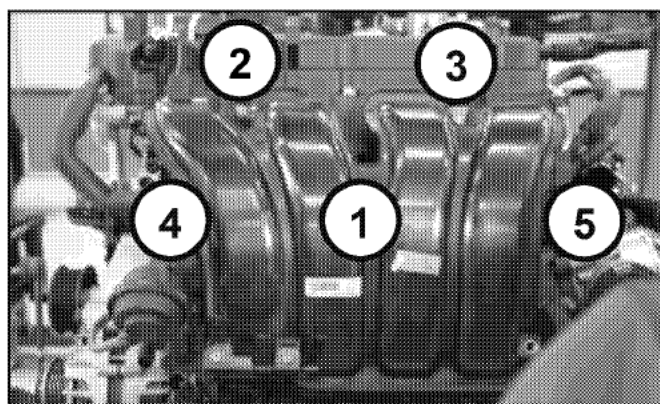
- Refer to "Guidelines in case of Catastrophic Failure" on page 13.
- Prior to installation, replace the intake manifold gaskets.
- Torque bolts in the sequence shown.

**13.7 – 17.4 lb.ft (18.6 – 23.5 N.m,
1.9 – 2.4 kgf.m)**

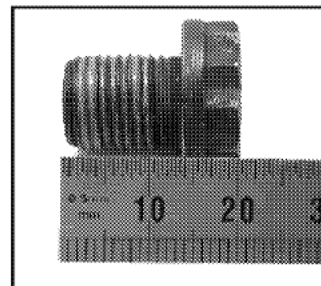
Drive Plate Bolt (A/T)

- Replace all seven (7) drive plate (AT) or flywheel (MT) bolts.
