GROUP Safety Recall Campaign	MODEL 2011-2014MY Optima (QF/TF) 2012-2014MY Sorento (XMa) 2011-2013MY Sportage (SL)
	NUMBER SC147 (Rev 6, 2/7/2018)	DATE June 2017
SAFETY RECALL CAMPAIGN		
SUBJECT: THETA II ENGINE INSPECTION AND/OR REPLACEMENT

This bulletin provides the procedure to inspect, and if necessary, replace the engine long block assembly on the following vehicles:

Metal debris may have been generated from factory machining operations of the engine crankshaft and may not have been completely removed from the crankshaft's oil passages during the cleaning process. It was also determined that the additional machining processes of the crankpins may have caused uneven surface roughness. These combined conditions can restrict oil flow to the bearings increasing the potential for premature bearing wear.

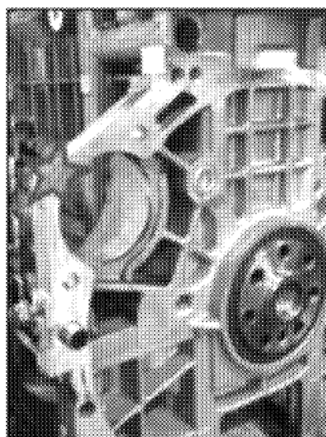
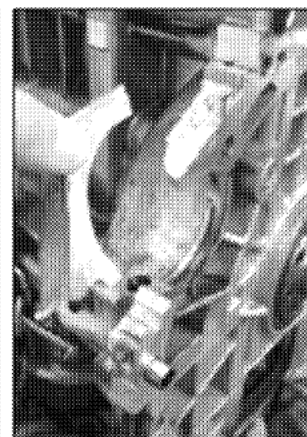
7. Prior to discarding the removed engine, disable it to prevent reuse by using a large mallet and striking firmly at the center of the starter mount tab on the removed engine to break off the tab.

Provide the removed starter mount tab to your dealership's Parts Department for campaign engine core charge reimbursement request processing.
