Safety Recall

N252494000 L87 Engine Loss of Propulsion

Release Date: February 2026

Revision: 12

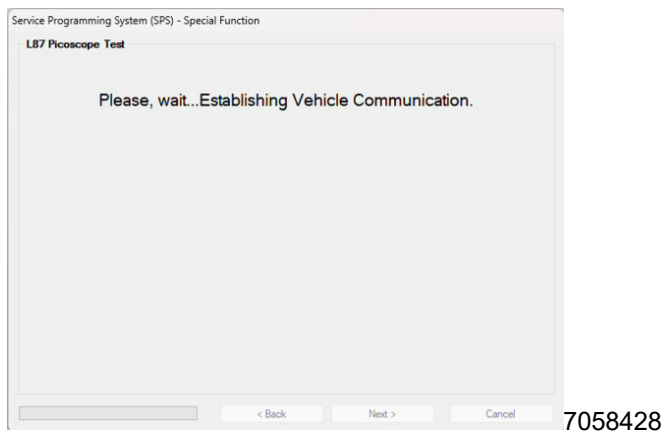
11. The above screen will pop up, indicating the procedure has been initiated.
12. The next screens will instruct you to connect the Picoscope to the vehicle and to start the engine, please follow the instructions as they are displayed.

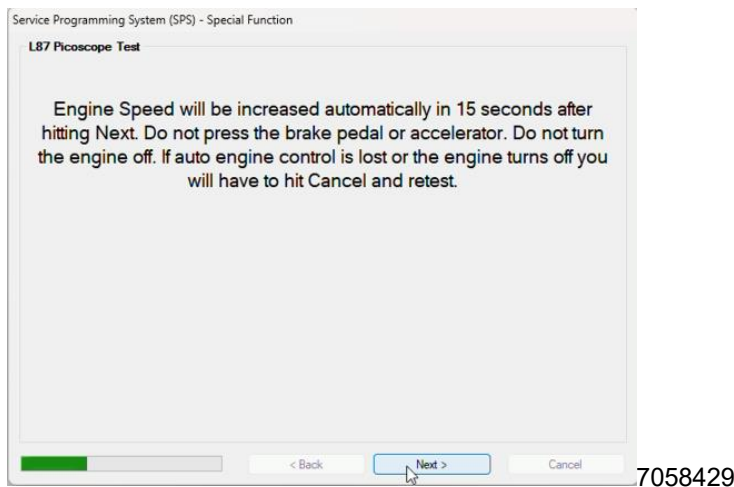
13. The above screen will display when the Picoscope is connected, engine is running, and after pressing next. 15 seconds after clicking “Next”, engine speed will be increased automatically to 2000 RPMs.

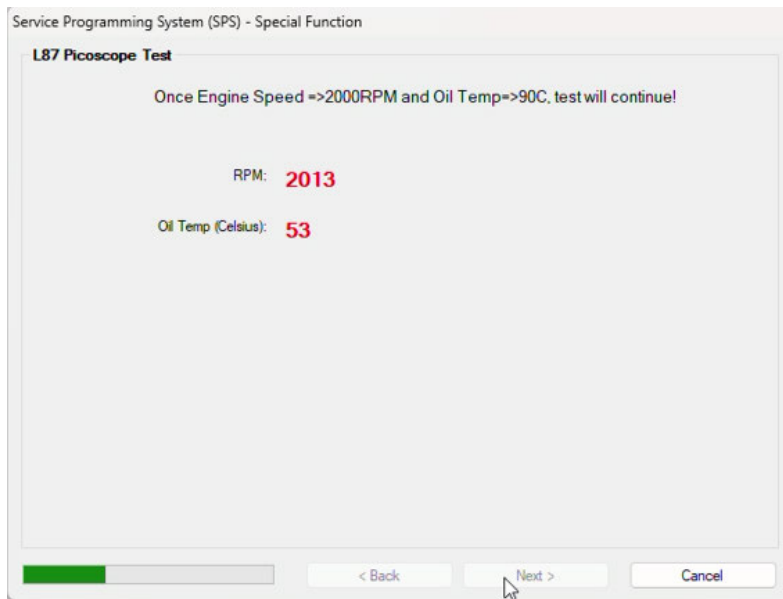
7058430

14. The above screen will display until the listed parameters are met. Engine Speed must be 2000 RPM and Oil Temp must reach 90 degrees Celsius. Please do not touch the accelerator pedal during the procedure.

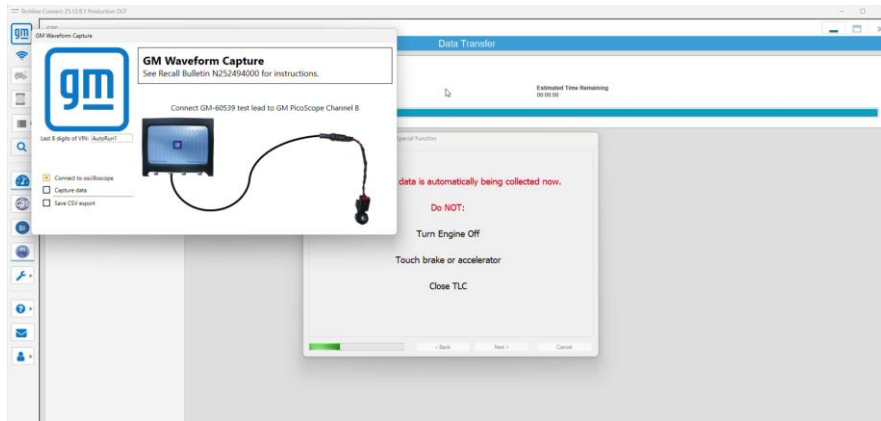
7058431

15. After the parameters have been met, the screen will change and GM Waveform Capture will open. No action needs to be completed at this time. The program will automatically record and capture the required data.

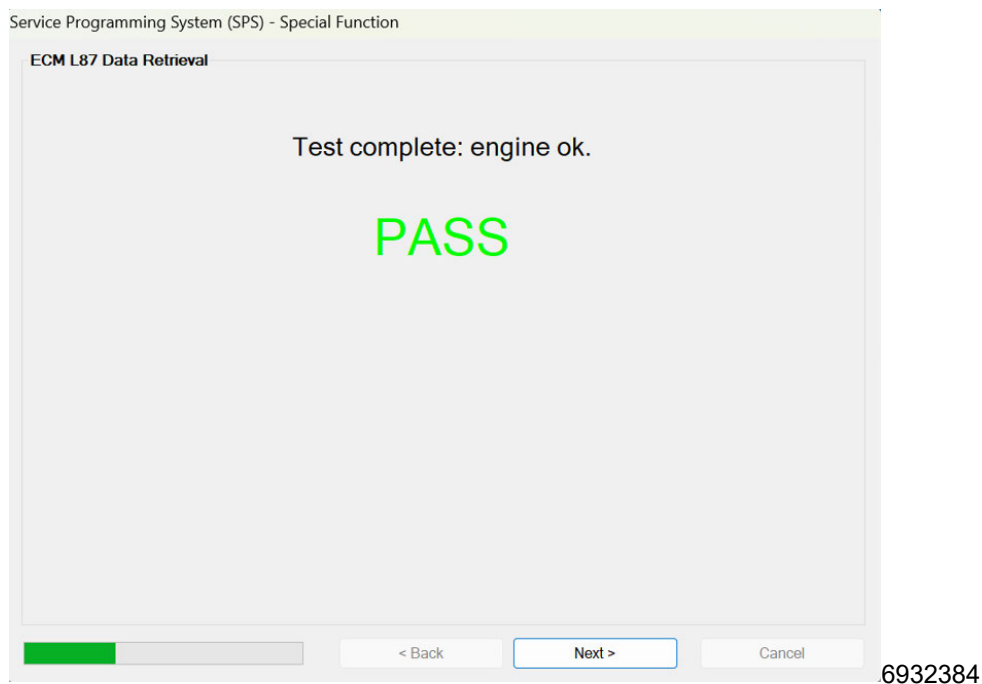
- When GM Waveform Capture has completed its sequence, the program will automatically save and upload the captured data.
- The next screen will automatically populate with a PASS or FAIL result. After recording the result, press “Next” on the following screens to retrieve the Warranty Claim Code and exit the procedure.

- If the engine PASSES the test, proceed to the next step.

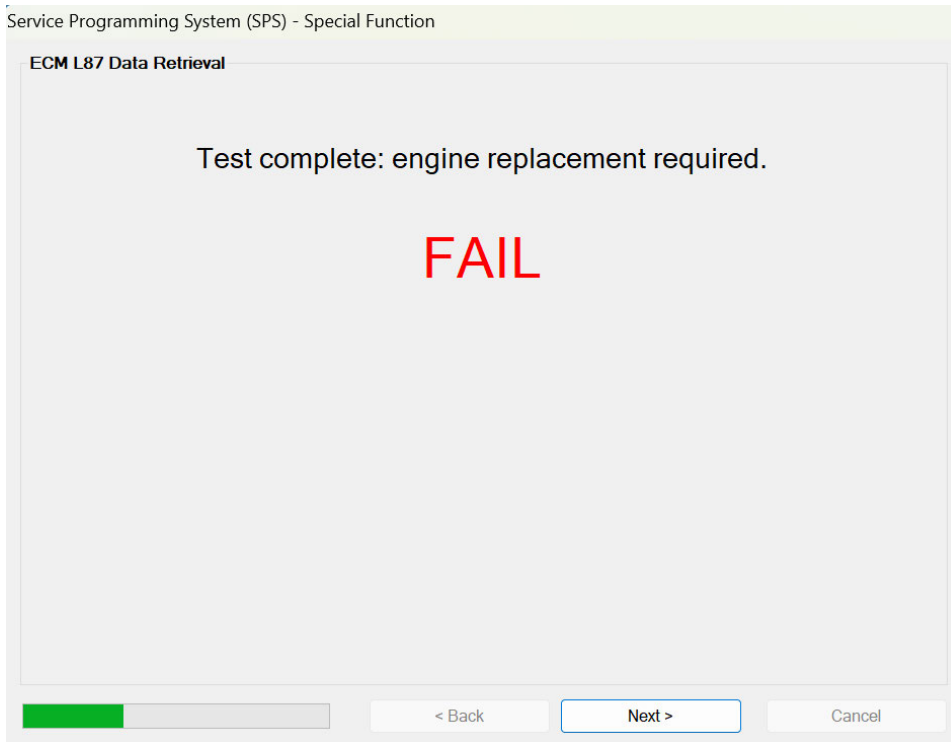
6932386

- If the engine FAILS the test, refer to *Engine Replacement* in SI. Transfer the engine oil cap from the original engine to the replacement engine and fill the engine with the oil grade that is indicated on the cap.

18. FOR ENGINES THAT PASS: Perform an oil change to 0W-40 Oil, *Refer to Engine Oil and Oil Filter Replacement* in SI. Install a NEW engine oil cap and place the owner's manual insert(s) in the glovebox.
