**GENERAL MOTORS NORTH AMERICA**  
**Safety Center**

00V-085 (01)

**SUBJECT: 000XX - POWER STEERING COOLER HOSE SEPARATION**

**MODELS: 1999-2000 CHEVROLET AND GMC G-VANS**

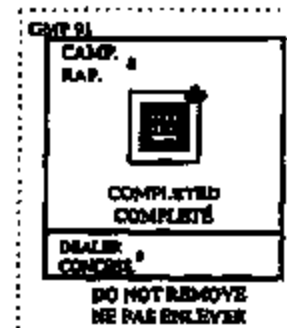
Place a Campaign Identification Label on each vehicle corrected in accordance with the instructions outlined in this Product Campaign Bulletin. Each label provides a space to include the campaign number and the five (5) digit dealer code of the dealer performing the campaign service. This information may be inserted with a typewriter or a ball point pen.

Put the Campaign Identification Label on a clean and dry surface of the radiator core support in an area that will be visible to people servicing the vehicle. Additional Campaign Identification Labels for Canadian dealers can be obtained from DGN by calling 1-800-668-5538 (Monday-Friday, 8:00 a.m. to 5:00 p.m. EST). Ask for Item Number GMP 91 when ordering.
