**Q&A Regarding Concerns on Ball Joint Recall Campaign
(Dealer/Call Center)**

**** ADVANCE TECHNICAL INFORMATION NOTICE ****99V-066.002
00V-421.001

DATE: February 14, 2001
TO: Mitsubishi Motors Service Managers
FROM: Dave McKenzie, Vice President, Product Support
RE: Safety Recall SR-99-002 – New Inspection Procedure And Expanded Model Years
ATIN NO. ATIN-01-SR-005

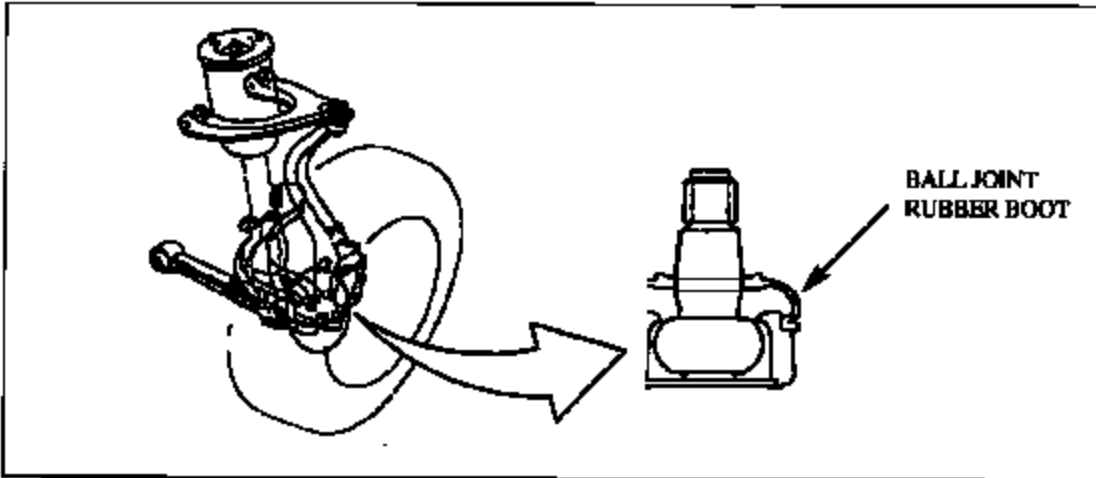
1. Raise the vehicle.

2. Inspect the lateral lower arm ball joint rubber boot on both sides for cracks and damage. Gently push the boot in with your fingers. Do not remove any parts for the inspection. Damage to the boot is evident if any cuts or tearing are observed or if grease comes out when it is pushed in.
 - a. If the rubber boot is not damaged on either side of the vehicle, go to Steps 3 and 4 for ball joint inspection.

- b. If the rubber boot is damaged, replace the lateral lower arm assembly, using the parts listed in the PARTS INFORMATION section of this notice. Go to Step 5 for lateral lower arm replacement instructions.
