Campaign Bulletin

File In Section: Product Campaigns
Bulletin No.: 00100A
Date: August, 2001

SUBJECT: 00100A – CONSOLE/ARMREST CAM LATCH COMPLIANCE

**MODELS: 1998-2001 GMC ENVOY
2000-2001 GMC JIMMY DIAMOND EDITION**

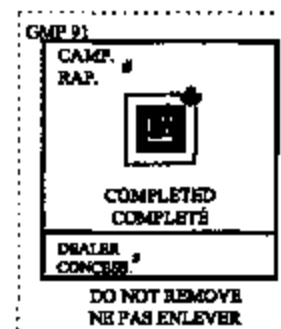
Place a Campaign Identification Label on each vehicle corrected in accordance with the instructions outlined in this Product Campaign Bulletin. Each label provides a space to include the campaign number and the five (5) digit dealer code of the dealer performing the campaign service. This information may be inserted with a typewriter or a ball point pen.

Put the Campaign Identification Label on a clean and dry surface of the radiator core support in an area that will be visible to people servicing the vehicle. **Additional Campaign Identification Labels for Canadian dealers can be obtained from DGN by calling 1-800-668-5538 (Monday-Friday, 8:00 a.m. to 5:00 p.m. EST). Ask for Item Number GMP 91 when ordering.**
