RECALL CAMPAIGN BULLETIN

NTB01-062a

VOLUNTARY RECALL CAMPAIGN REAR DOOR (HATCH) STRUT BRACKET REPLACEMENT

APPLIED VEHICLE: 1997 - 2001 Pathfinder (R50)

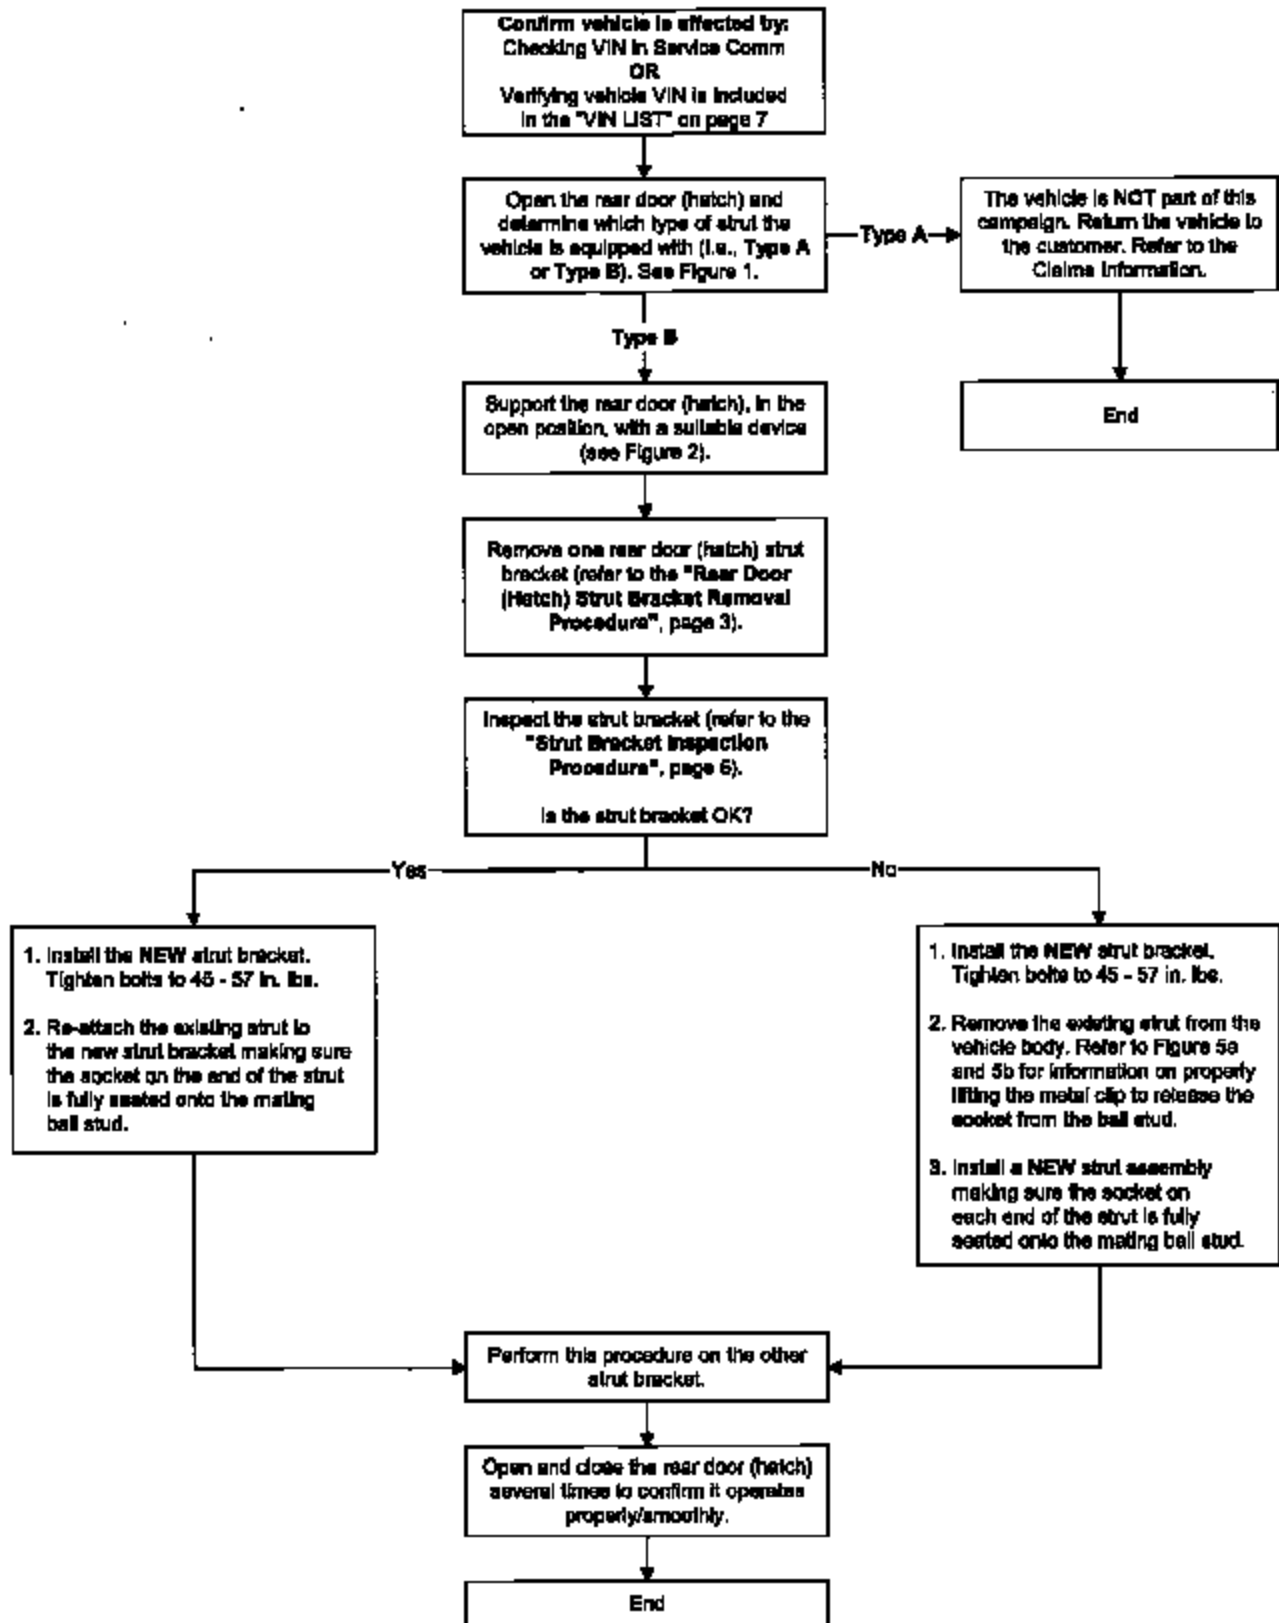
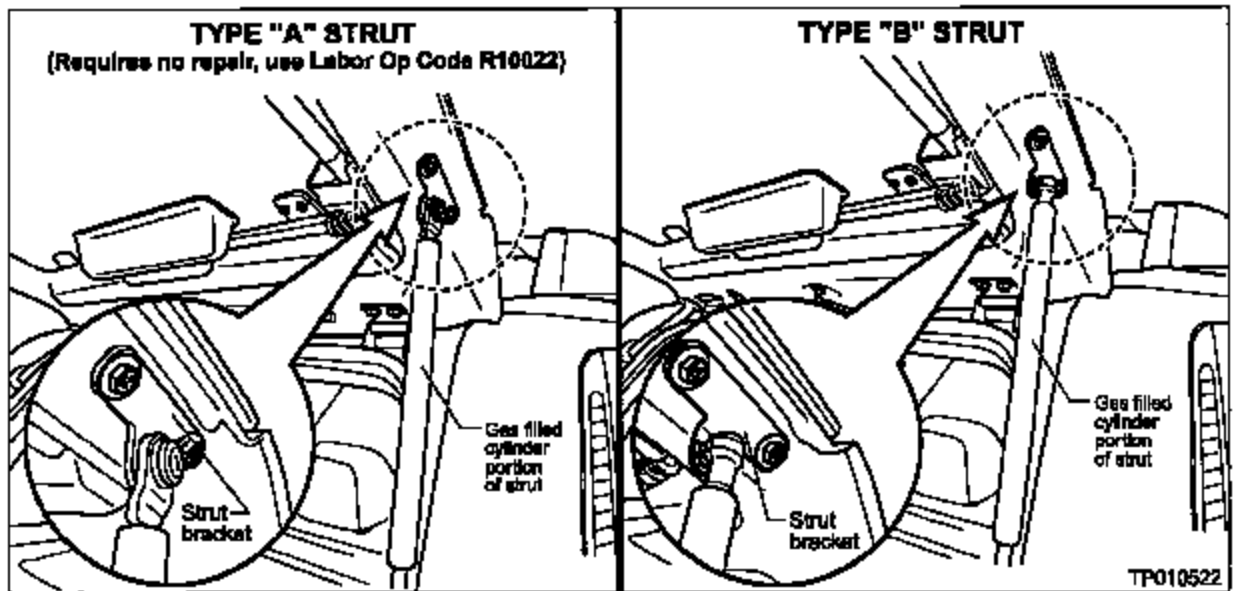
* See additional VINs on page 7. These vehicles may have had the "Type B" struts (refer to Figure 1 and Parts Information) previously installed as service parts.

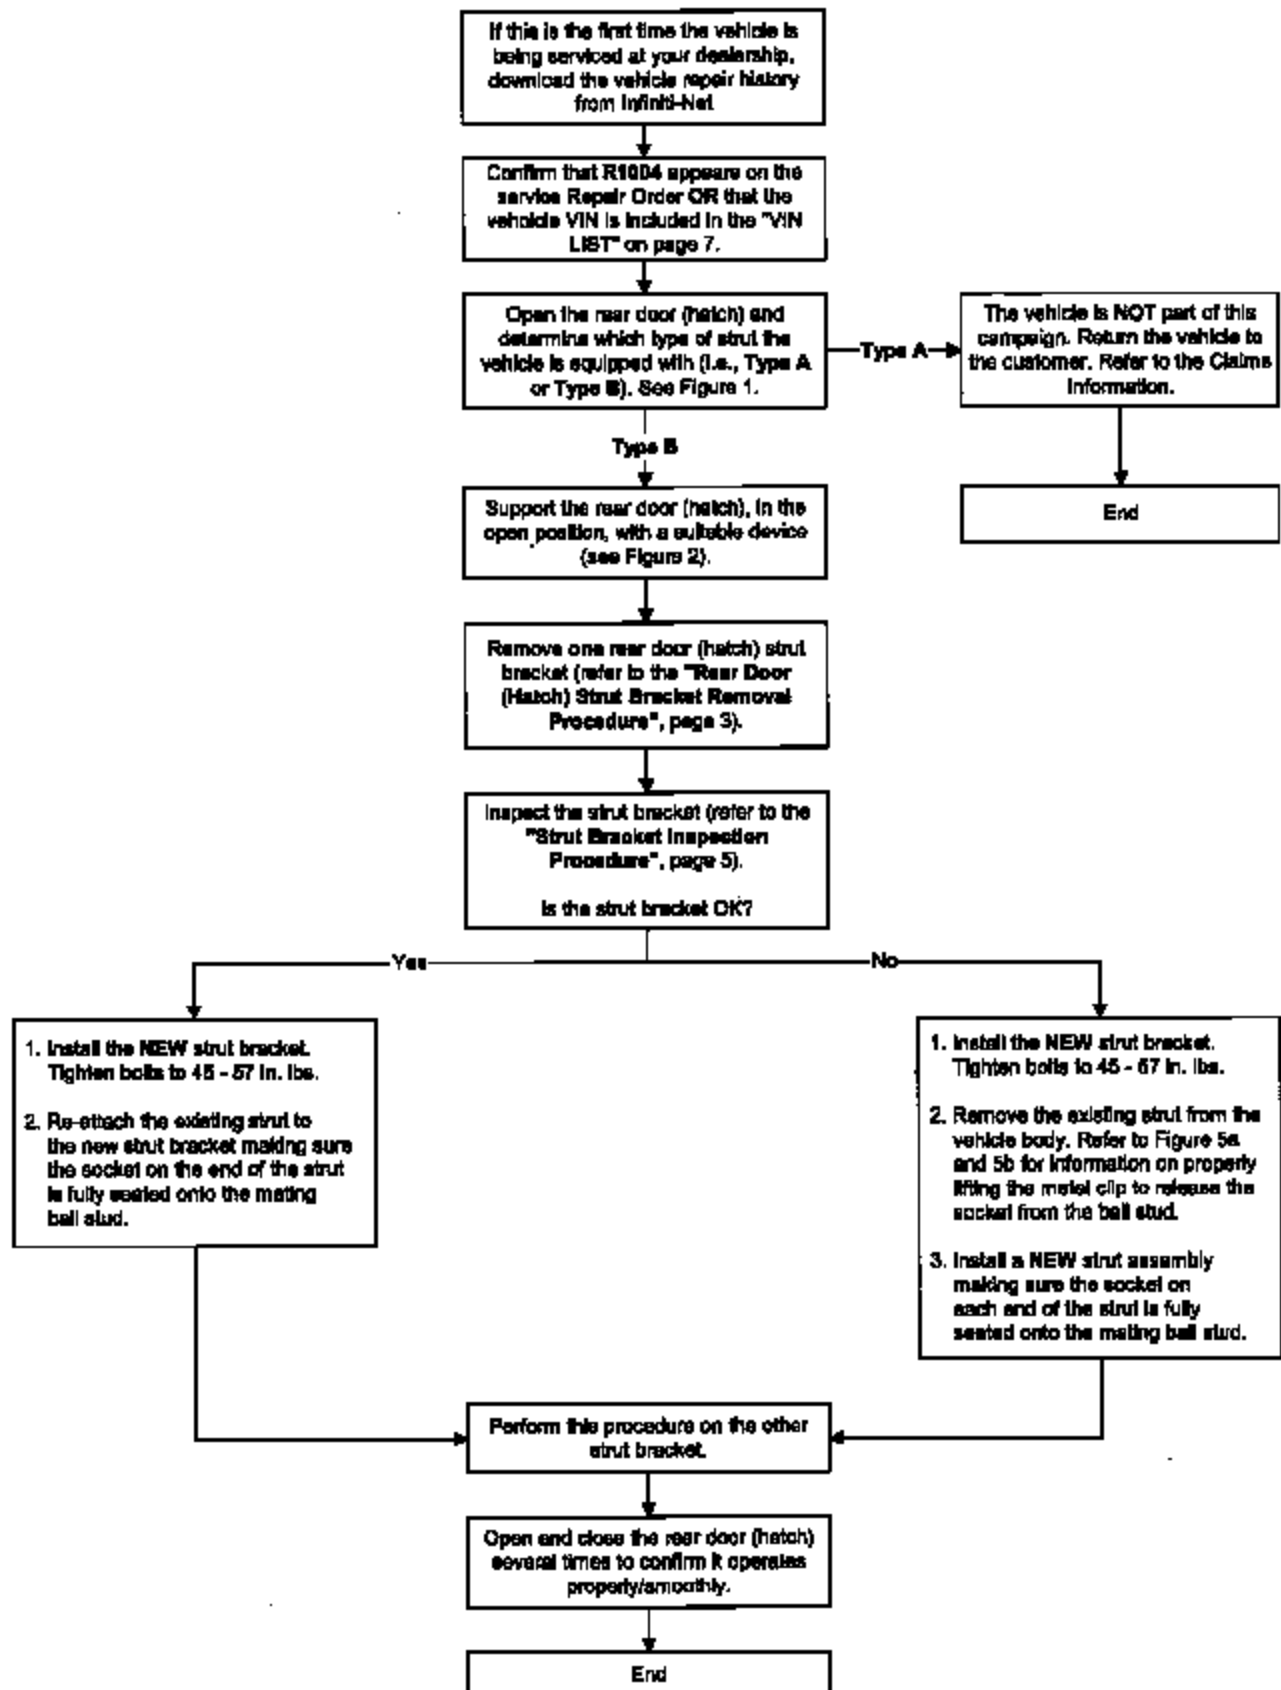
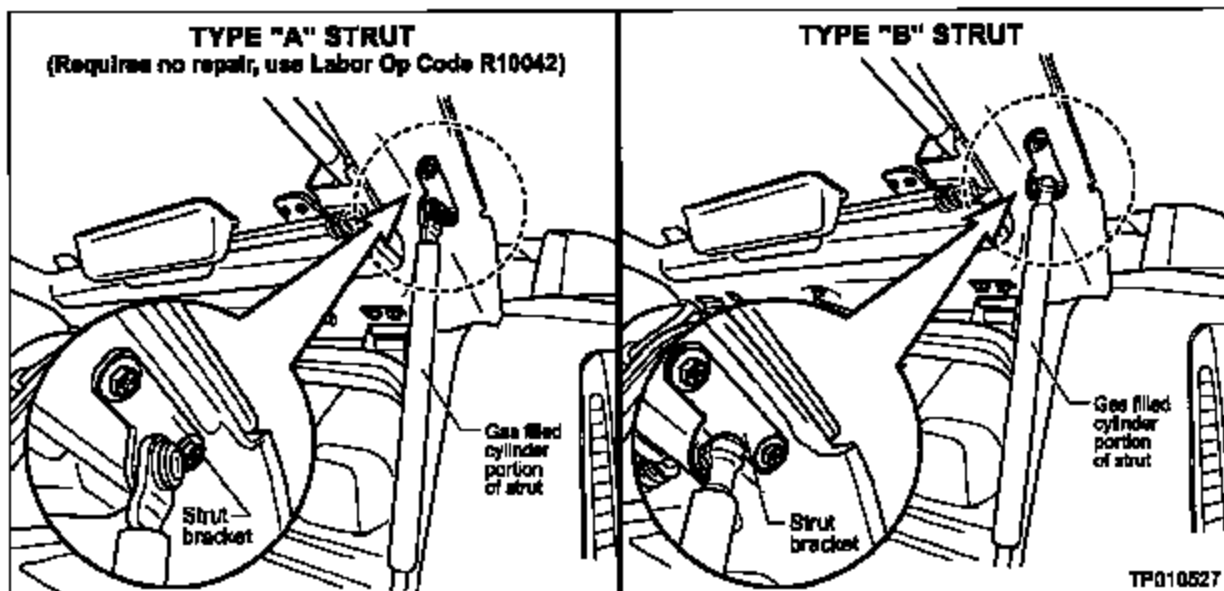
* See additional VINs on page 7. These vehicles may have had the "Type B" struts (refer to Figure 1 and Parts Information) previously installed as service parts.
