04V-135 ① of ⑮

IMPORTANT MOTORCYCLE SAFETY RECALL

**Service Bulletin 327
Recall Action
Confidential**

Affected Models Daytona 600, Speed Four
VIN Range See attached appendix
Markets France, Italy, Netherlands, Sweden, USA
Subject Fuel pump plate seal.

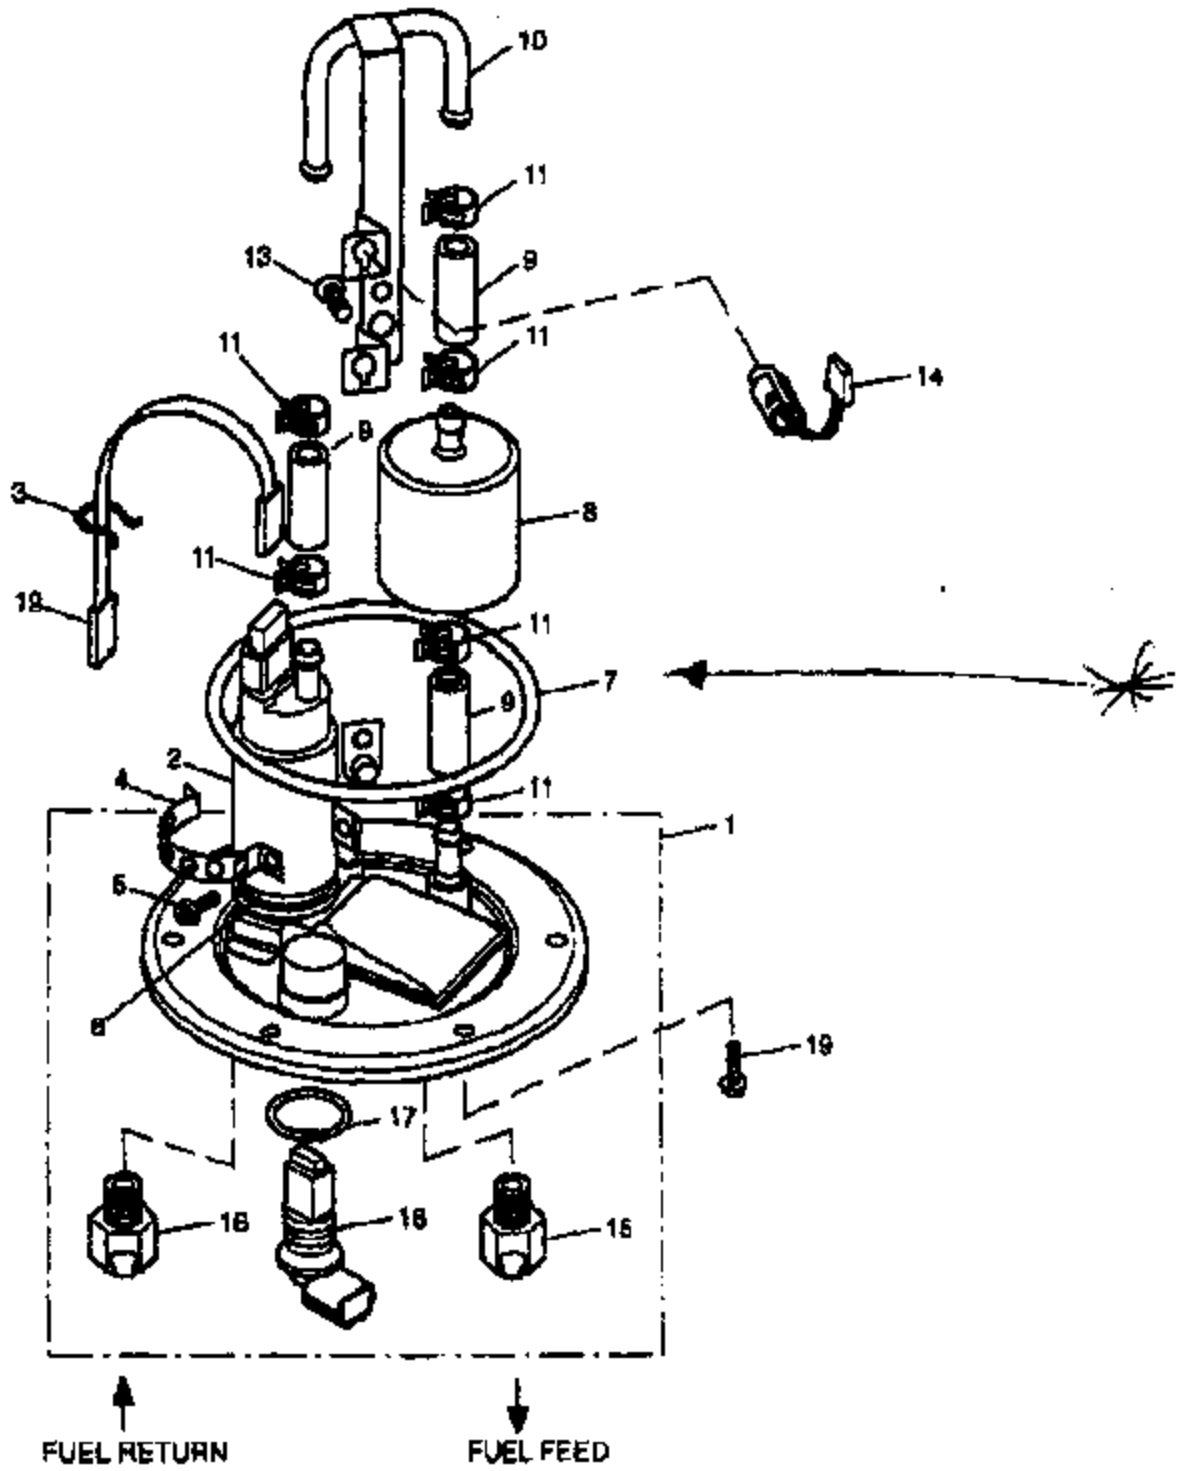
Quality control reviews and resulting tests have revealed the possibility of the fuel pump plate seal on the above models developing a leak. In order to ensure continued customer satisfaction, and in accordance with industry recall codes of practice, we require dealers to replace the fuel pump plate seal on all affected motorcycles.

4. Invert the fuel tank and place on a protective surface to prevent paint damage.
5. Remove the lock nuts and washers securing the fuel pump mounting plate to the tank.
