**RE: NOTIFICATION OF DEFECT**

MCI 2001 through 2003 model G4500 motor coaches manufactured at Motor Coach Industries Mexico's Sahagun facility prior to unit 80518.

# Service Bulletin No. 227

MODEL G4100/G4500 Series Coaches	TYPE Field Change Program	SECTION/GROUP 12-Suspension	DATE
SUBJECT <b>RADIUS ROD BRACKETS ON FRONT AXLE LEG ASSEMBLY</b>			
CONDITIONS

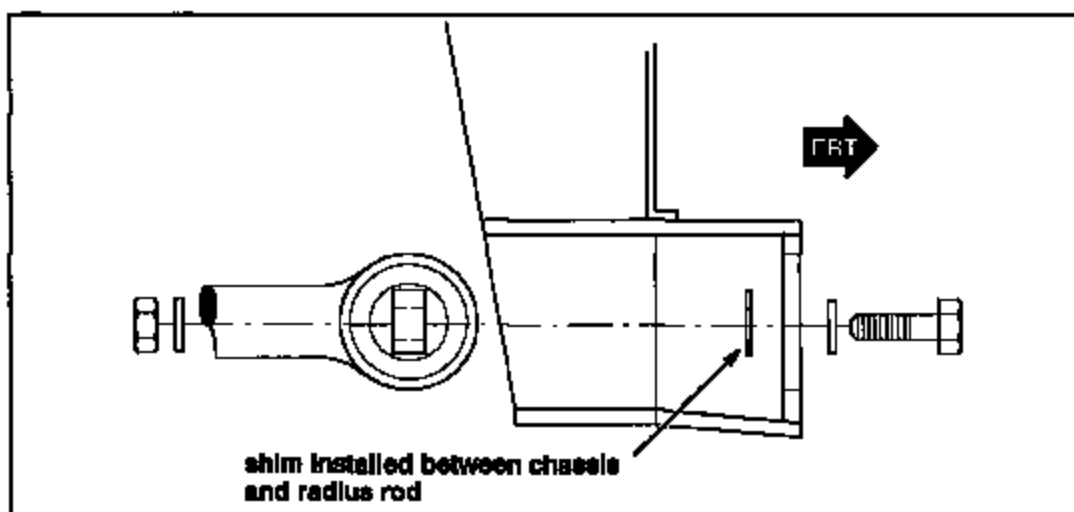
Figure 8.

**NOTE:** Excessive caster, in combination with some of the other items, and/or in combination with road conditions, can cause wheel shimmy. A recommended 3.0 degree caster angle can be achieved by shimming the radius rod's front mounting brackets. The lower bracket mountings are in line with the axle center, and therefore effect greater change (Figure 8). If caster angle is less than 2.0 degrees or more than 4.0 degrees contact MCI Customer Service for further instructions.
