04V-333
(17 pages)

DEFECT INFORMATION REPORT FOR DAIMLERCHRYSLER RECALL D21

Safety Recall B21 **Rear Floorpan Reinforcement Spot Welds**

2005 (LX) Chrysler 300 and Dodge Magnum

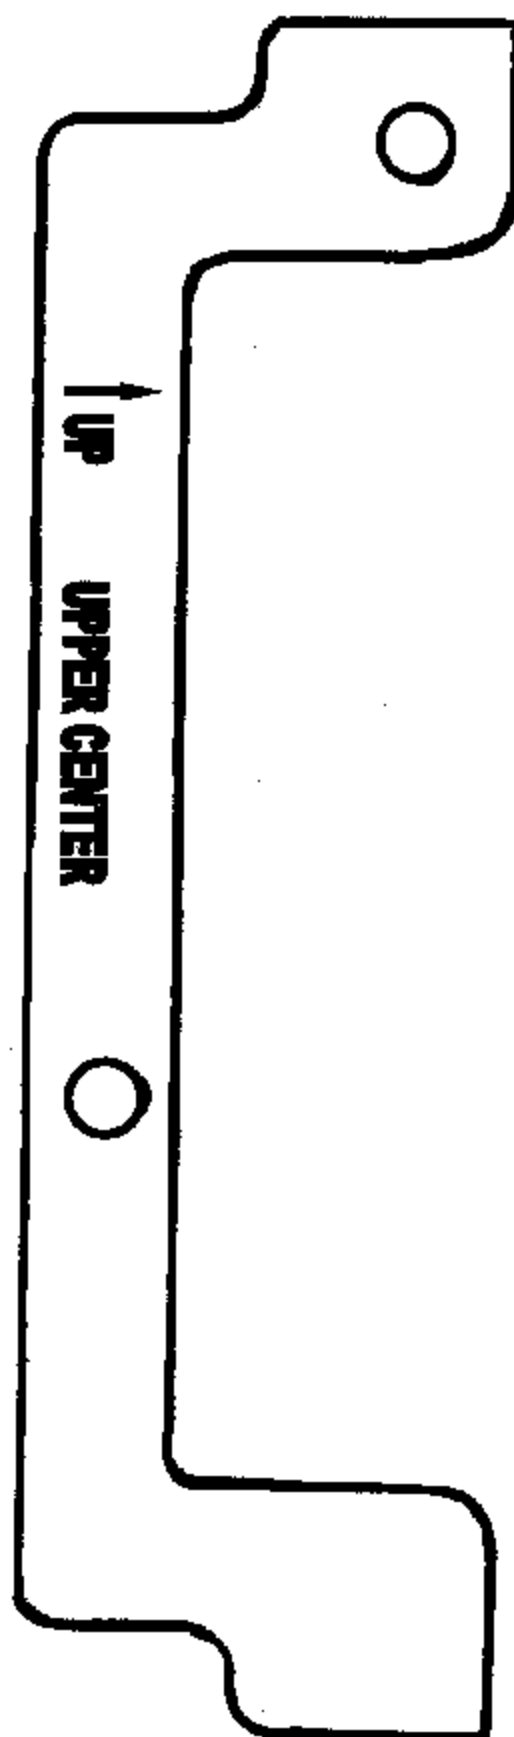
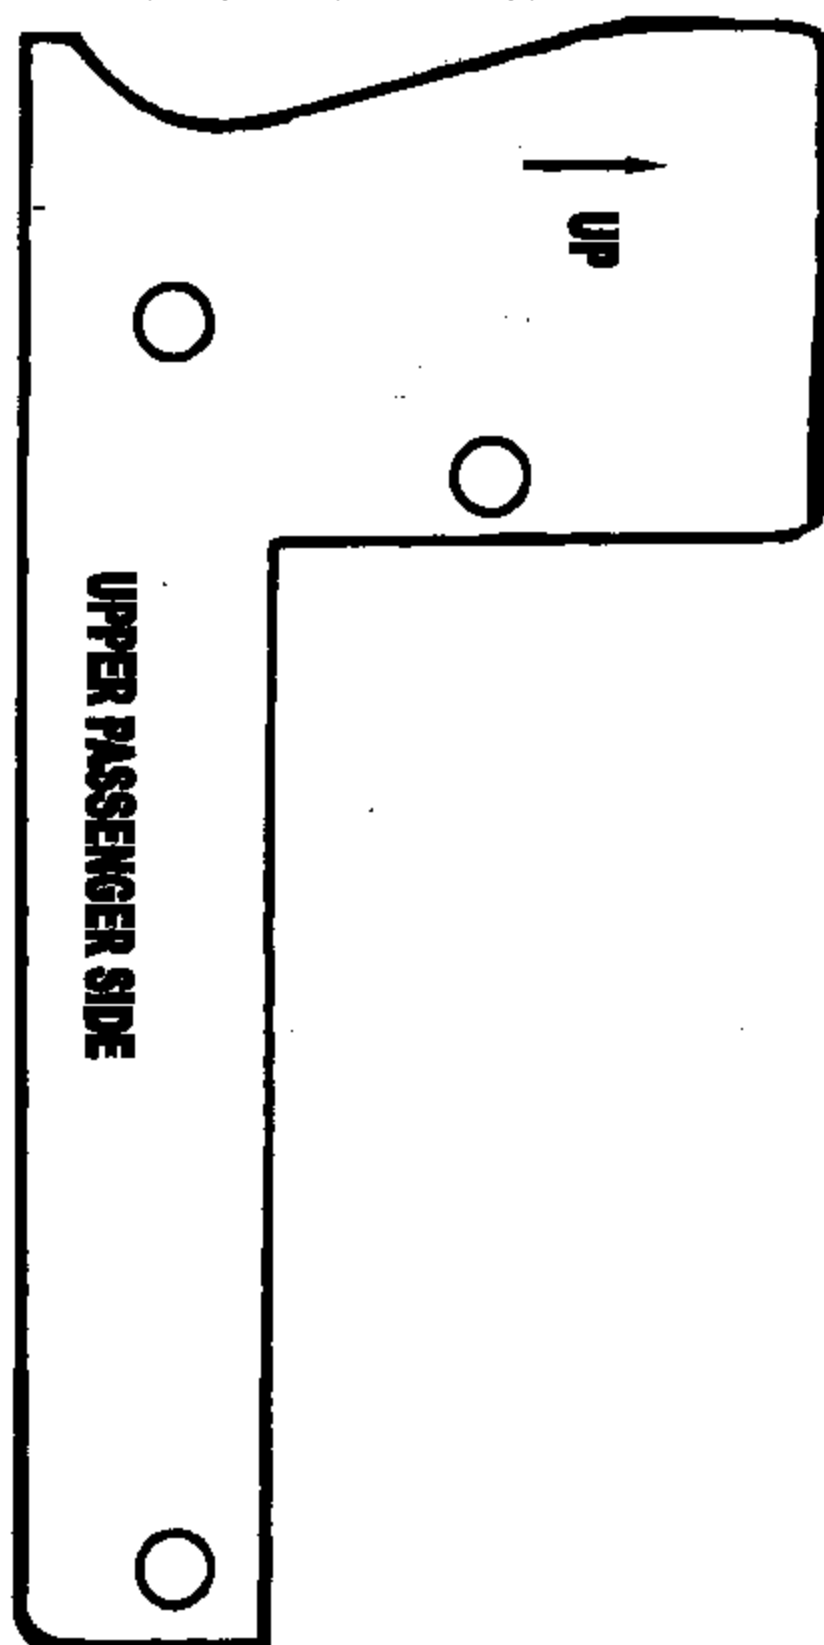
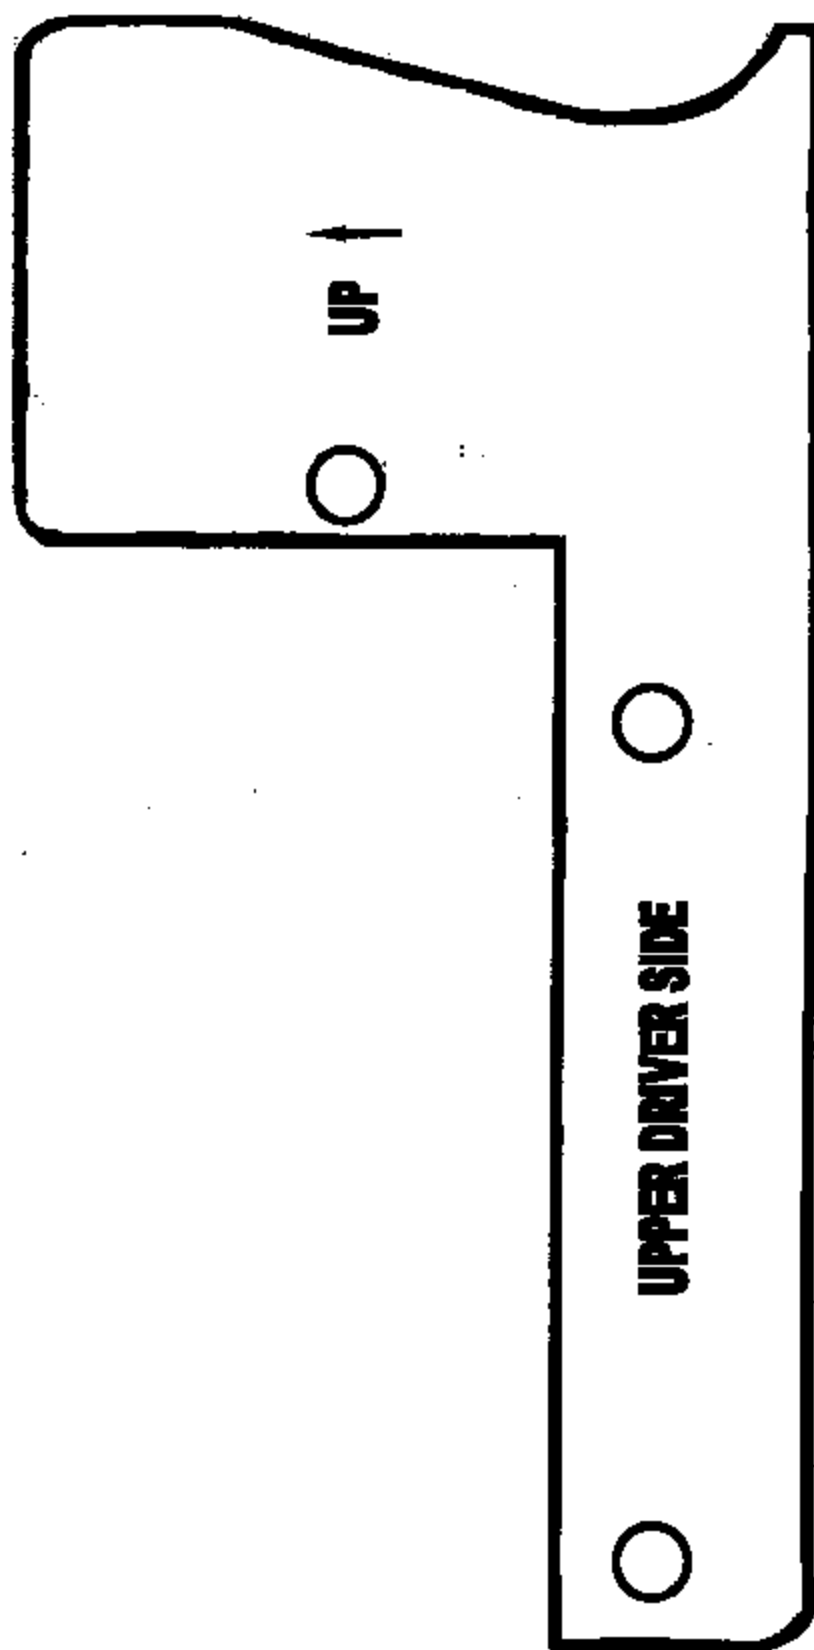
A spot welding operation for the rear floorpan reinforcement on 21 of the above vehicles may not have been performed. This could cause the rear seat belt anchors and the child seat anchors to separate in certain crash conditions, which can increase the risk of injury to rear seat passengers.

All involved vehicles must be inspected for the presence of rear floorpan reinforcement spot welds. Vehicles that have missing welds must have structural rivets installed.

8.
 - If spot welds are present, no further action is necessary. Continue with Step 9.
 - If spot welds are missing, continue with Section B – Install Structural Rivets.
9. Return the floor silencer pad to its original position.
10. Return the seat back carpet to its original position and install the push pins.
11. Return the seat back to its upright position.
12. Close the door.
13. Return the trunk floor cover to its original position.
14. Close the trunk lid.
15. Return the vehicle to the customer.

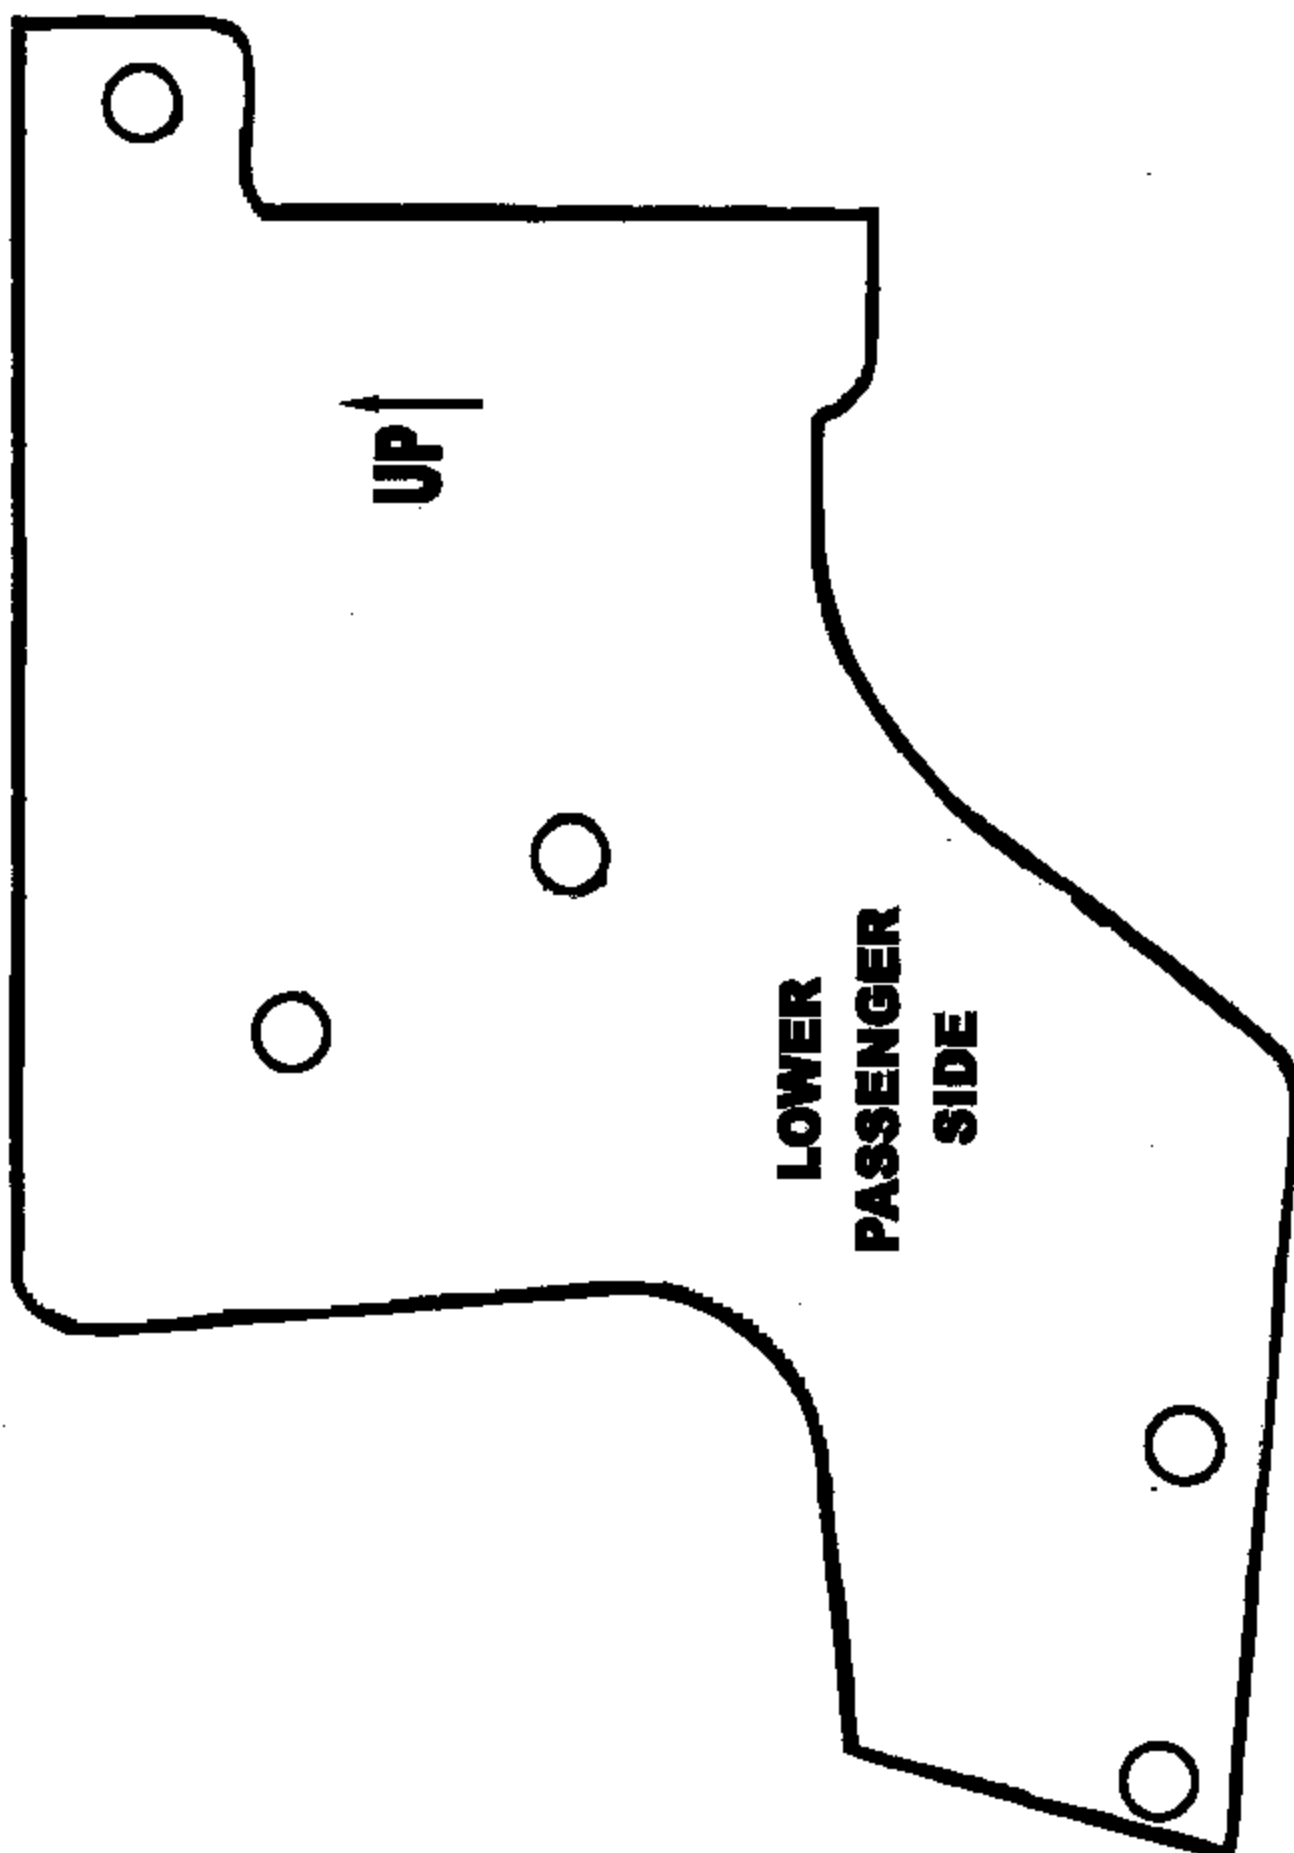
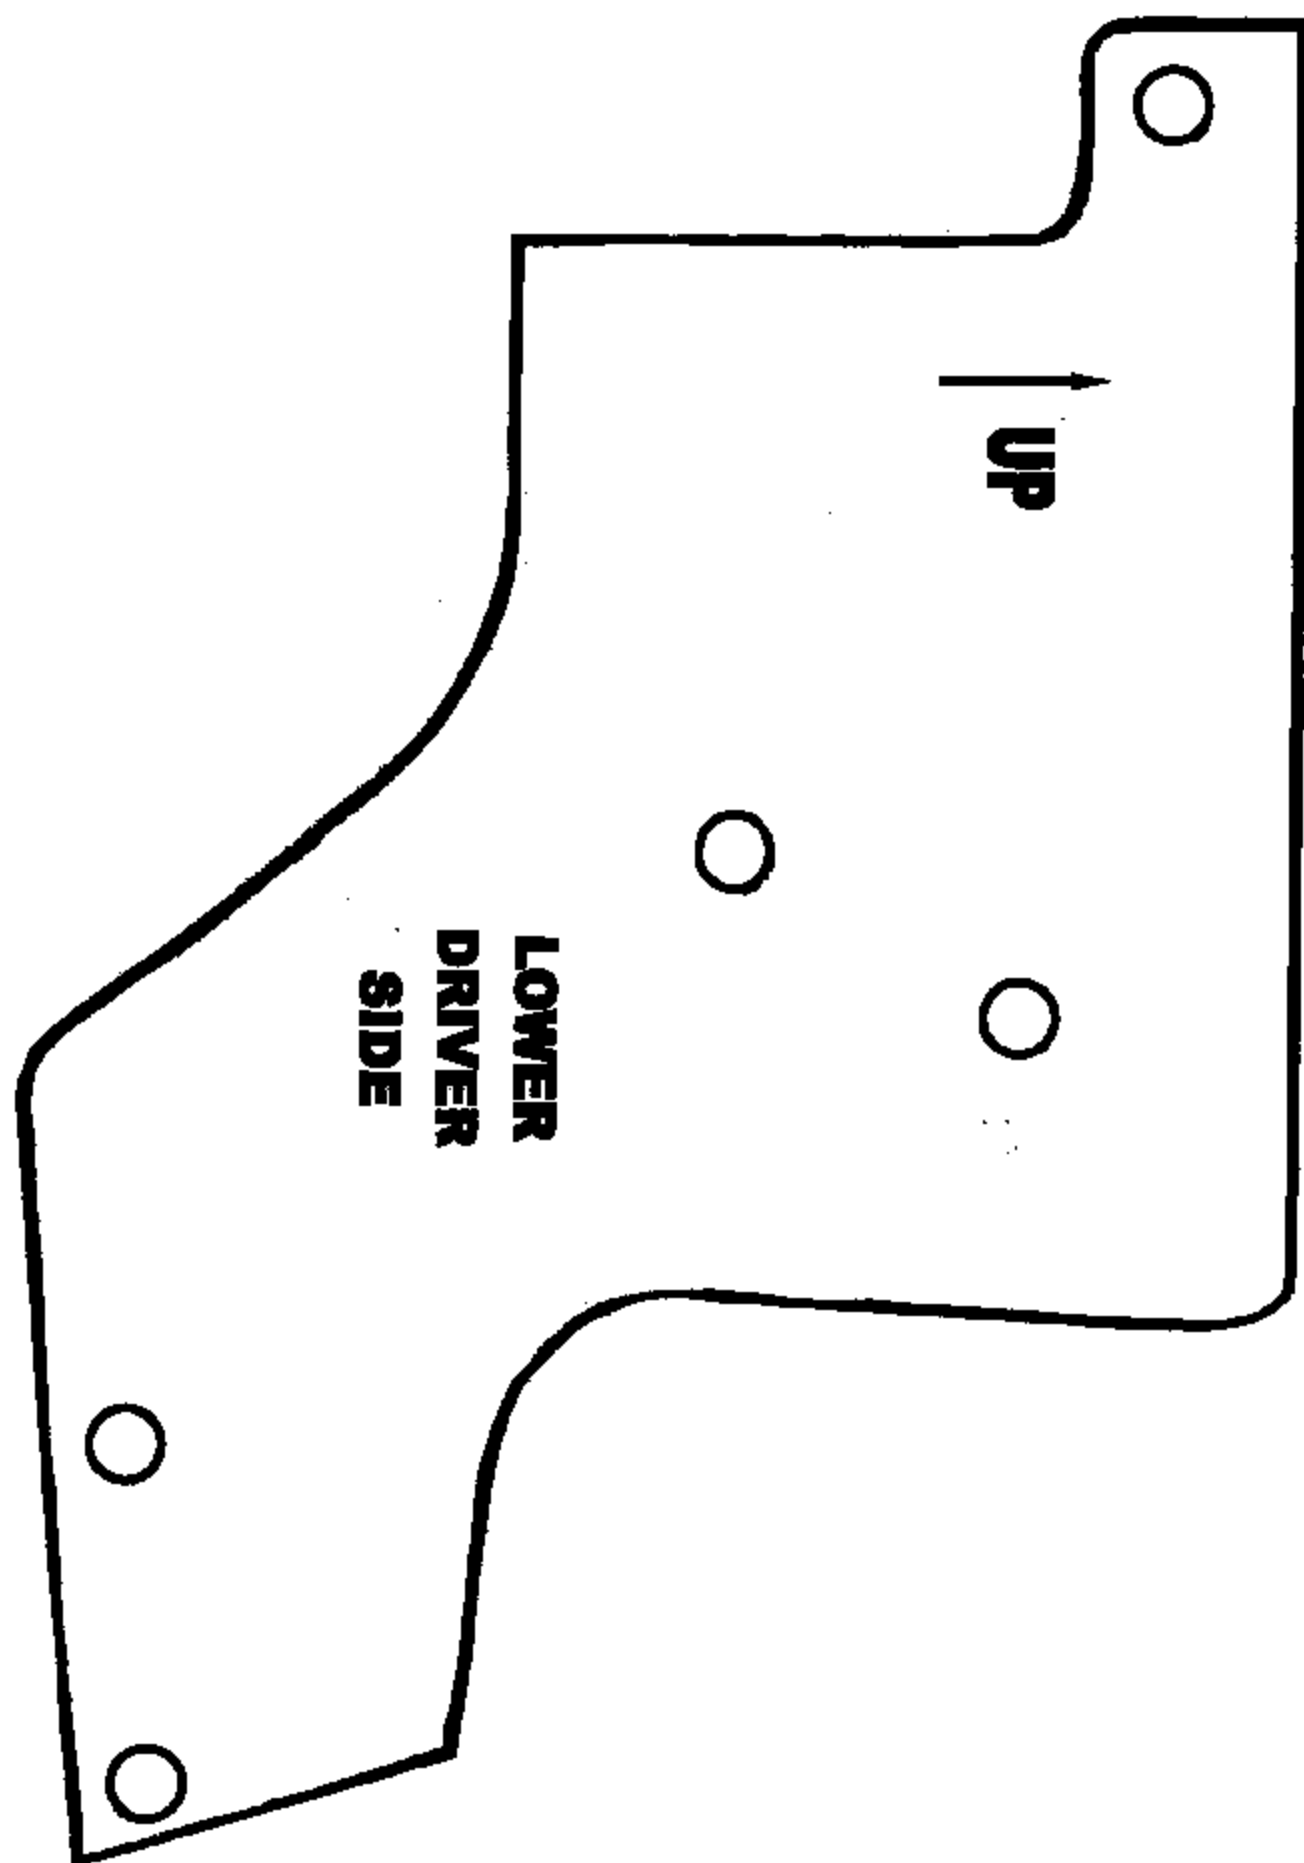
NOTE: Only vehicles with missing spot welds, as determined by the inspection in Section A, require repair. Very few vehicles are expected to require rivet installation.

13. Return the floor silencer pad to its original position.
14. Install the rear seat back. Tighten the six (6) seat back nuts to 35 ft-lbs (47 N·m).
15. Install the rear seat cushion.

16. Close the door.
17. Return the trunk floor cover to its original position.
18. Close the trunk lid.
