TOYOTA CUSTOMER SERVICES

Volume: XI
Number: TC04-020
Date: 11/15/2004
 Action
 Retain
 Information

SUBJECT: SPECIAL SERVICE CAMPAIGN (SSC) – 40K
(2000 MODEL YEAR TOYOTA CELICA AND ECHO MASTER CYLINDER INSPECTION)

TECHNICAL INSTRUCTIONS
FOR
SPECIAL SERVICE CAMPAIGN 40K
2000 CELICA
MASTER CYLINDER AND BRAKE BOOSTER INSPECTION

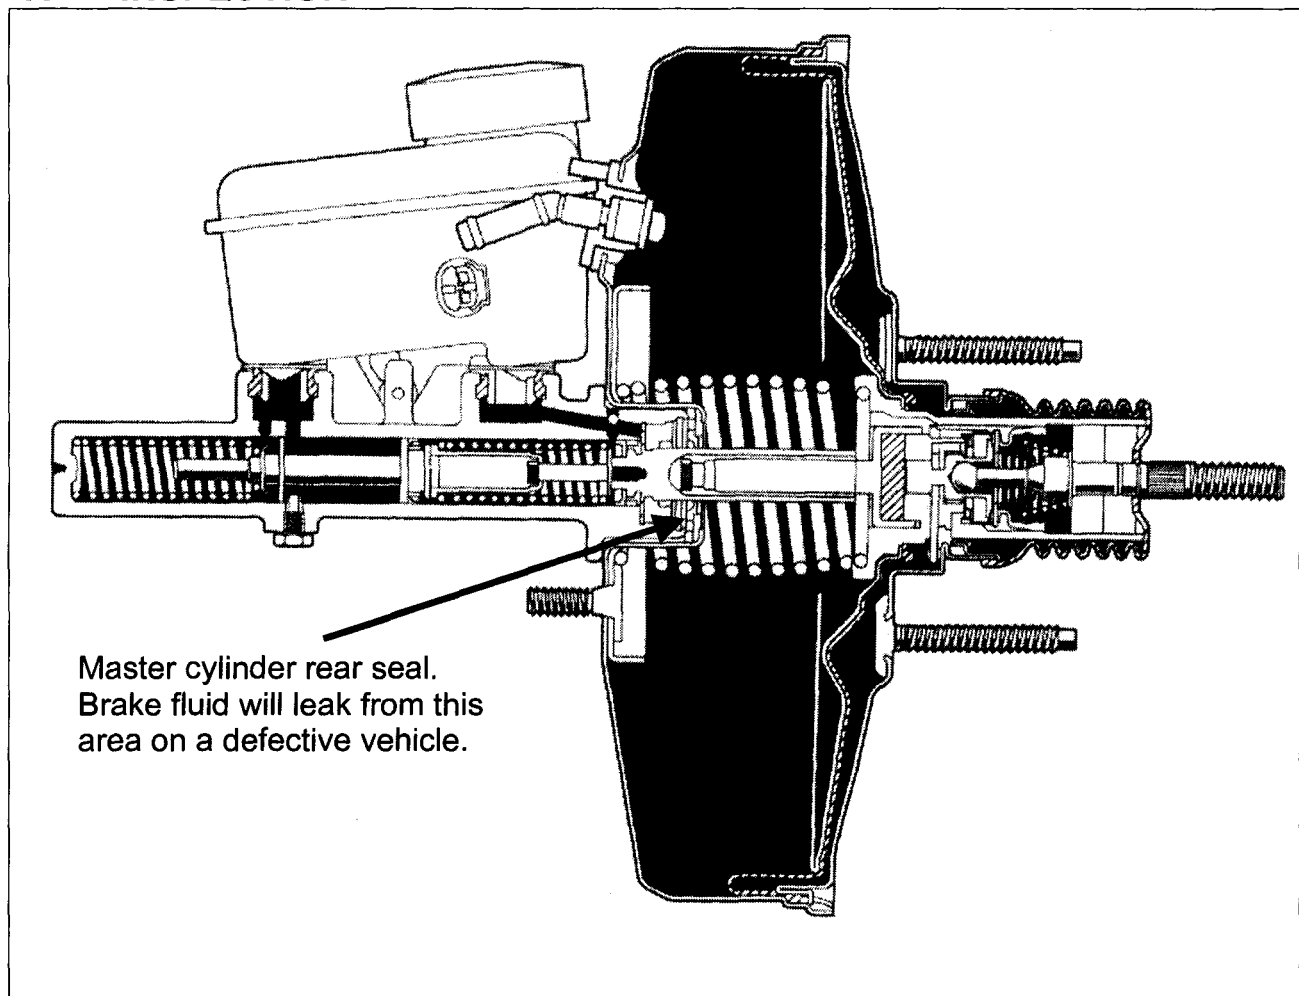
This SSC involves inspection to determine if the brake master cylinder is leaking. In certain 2000 MY Celica and Echo vehicles, there is a possibility that the recess that retains a rubber seal ring, which is located at the end of the brake master cylinder, may be corroded due to an improper cleaning process. In this condition, brake fluid may leak from the seal, or a small amount of air may enter the master cylinder, which could lead to an increase of vehicle stopping distance and thus raise the possibility of a crash. While doing the inspection ensure that any signs of external leakage are not from previous overfilling or spillage of the brake fluid when refilling the reservoir. ***The brake master cylinder/brake booster assembly replacement rate is expected to be between 3 and 5%.***

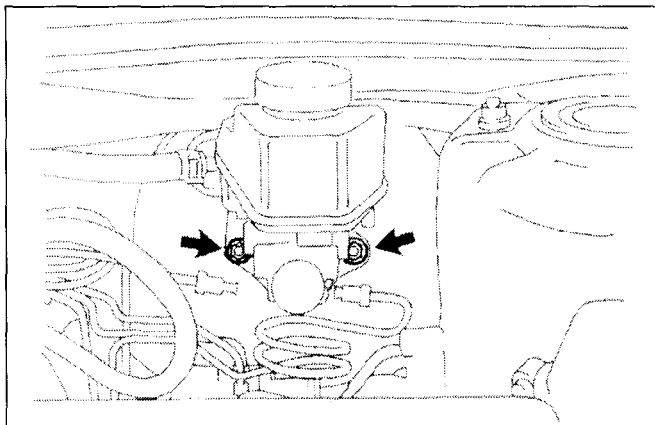
- (j) Check for signs of brake fluid leakage inside the booster. Use a pencil as shown. Check that the paint does not come off the brake booster.

The pencil is used as a non-abrasive tool to determine if the paint on the booster has been damaged due to leaking brake fluid.

If the master cylinder is leaking, it must be replaced along with the brake booster. Refer to the appropriate repair manual for replacement procedures and to page 3 for parts information. (Remember to keep the replaced master cylinder/brake booster assembly under the terms of the Warranty Parts Return Policy)

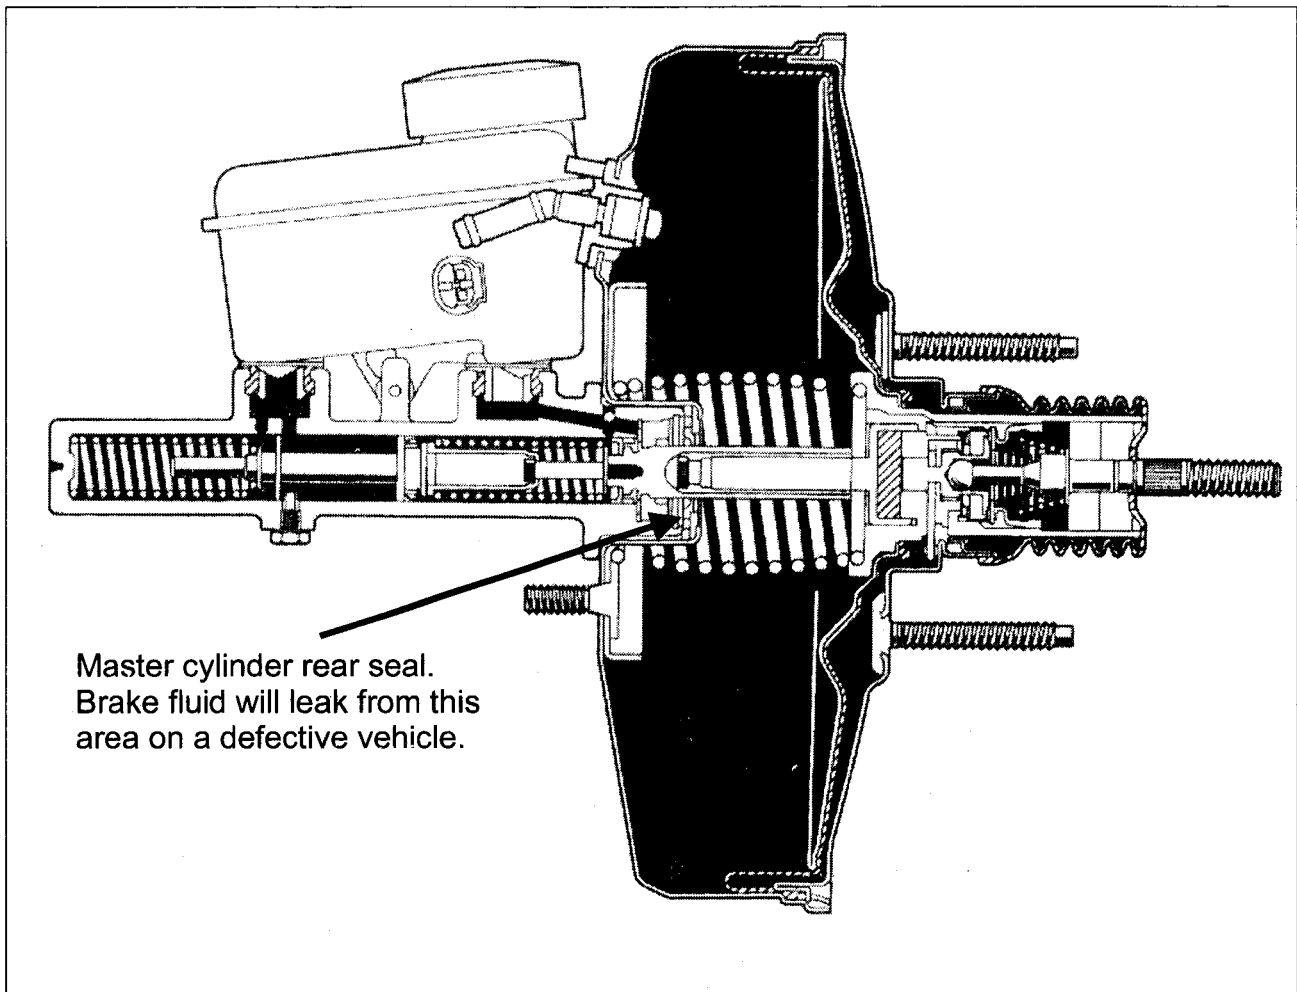
This SSC involves inspection of the rear seal of the brake master cylinder for leakage. In certain 2000 MY Celica and Echo vehicles, there is a possibility that the recess that retains a rubber seal ring, which is located at the end of the brake master cylinder, may be corroded due to an improper cleaning process. In this condition, brake fluid may leak from the seal, or a small amount of air may enter the master cylinder, which could lead to an increase of vehicle stopping distance and thus raise the possibility of a crash. While doing the inspection ensure that any signs of external leakage are not from previous overfilling or spillage of the brake fluid when refilling the reservoir. ***The brake master cylinder/brake booster assembly replacement rate is expected to be between 3 and 5%.***

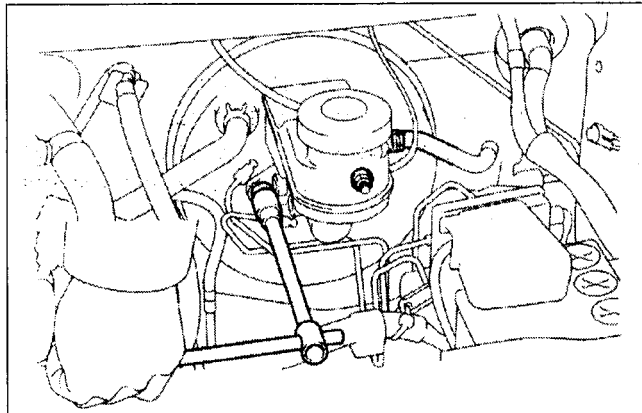
- (f) Check for signs of brake fluid leakage inside the booster. Use a pencil as shown. Check that the paint does not come off the brake booster.

If the master cylinder is leaking, it must be replaced along with the brake booster. Refer to the appropriate repair manual for replacement procedures and to page 3 for parts information.
