# TOYOTA CUSTOMER SERVICES

Volume: XI  
Number: TC04-020  
Date: 11/15/2004  
 Action  
 Retain  
 Information

SUBJECT: SPECIAL SERVICE CAMPAIGN (SSC) – 40K  
(2000 MODEL YEAR TOYOTA CELICA AND ECHO MASTER CYLINDER INSPECTION)

**TECHNICAL INSTRUCTIONS**  
**FOR**  
**SPECIAL SERVICE CAMPAIGN 40K**  
**2000 CELICA**  
**MASTER CYLINDER AND BRAKE BOOSTER INSPECTION**

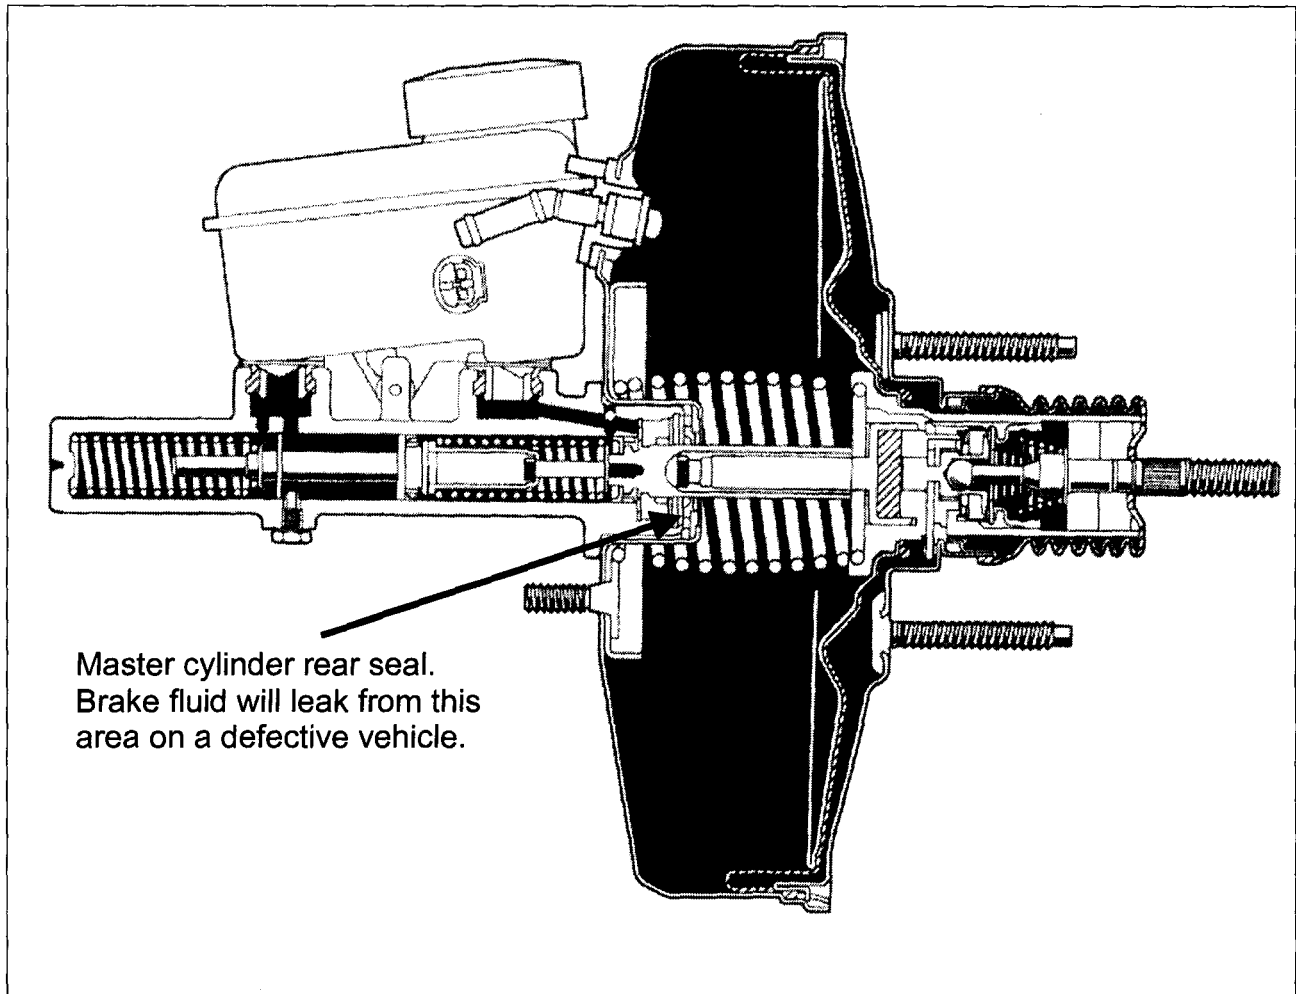
This SSC involves inspection to determine if the brake master cylinder is leaking. In certain 2000 MY Celica and Echo vehicles, there is a possibility that the recess that retains a rubber seal ring, which is located at the end of the brake master cylinder, may be corroded due to an improper cleaning process. In this condition, brake fluid may leak from the seal, or a small amount of air may enter the master cylinder, which could lead to an increase of vehicle stopping distance and thus raise the possibility of a crash. While doing the inspection ensure that any signs of external leakage are not from previous overfilling or spillage of the brake fluid when refilling the reservoir. ***The brake master cylinder/brake booster assembly replacement rate is expected to be between 3 and 5%.***

- (a) Check (visually and by feel) for fluid leakage from the master cylinder in the area shown.

If the master cylinder is leaking, it must be replaced along with the brake booster. Refer to the appropriate repair manual for replacement procedures and to page 3 for parts information. (Remember to keep the replaced master cylinder/brake booster assembly under the terms of the Warranty Parts Recovery policy)

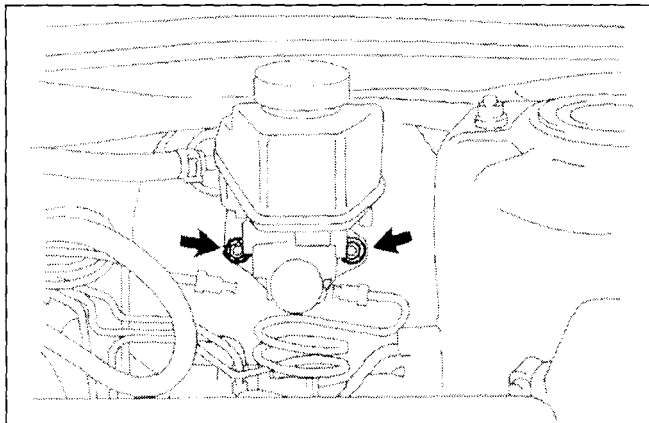
- (j) Check for signs of brake fluid leakage inside the booster. Use a pencil as shown. Check that the paint does not come off the brake booster.

The pencil is used as a non-abrasive tool to determine if the paint on the booster has been damaged due to leaking brake fluid.

If the master cylinder is leaking, it must be replaced along with the brake booster. Refer to the appropriate repair manual for replacement procedures and to page 3 for parts information. (Remember to keep the replaced master cylinder/brake booster assembly under the terms of the Warranty Parts Return Policy)

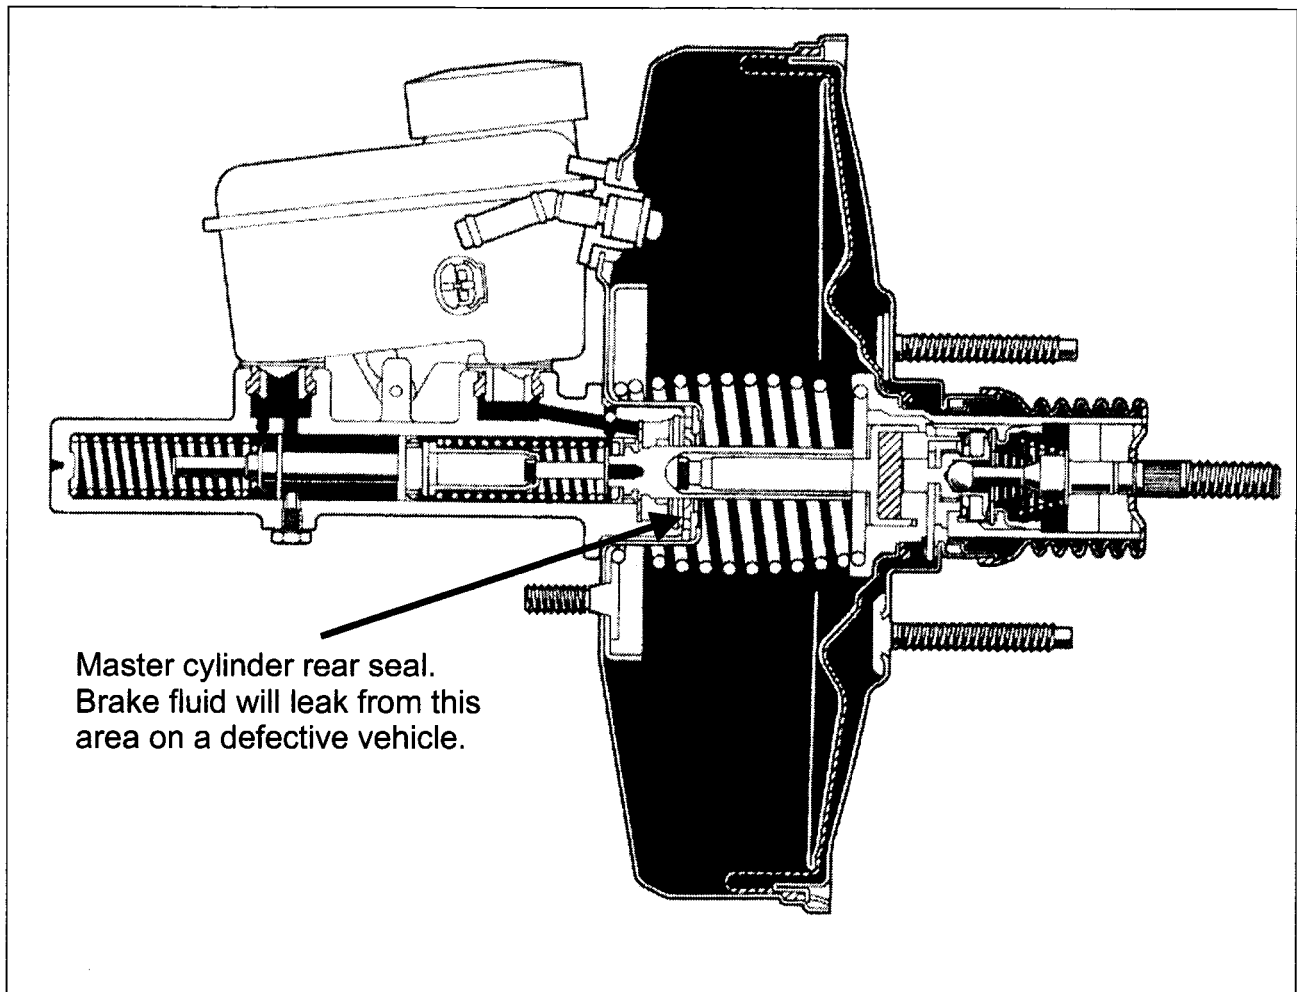
This SSC involves inspection of the rear seal of the brake master cylinder for leakage. In certain 2000 MY Celica and Echo vehicles, there is a possibility that the recess that retains a rubber seal ring, which is located at the end of the brake master cylinder, may be corroded due to an improper cleaning process. In this condition, brake fluid may leak from the seal, or a small amount of air may enter the master cylinder, which could lead to an increase of vehicle stopping distance and thus raise the possibility of a crash. While doing the inspection ensure that any signs of external leakage are not from previous overfilling or spillage of the brake fluid when refilling the reservoir. ***The brake master cylinder/brake booster assembly replacement rate is expected to be between 3 and 5%.***

- (a) Check (visually and by feel) for fluid leakage from the master cylinder in the area shown.

If the master cylinder is leaking, it must be replaced along with the brake booster. Refer to the appropriate repair manual for replacement procedures and to page 3 for parts information. (Remember to keep the replaced master cylinder/brake booster assembly under the terms of the Warranty Parts Recovery policy)

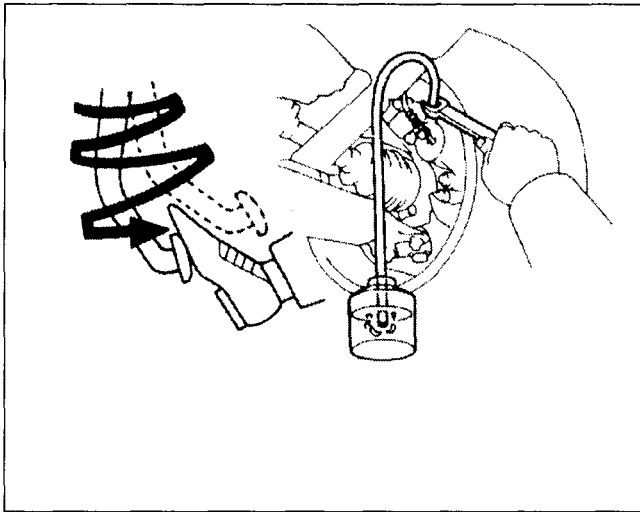
**2. INSPECT FOR AIR BY MANUALLY BLEEDING THE BRAKE SYSTEM.**  
**(Do not use a pressure or vacuum type brake bleeder)**

If any air is found, the master cylinder and brake booster must be replaced.

***However, ensure that the any air found in the brake system is from the master cylinder. Due to the distance of the master cylinder, immediately visible air is not from the master cylinder. (Remember to keep the replaced master cylinder/brake booster assembly under the terms of the Warranty Parts Recovery policy)***

Refer to the appropriate repair manual for replacement procedures and to page 3 for parts information.

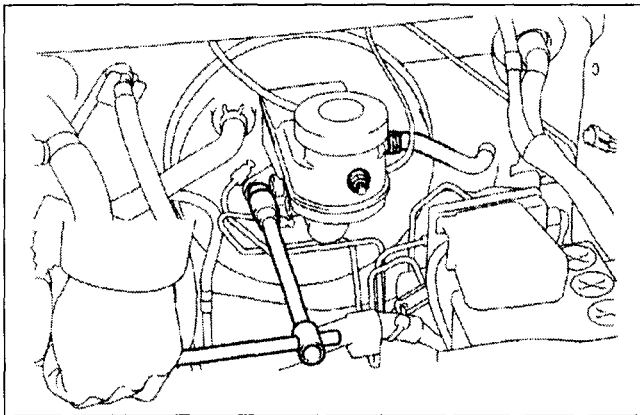
- (f) Check for signs of brake fluid leakage inside the booster. Use a pencil as shown. Check that the paint does not come off the brake booster.

If the master cylinder is leaking, it must be replaced along with the brake booster. Refer to the appropriate repair manual for replacement procedures and to page 3 for parts information.
