TO: All Mazda Dealership General Managers, Service Managers, and Parts Managers
DATE: July 2012
SUBJECT: 2002-2004 Tribute Accelerator Cable Safety Recall 2704L – **UPDATE**

On certain 2002-2004 Tribute vehicles equipped with 3.0L engines, the accelerator cable may prevent the throttle from returning to the idle position, possibly resulting in elevated engine speeds while driving. An unexpected increase in engine idle speed may increase stopping distance and may result in a vehicle crash without warning.

2002 - 2004 TRIBUTE ACCELERATOR CABLE [RECALL 2704L]

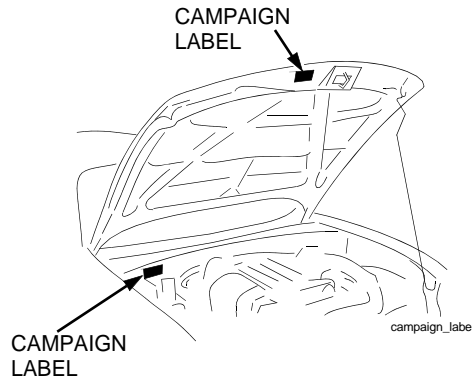
2. Perform a Warranty Vehicle Inquiry using your eMDCS System and inspect vehicle for an Authorized Modification Label **Recall 2704L** attached to the vehicle's hood. Refer to eMDCS System - Warranty Vehicle Inquiry Results table below.

NOTE: Be sure to verify RECALL number as the vehicle may have multiple Recall labels.
