Transport Canada Recall # 04-214 (NHTSA Recall # 04V-380)

This letter is a Motor Vehicle Safety Act, Section 10, Article report that Fleetwood Enterprises Inc., is voluntarily initiating a recall campaign for conventional and fifth wheel travel trailers.

## IMPORTANT RECALL INFORMATION #40521

#### Recall Service Bulletin

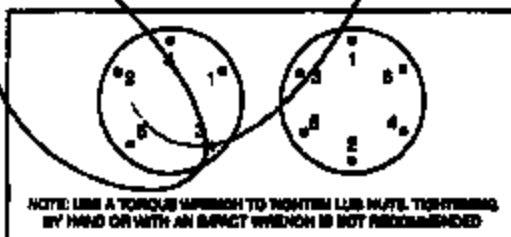
### Wheel Lug Nut Tightening Sequence

If not properly tightened, loose lug nuts can damage the stud and/or wheel. If driven in this condition for any extended period, severe wheel damage or loss could occur affecting the handling of your trailer.

Before each trip be sure to check and tighten the wheel lug nuts if necessary to the torque specification. If a wheel has been removed or replaced check the torque again at 10, 25, and 50 miles of initial road use.
