GM SERVICE AND PARTS OPERATIONS
DCS1282
URGENT DISTRIBUTE IMMEDIATELY

Subject: 04007A - Product Safety Recall
Tailgate Support Cable
Parts Availability Update

Models: 2002-2004 Cadillac Escalade EXT
2000 Chevrolet C/K
2000-2004 Chevrolet Silverado
2002-2004 Chevrolet Avalanche
2000-2004 GMC Sierra

Bulletin No.: 04007A

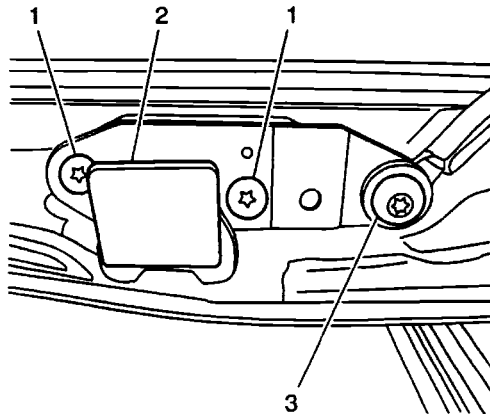
1551755

If the support cable (2) has NOT been replaced previously, there will be a toothed nut or plastic nut (1) located between the latch (4) and the tailgate that MAY prevent the bolt (3) from being removed in the next step. The nut is an assembly aid used in the assembly plant. Do not reinstall or replace the toothed or plastic nut when installing the new support cable.

3. Loosen the bolt (3) that attaches the opposite end of the support cable to the latch assembly (2).
 - o If the toothed or plastic nut IS present, you will only be able to loosen the bolt partially from the latch. If this condition is encountered, proceed to the next step.
 - o If the toothed or plastic nut is NOT present, proceed to Step 8.

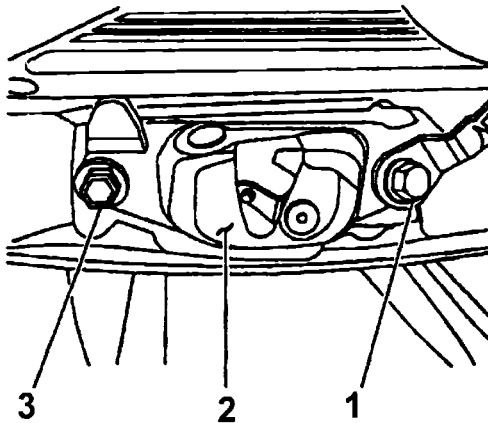
1537875

If the support cable (2) has NOT been replaced previously, there will be a toothed nut (1) located between the latch (4) and the tailgate that will prevent the bolt (3) from being removed in the next step. The nut is an assembly aid used in the assembly plant. The nut does NOT need to be reinstalled or replaced when installing a new support cable in this recall.

1. Loosen the bolt (1) that attaches the opposite end of the support cable to the latch assembly (2).
 - o If the toothed nut is present, you will only be able to loosen the bolt partially from the latch. If this condition is encountered, proceed to the next step.
 - o If the toothed nut is not present, proceed to Step 6.
