**GM SERVICE AND PARTS OPERATIONS
DCS1489
URGENT - DISTRIBUTE IMMEDIATELY**

Subject: Product Safety Recall Bulletin 04007B
Tailgate Support Cable
Addition to Involved Vehicle Population

Bulletin No.: 04007B

SUBJECT: TAILGATE SUPPORT CABLE

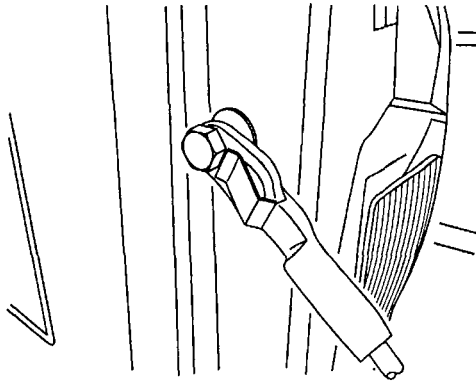
1537874

3. Inspect the end (eyelet) of the support cable that attaches to the tailgate for sealant covering the end of the cable strands.
 - If there IS a clear type sealant (1) over the end of the cable strands, the support cable needs to be replaced. Reconnect the support cable to the pickup box and perform this same inspection on the left support cable. After inspecting both cables, proceed to the section titled, "Hinge Inspection."
 - If there IS NOT a clear type sealant (2) over the end of the cable strands, that support cable does NOT need to be replaced. Reconnect the support cable to the pickup box and perform this same inspection on the left support cable. After inspecting both cables, proceed to the section titled, "Hinge Inspection."

2. Release (unhook) the right side tailgate support cable from the pickup box.
