**GM SERVICE AND PARTS OPERATIONS  
DCS1489  
URGENT - DISTRIBUTE IMMEDIATELY**

Subject: Product Safety Recall Bulletin 04007B  
Tailgate Support Cable  
Addition to Involved Vehicle Population

Bulletin No.: 04007B

**SUBJECT:** TAILGATE SUPPORT CABLE

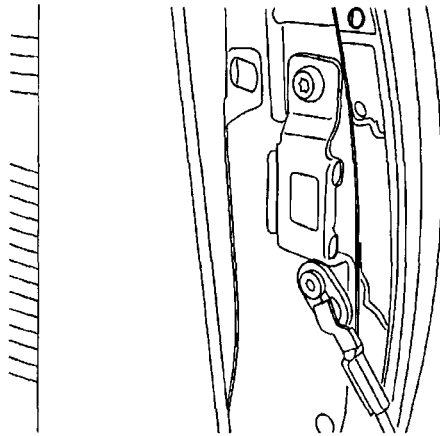
1551752

2. Release (unhook) the right side tailgate support cable from the pickup box.

**Important:** If the support cable (2) has NOT been replaced previously, there will be a toothed nut or plastic nut (1) located between the latch (4) and the tailgate that MAY prevent the bolt (3) from being removed in the next step. The nut is an assembly aid used in the assembly plant. Do not reinstall or replace the toothed or plastic nut when installing the new support cable.

3. Loosen the bolt (3) that attaches the opposite end of the support cable to the latch assembly (2).
  - If the toothed or plastic nut IS present, you will only be able to loosen the bolt partially from the latch. If this condition is encountered, proceed to the next step.
  - If the toothed or plastic nut is NOT present, proceed to Step 8.

4. If the toothed or plastic nut is present, loosen the other two bolts (1) attaching the latch (2) to the tailgate. DO NOT remove these bolts.
5. Finish loosening the bolt that attaches the support cable. The bolt will NOT be removable even though the threads are completely out.

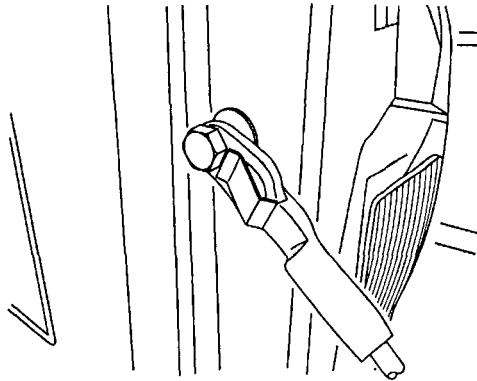
1537874

2. Release (unhook) the right side tailgate support cable from the pickup box.

3. Inspect the end (eyelet) of the support cable that attaches to the tailgate for sealant covering the end of the cable strands.
  - If there IS a clear type sealant (1) over the end of the cable strands, the support cable needs to be replaced. Reconnect the support cable to the pickup box and perform this same inspection on the left support cable. After inspecting both cables, proceed to the section titled, "Hinge Inspection."
  - If there IS NOT a clear type sealant (2) over the end of the cable strands, that support cable does NOT need to be replaced. Reconnect the support cable to the pickup box and perform this same inspection on the left support cable. After inspecting both cables, proceed to the section titled, "Hinge Inspection."
